Japanese Thunderfish

By John F. De Virgilio

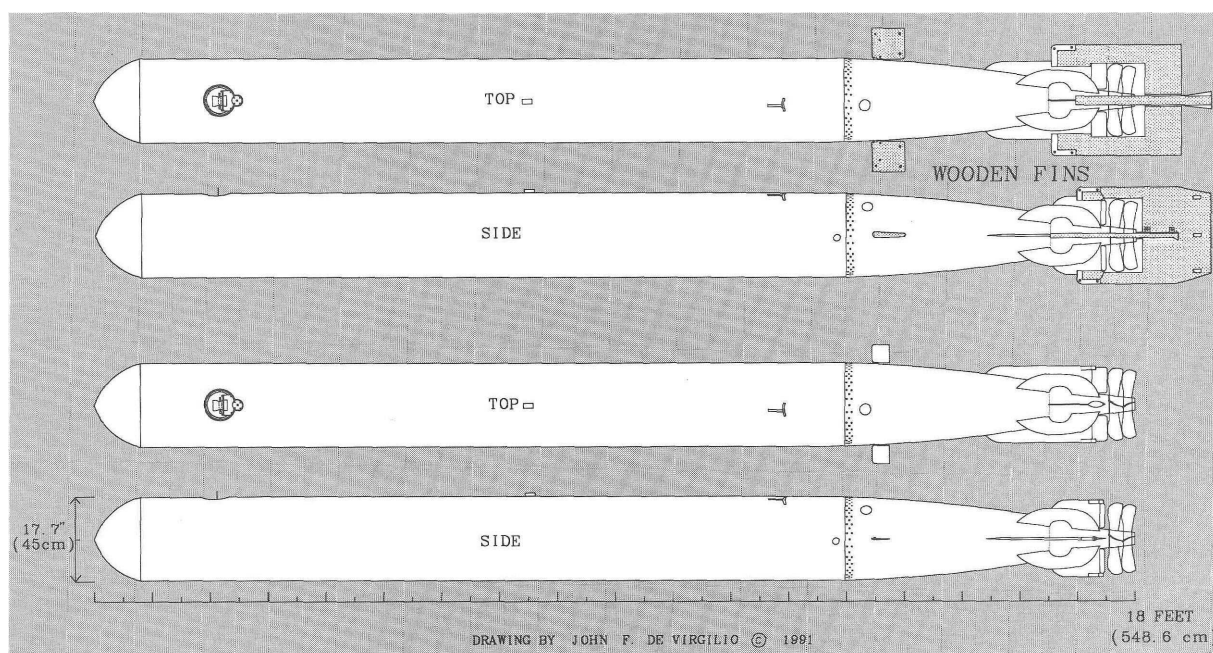
Illus. A: The shaded portions are the wooden fins that came off on entering the water.

things, wooden extension fins were attached to the metal horizontal and vertical tail fins of the torpedo. Smaller wooden fin attachments were added to the anti-roll stabilizers located on both sides and several feet forward of the torpedo's

metal horizontal tail fin (see Illustration A). These fins served to stabilize the torpedo in its aerial flight and came off upon entering the water.⁵ The large steel horizontal variable-depth control rudders located on the very tail end of the fin as-

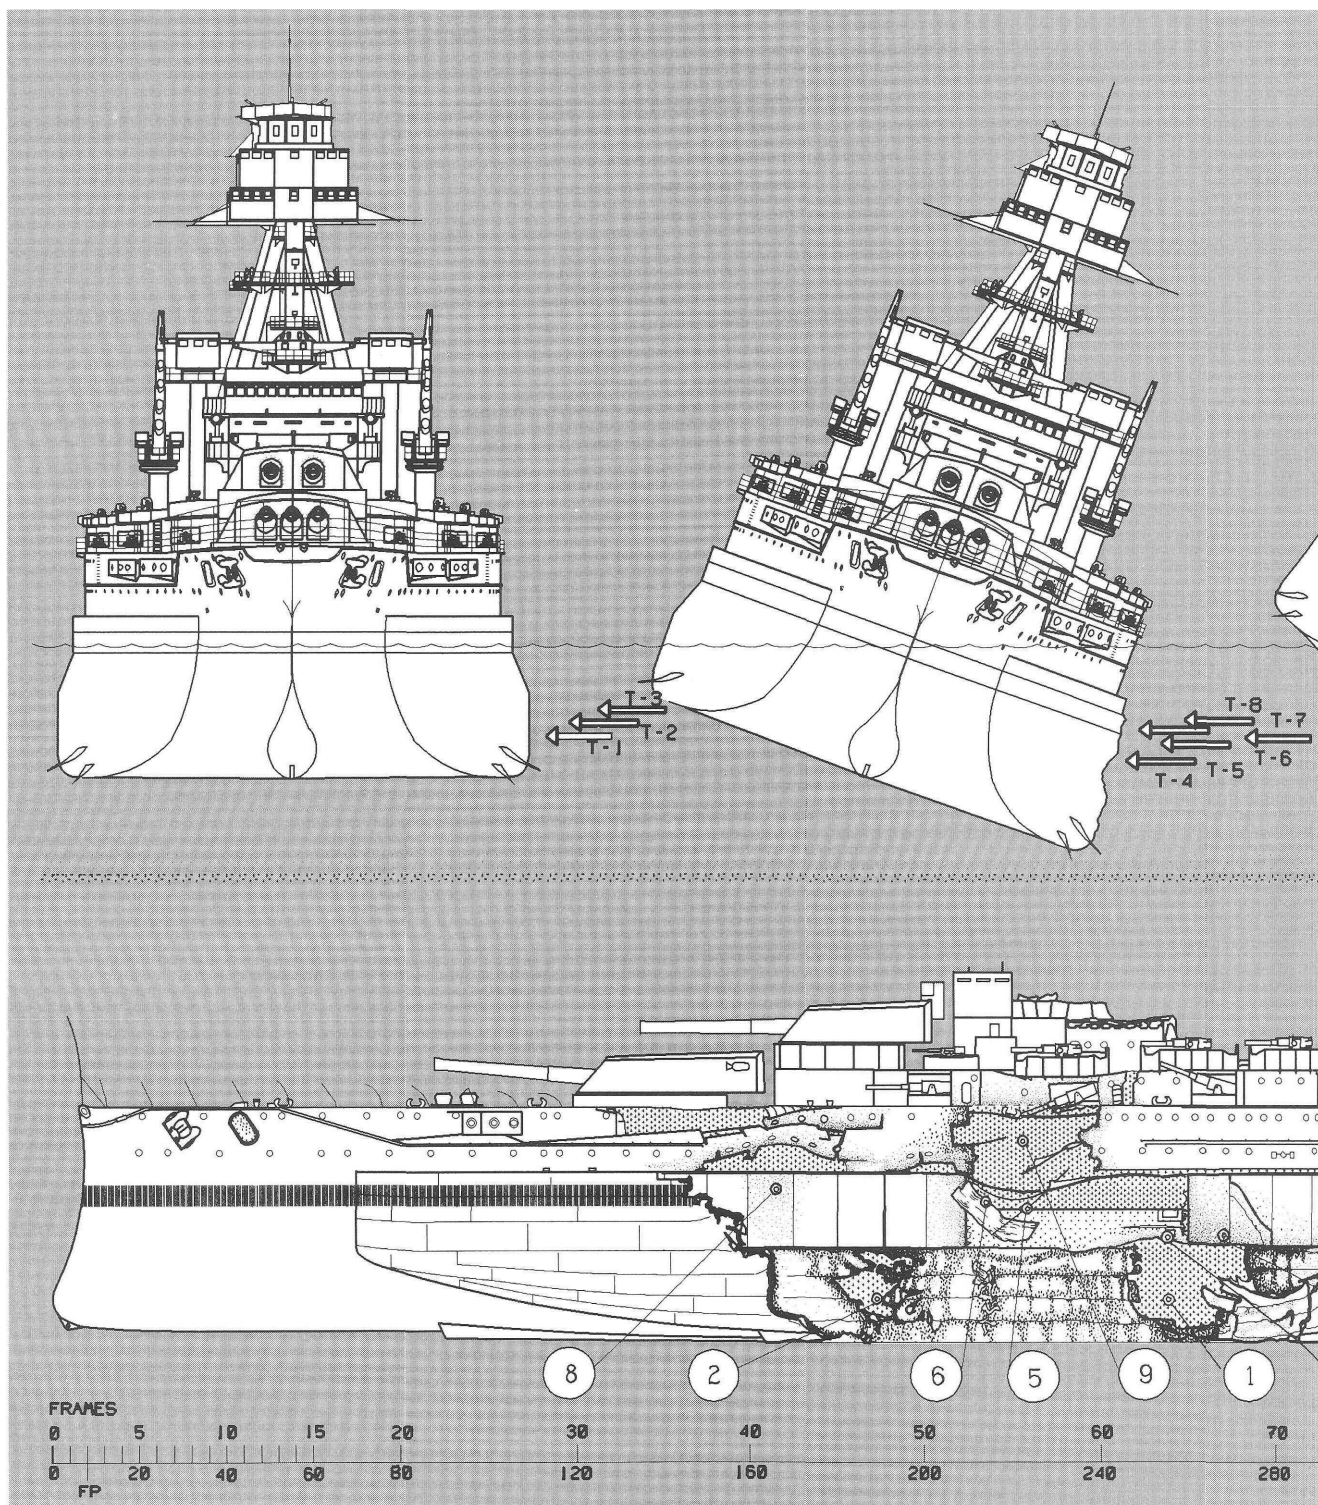
Illus. B: As more and more torpedoes hit her port side, the *Oklahoma* rolled farther over and then capsized. Each group of torpedoes thus hit higher on the hull.

The massive amount of torpedo damage to the *Oklahoma* is fully illustrated in the enclosed composite drawing (see Illustration B).¹⁴ The *Oklahoma* received nine hits and capsized within 15 minutes. Initial torpedo strikes occurred at frames 64 and 47.5, about 20 feet below the water line. These early hits tore away major portions of the outside blister shell and gouged the internal hull plating, which immediately caused a heavy list to port (see points 1 and 2 on Illustration B).

Following closely behind the first couple of hits, a third torpedo struck at frame 63, very near the lower edge of the armor belt (see point 3 on Illustrations B and C). The fourth torpedo hit near frame 67, close to the lower edge of the armor belt. The resulting explosion smashed the lower half of the armor belt inward several feet and caused a 5-inch-wide crack in the armor belt between frames 67 and 70 (see point 4 on Illustrations B and C). As a result of the excessive amount of armor belt distortion (inward several feet) in this area, there is a strong possibility that another torpedo may have struck between the third and fourth hits (points 3 and 4).

A torpedo struck the upper half of the armor belt near frame 56 about 5-6 feet down from the upper edge of the armor belt (see point 5 on Illustration B). The closest intact piece of armor belt in this area was at frame 52 and was smashed inward almost 2 feet. This large amount of inward armor belt displacement seems to indicate that a further torpedo detonated just above the mid-point on the

Another late torpedo exploded below the mainmast area on the blister shell plating outside the armor belt near frame 89. The resulting explosion tore a hole 46 by 34 feet. This hole included much of the shell plating above the armor belt as well as the upper half of the blister (see point 7 on Illustration B). The blister apparently detonated the warhead far enough away so that there was little or no recognizable armor belt distortion in this area.

A very late torpedo exploded on the upper half of the armor belt at frame 42. The blast tore through the light shell plating above the armor belt area and caused an upward arc-shaped distortion that measured approximately 38 by 18 feet. The armor belt itself was distorted inward several inches (point 8 on Illustration B).

The last and most destructive torpedo hit was at frame 55. This hit was well up on the side shell plating at the main deck level as the *Oklahoma* listed 35-40 degrees to port. This detonation tore a 38-foot-diameter hole in the shell plating and caused considerable damage to the internal and upper hull areas (see point 9 on Illustration B).

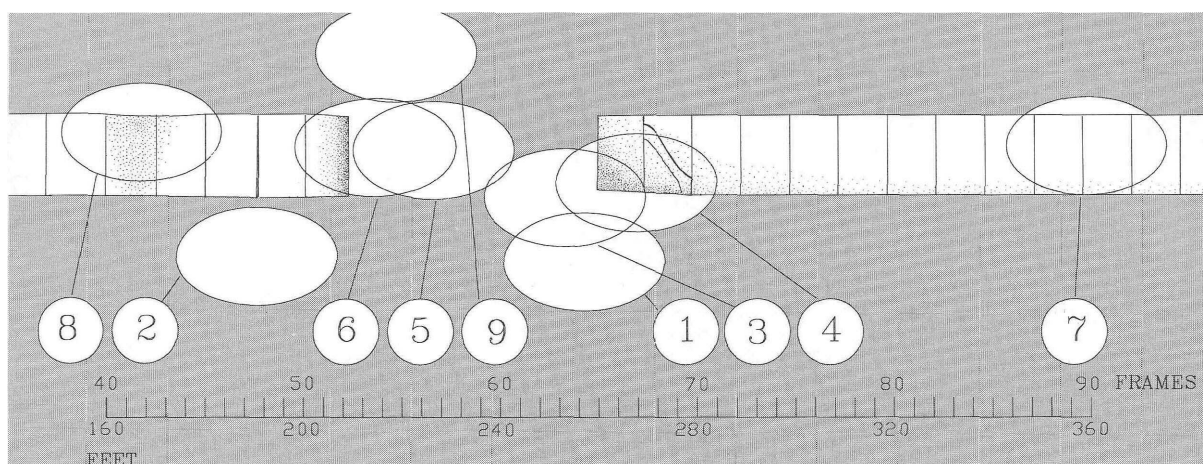
Illus. C: The numbered hits on the *Oklahoma's* armor belt correspond to the arrows on Illus. B.

armor belt at frame 53 (see point 6 on Illustrations B & C).

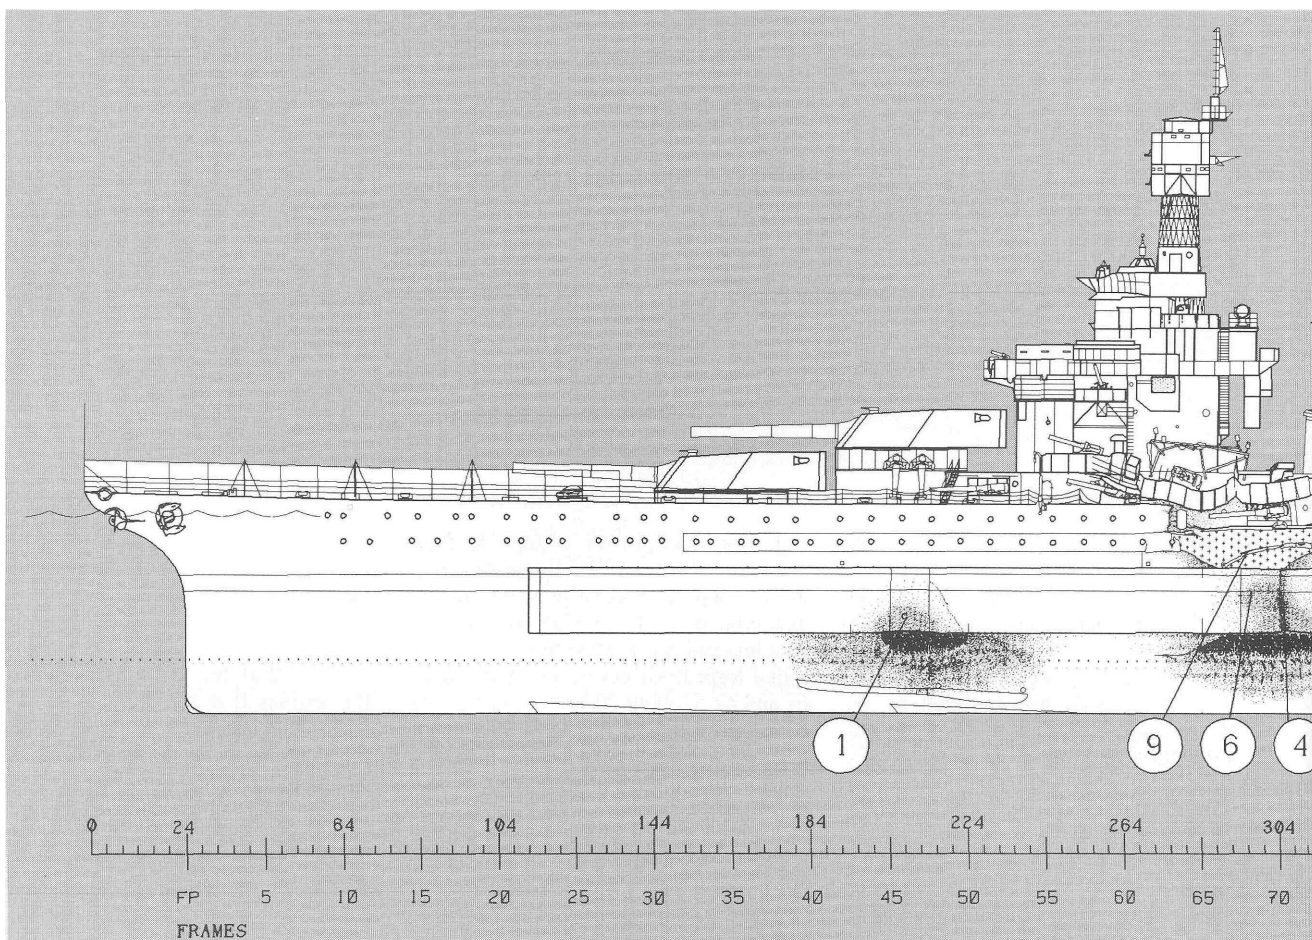
Illus. D: The *West Virginia* was heavily damaged by torpedoes but did not capsize because of timely counter-flooding and better armor protection than the *Oklahoma*'s.

Next in line was the *West Virginia*. Unlike the *Oklahoma*, the *West Virginia*'s damage is, in many ways, easier to assess. She was also struck by nine torpedoes (see Illustration D).¹⁵ Seven of the nine hits detonated on the armor belt itself. Four torpedoes exploded on the lower half of the armor belt, and three detonated on the upper half of the armor belt itself. The inward armor belt displacement ranged from about eight inches to approximately 22 inches. There were no hits on the shell plating below the armor belt.

in the areas of frames 41–53 and frames 60–100 was smashed inward and downward but did not disintegrate (see Illustration D). This indicates that there were no torpedo detonations below the armor belt in these areas.¹⁶ Damage in these areas was caused instead by torpedo detonations above these particular sites on the lower half of the armor belt itself.

The only deep-running torpedo (approximately 20 feet) hit the rudder at frame 145. The blast gouged out the rudder housing area and damaged the steering machinery in the area (see point 5 on Illustration D). The badly mangled rudder broke off and was later recovered in

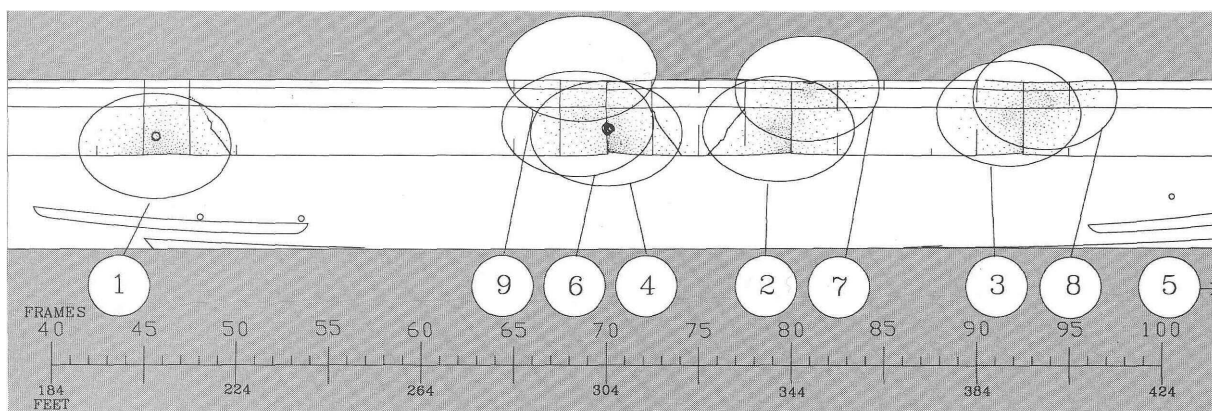
ing below the belt (see point 2 on Illustrations D & E). A further torpedo also struck the lower portion of the armor belt at frame 92. The impact point of this hit was approximately 7 feet up from the armor belt's lower edge at frame 92. The blast pushed in the lower half of the armor belt plate approximately 10 inches and smashed in the shell plating below the belt (see point 3 on Illustrations D & E).

Similarly, another torpedo hit on the lower half of the armor belt at the armor belt joint of frame 70. This torpedo left a circular scar about 5 feet up from the lower edge of the 13.5-inch armor belt. Again, the thinner shell plating below the armor belt was smashed inward and downward (see point 4 on Illustrations D & E).

arc-shaped damage area on the shell plating above the belt itself (see point 7 on Illustration D & E). Similarly, a late torpedo struck high on the armor belt at frame 94. The armor belt depression is similar to the hit at frame 81 (point 7). However, the damage to the shell plating above the armor belt is lengthier (see point 8 on Illustration D & E).

Illus. E: The numbered hits on the *West Virginia*'s armor belt match those on Illus. D.
