CONTENTS		
NAME	CAUSE OF DAMAGE	PAGE
INTRODUCTION		
ERIE (PG50)	Submarine Torpedo	5
RENO (CL96)	Submarine Torpedo	11
HOUSTON (CL-81)	Submarine Torpedo	19
CANBERRA (CA70)	Aircraft Torpedo	33
O'BRIEN (DD725)	Submarine Torpedo	39
WADLEIGH (DD689)	Mine	47
NEWCOMB (DD586)	4 Kamikaze Planes (1 Bomb)	59
KEARNY (DD432)	Submarine Torpedo	65
SELFRIIDGE (DD357)	Submarine Torpedo	69
FOOTE (DD511)	Submarine Torpedo	77
INTREPID (CV11)	Aircraft Torpedo	83
VIRBURNUM (AN57)	Mine	89

SOURCE:
National Archives & Records Administration, Seattle Branch
Record Group 181, Entry 59A-271 "13th Naval District Bremerton, Washington" General Correspondance 1947-1958
"Structural Repairs in Forward Areas During World War II" -BuShips Booklet dated December 1949.

The problem of effecting temporary repairs to damaged ships was encountered frequently during World War II and was handled with varying degrees of success. It was never feasible to make complete repairs to seriously damaged vessels in the forward area. Accordingly, repair work ordinarily was limited to that which would enable the ship to proceed to a larger repair activity and eventually to a shipyard. Repairs to machinery and electrical equipment were

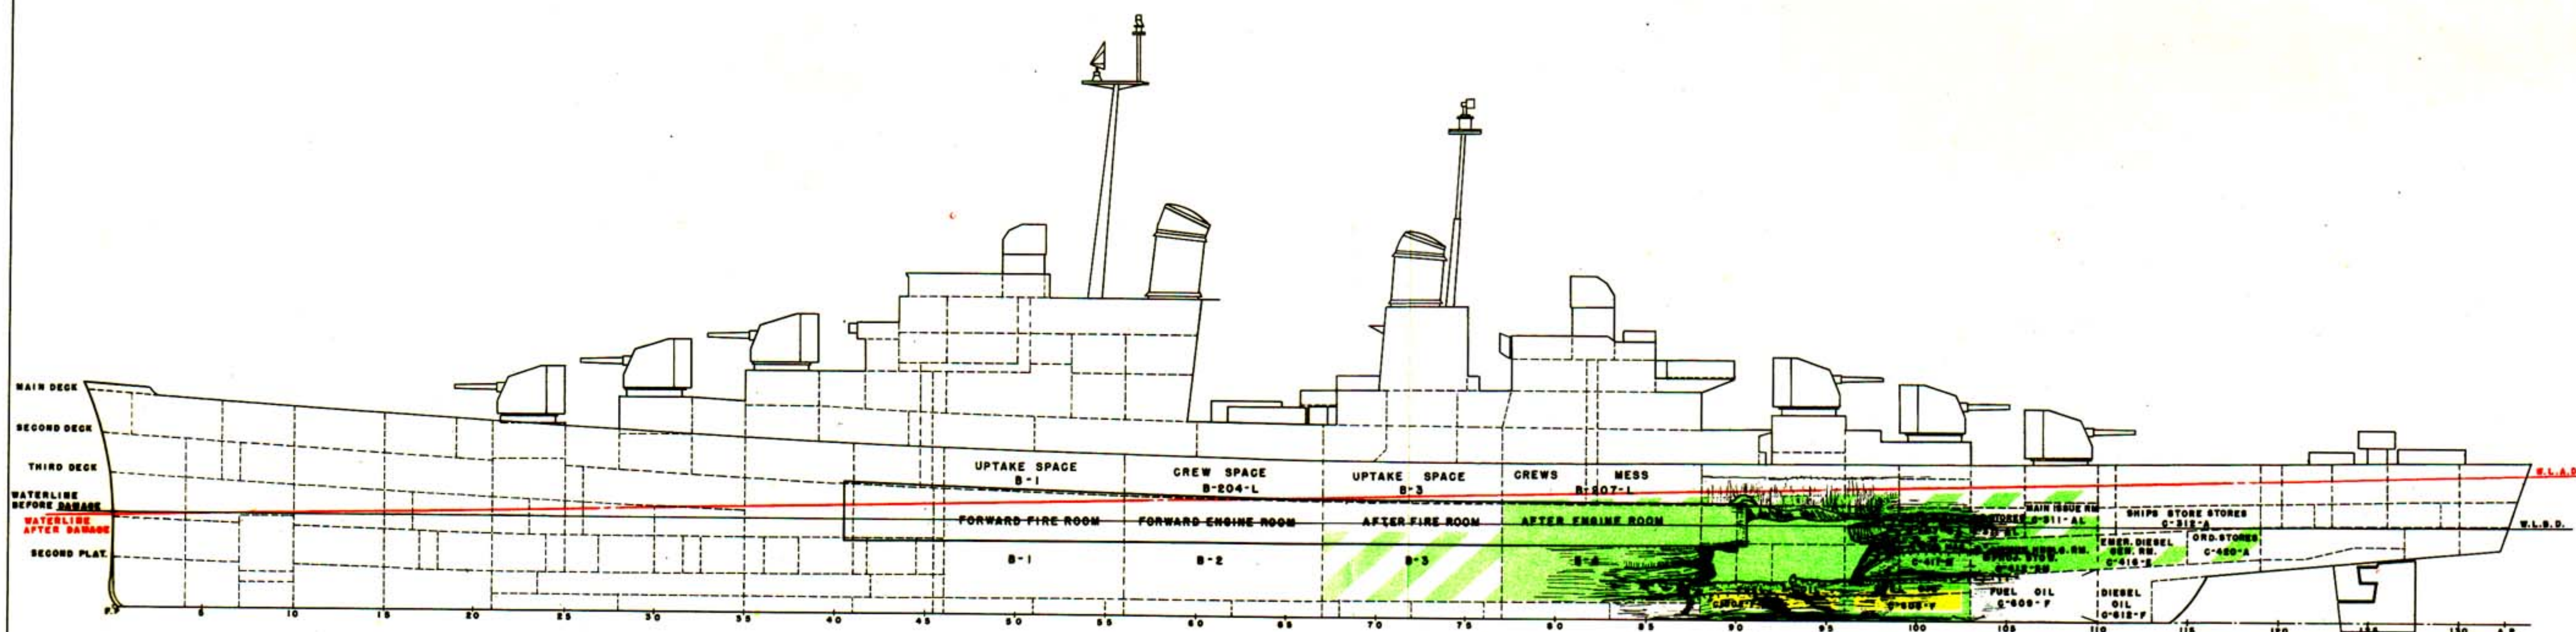
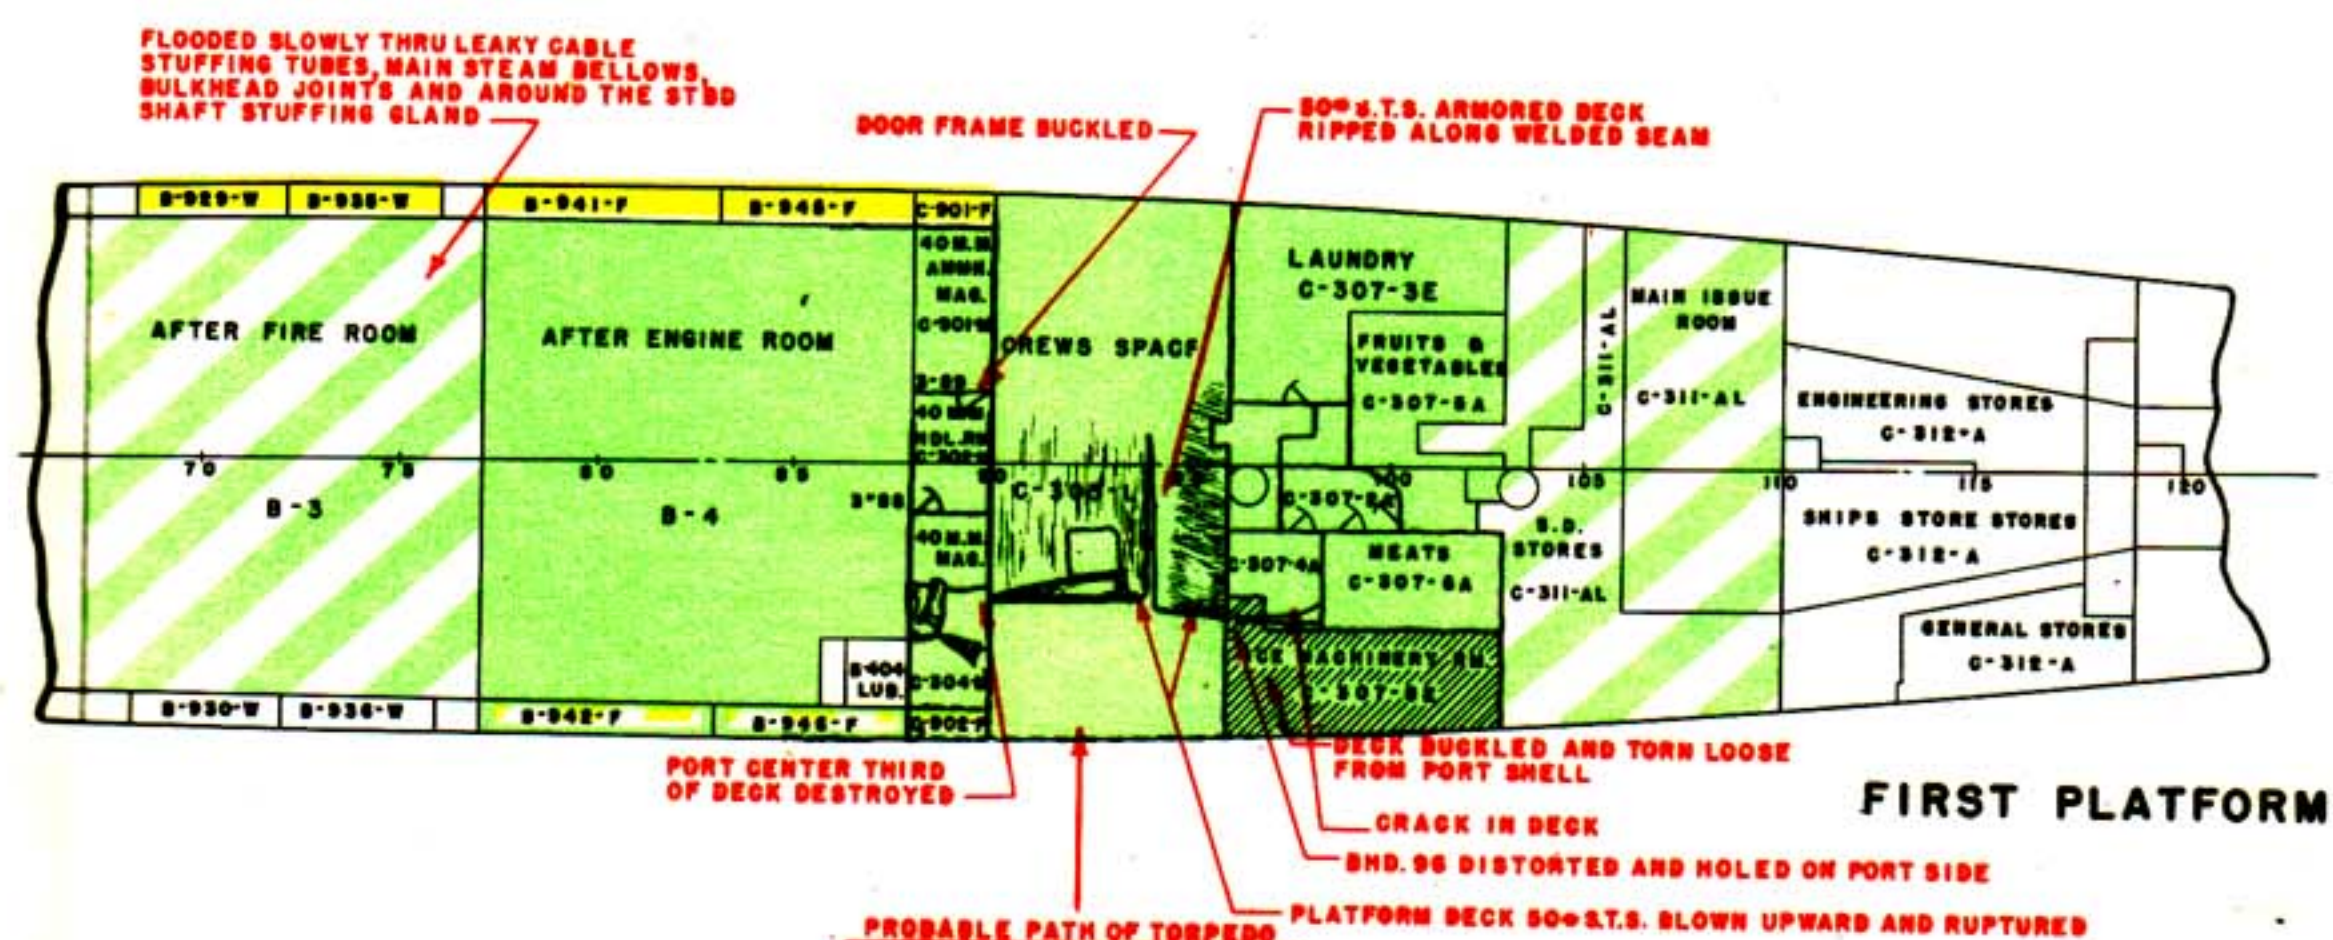
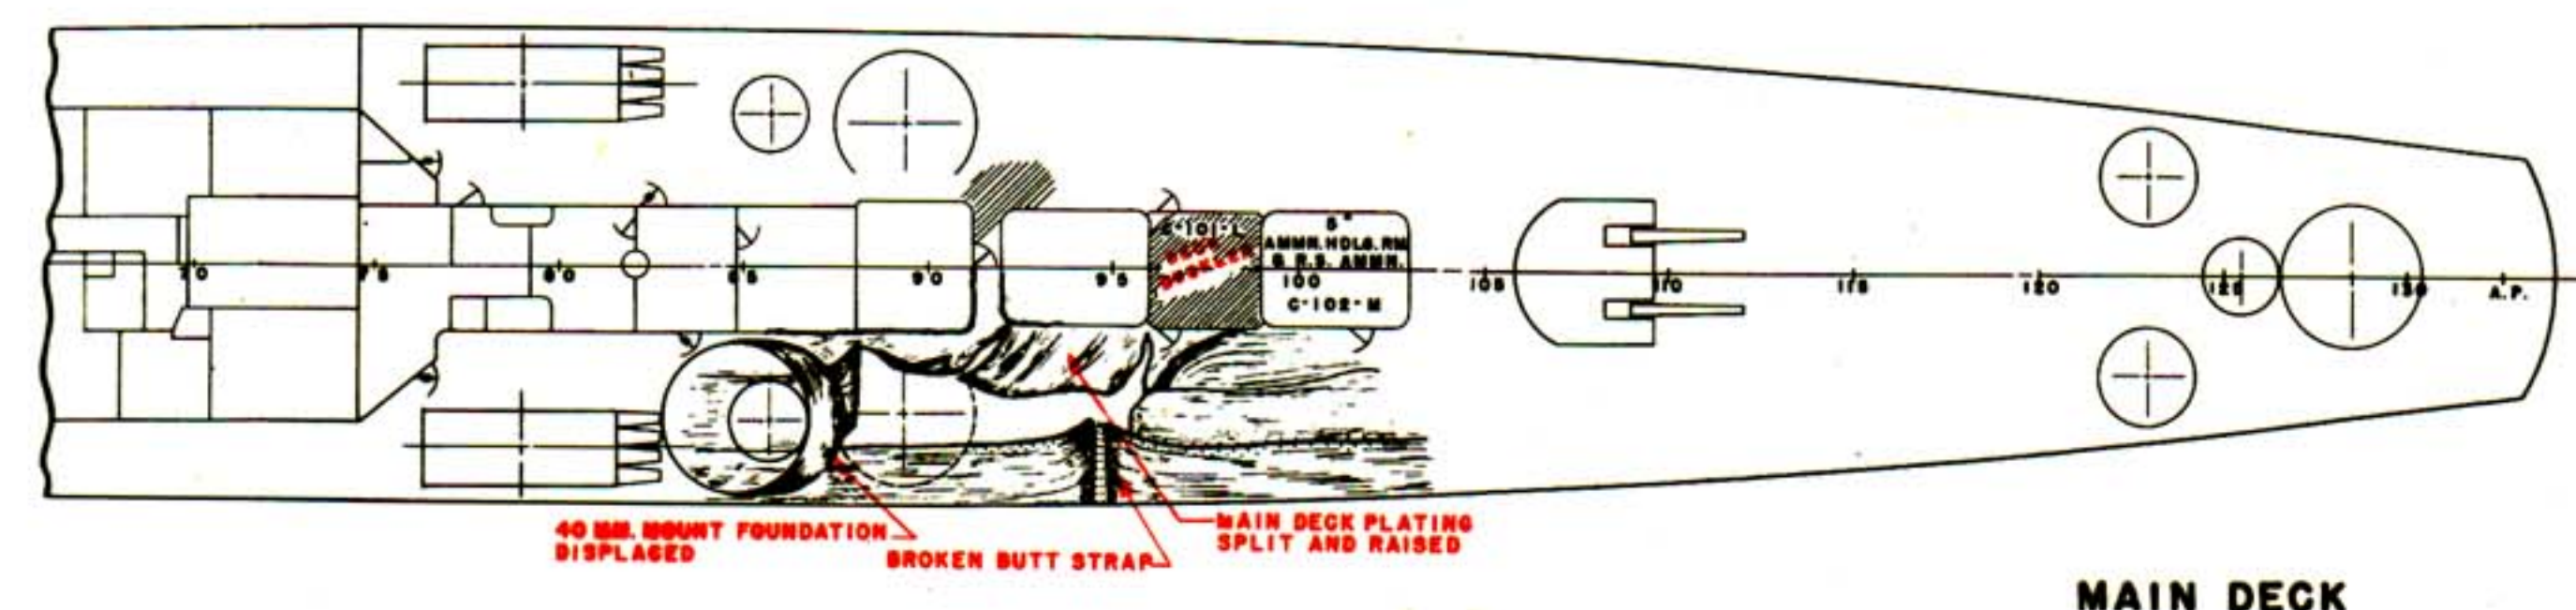
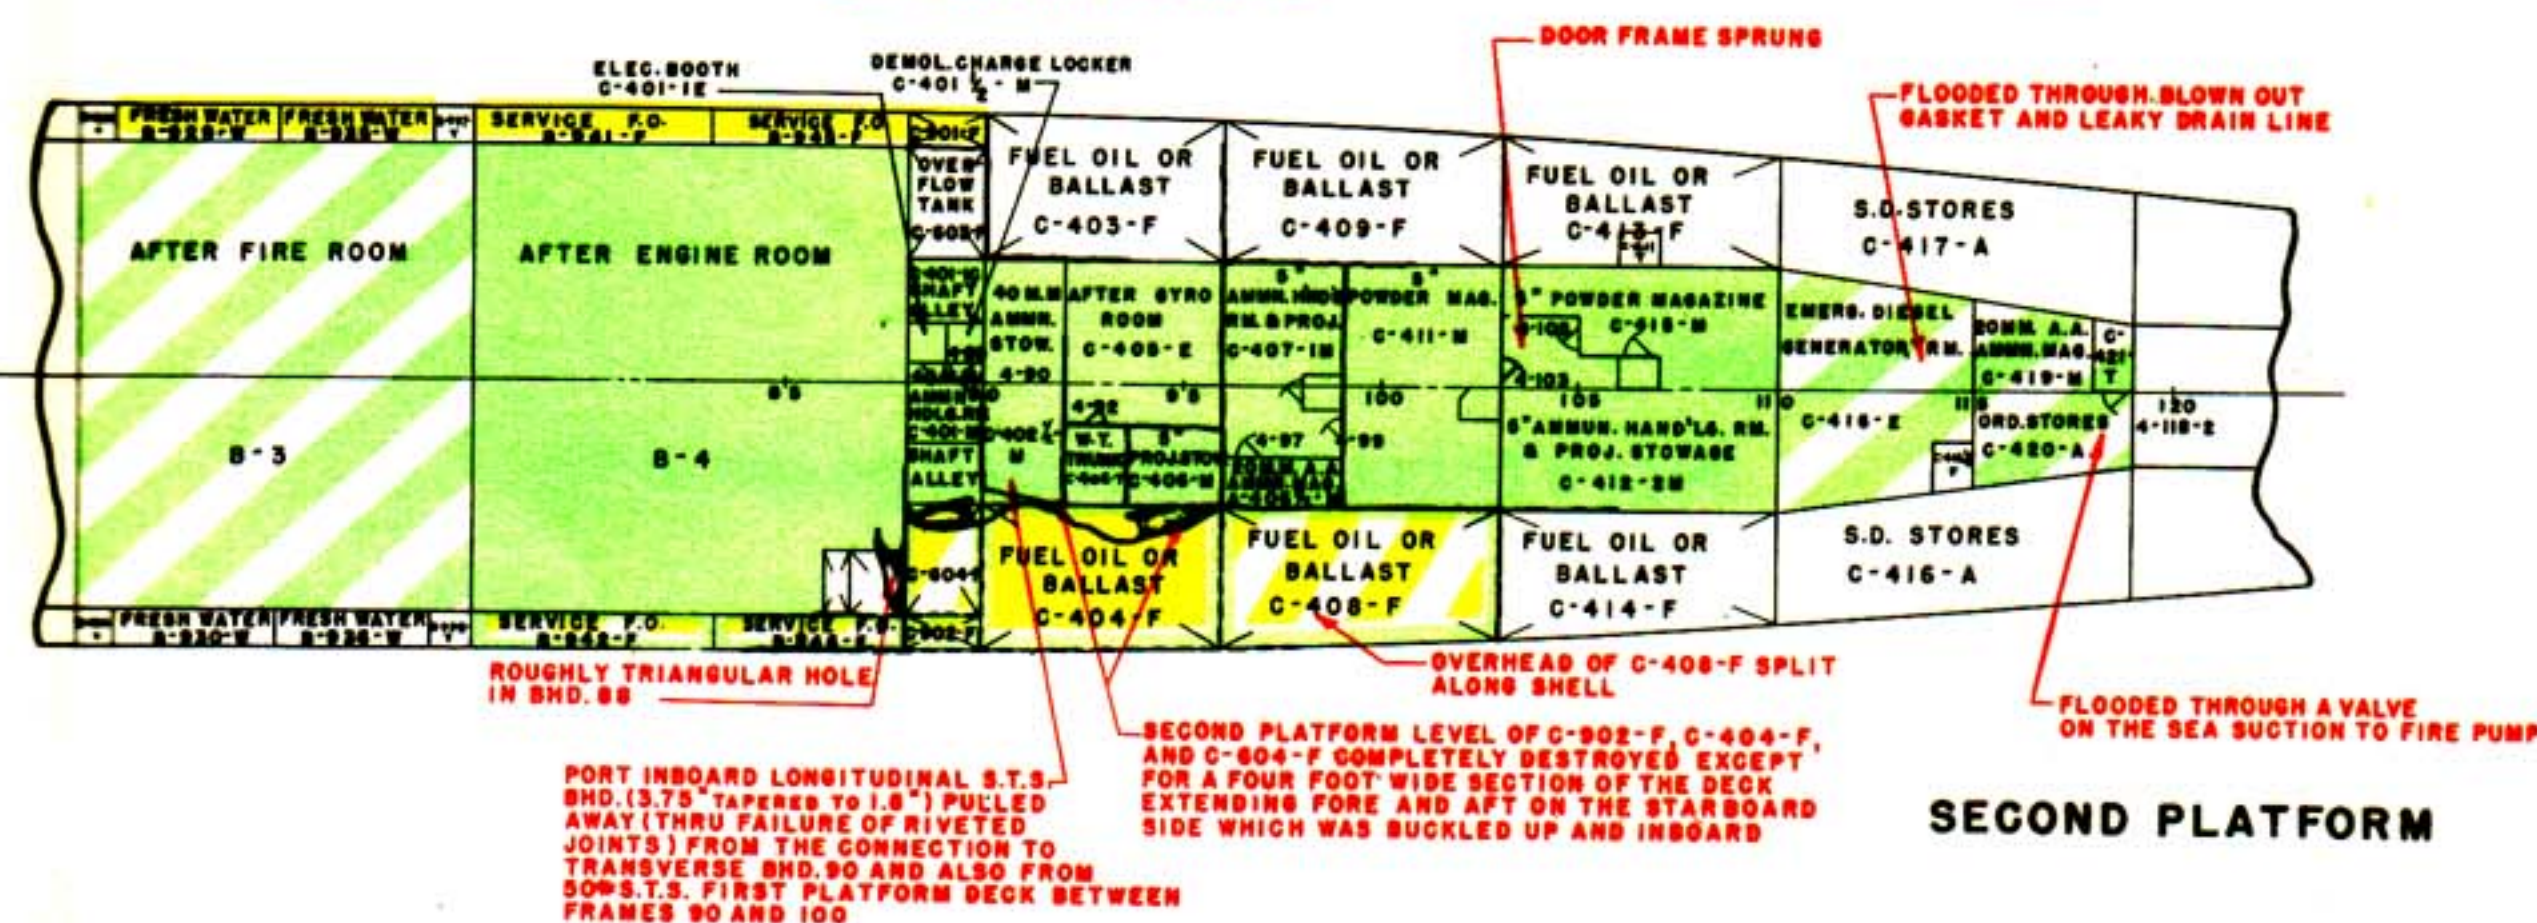
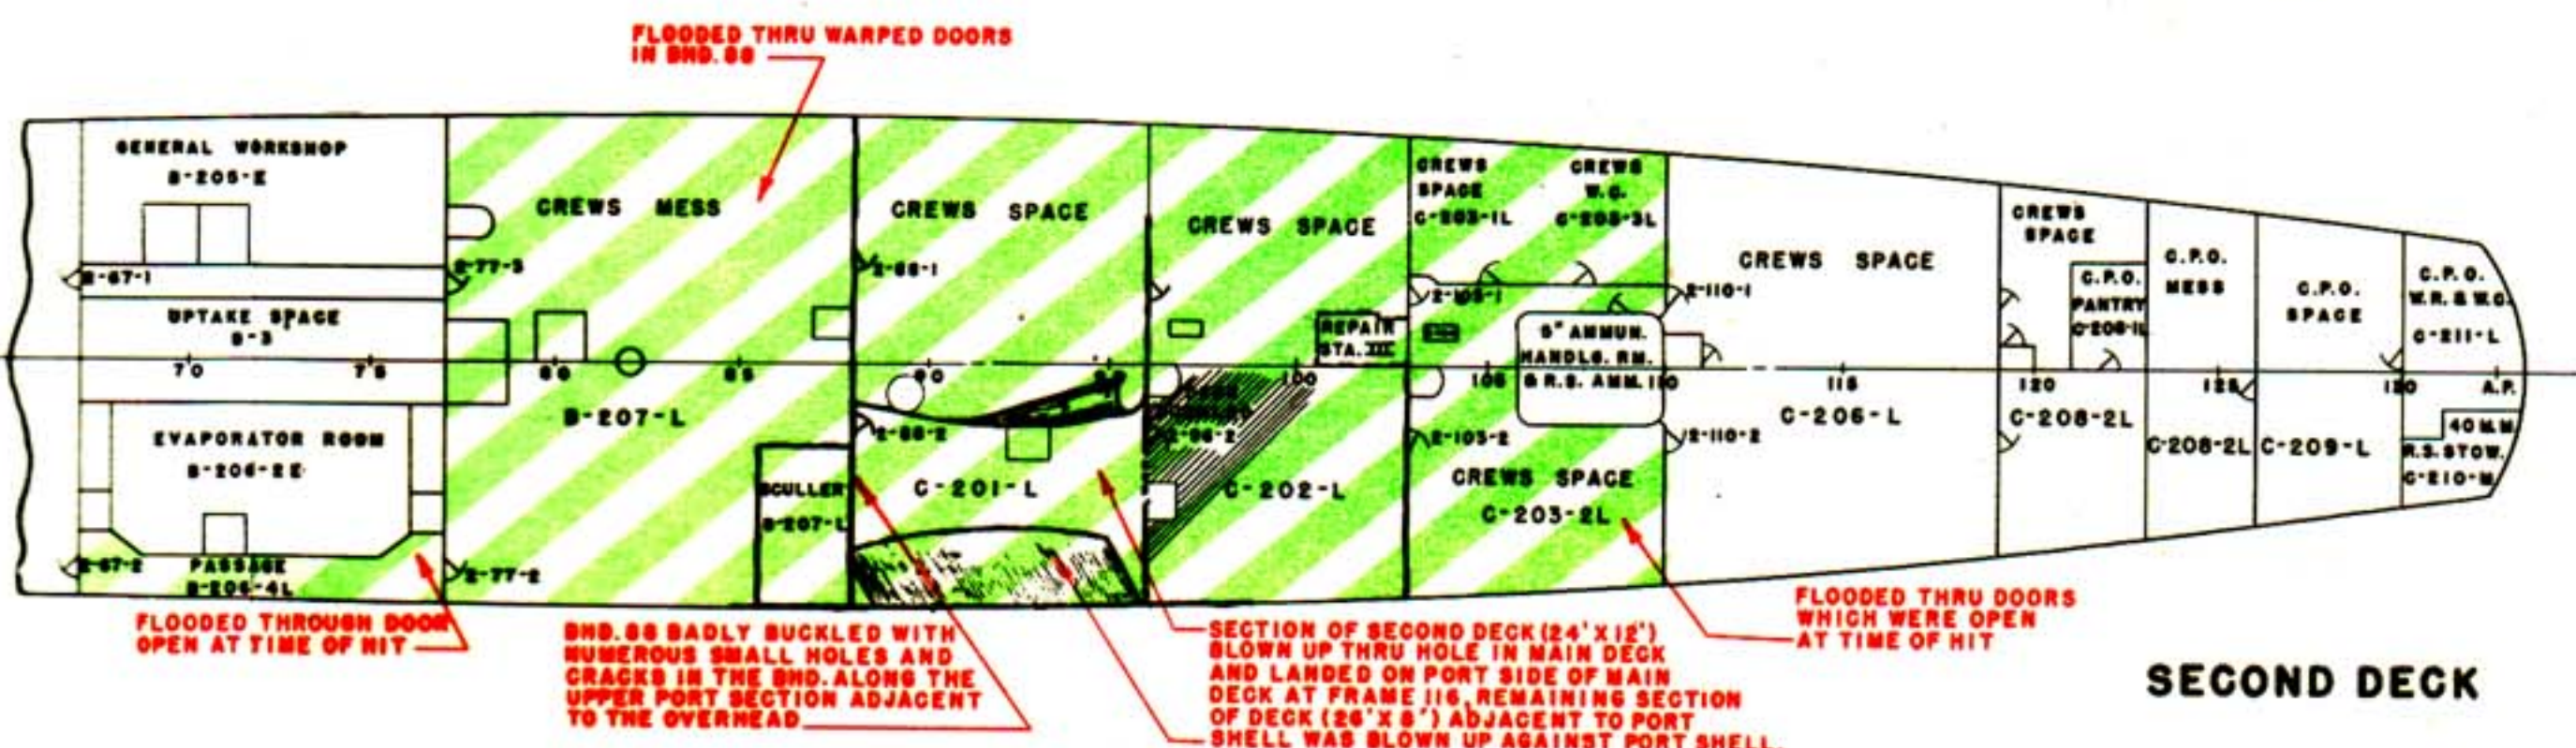
TORPEDO DAMAGE
U.S.S. RENO CL 96

1. A submarine torpedo detonated at about frame 92, port, in way of shell strake "C", and caused serious local damage. Shell plating and supporting structure was ruptured between frames 88 and 97, a distance of about 33 feet, and from "B" strake to "F" strake, a distance of about 22 feet. Damage to adjacent plating extended between frames 84 and 103 and from "A" strake to the main deck. The main, 2nd and 1st platform decks were destroyed between frames 88 and 97, port. This damage as well as that to the main deck and interior structure is shown on [Plate 4](#) and Photos [2](#) and [3](#). Extensive flooding resulted in a condition of negative initial stability, however, damage control measures undertaken by the ship's force and ZUNI (ATF 95) enabled the ship to be towed 700 miles to Ulithi. Despite the marked loss of strength at frame 93, port, no progressive structural failures were noted during this passage in heavy weather.

On arrival, RENO had 1800 tons of flood water and GM had been reduced from 3.5' to 1.4'. B3 had been dewatered, but B4 was completely flooded. Flooding extended aft to bulkhead 110 on the 2nd platform, and frame 103 on the 1st platform. C-201L and C-202L were flooded to the waterline. Calculations of the stability condition showed that it would be necessary to remove 200 tons of topside weight before it would be safe to accept the free surface in the after engine room resulting from unwatering flooded spaces aft to bring the

2nd deck above the waterline. Accordingly, about 200 tons of the highest practicable topside weights were removed. A careful record of weight and moment of removed items was made for use in a continuous calculation of stability. Forward tanks A-1W, A-2W, A-4F, A-5F, A-7F, A-8F, A-608F and A-609F were ballasted solid with oil or water. Then, C-412M and C-415M were unwatered to bring the 2nd deck above the waterline. C-201L and C-202L were dewatered. Later, the ship was listed to starboard to facilitate repairs near the waterline.

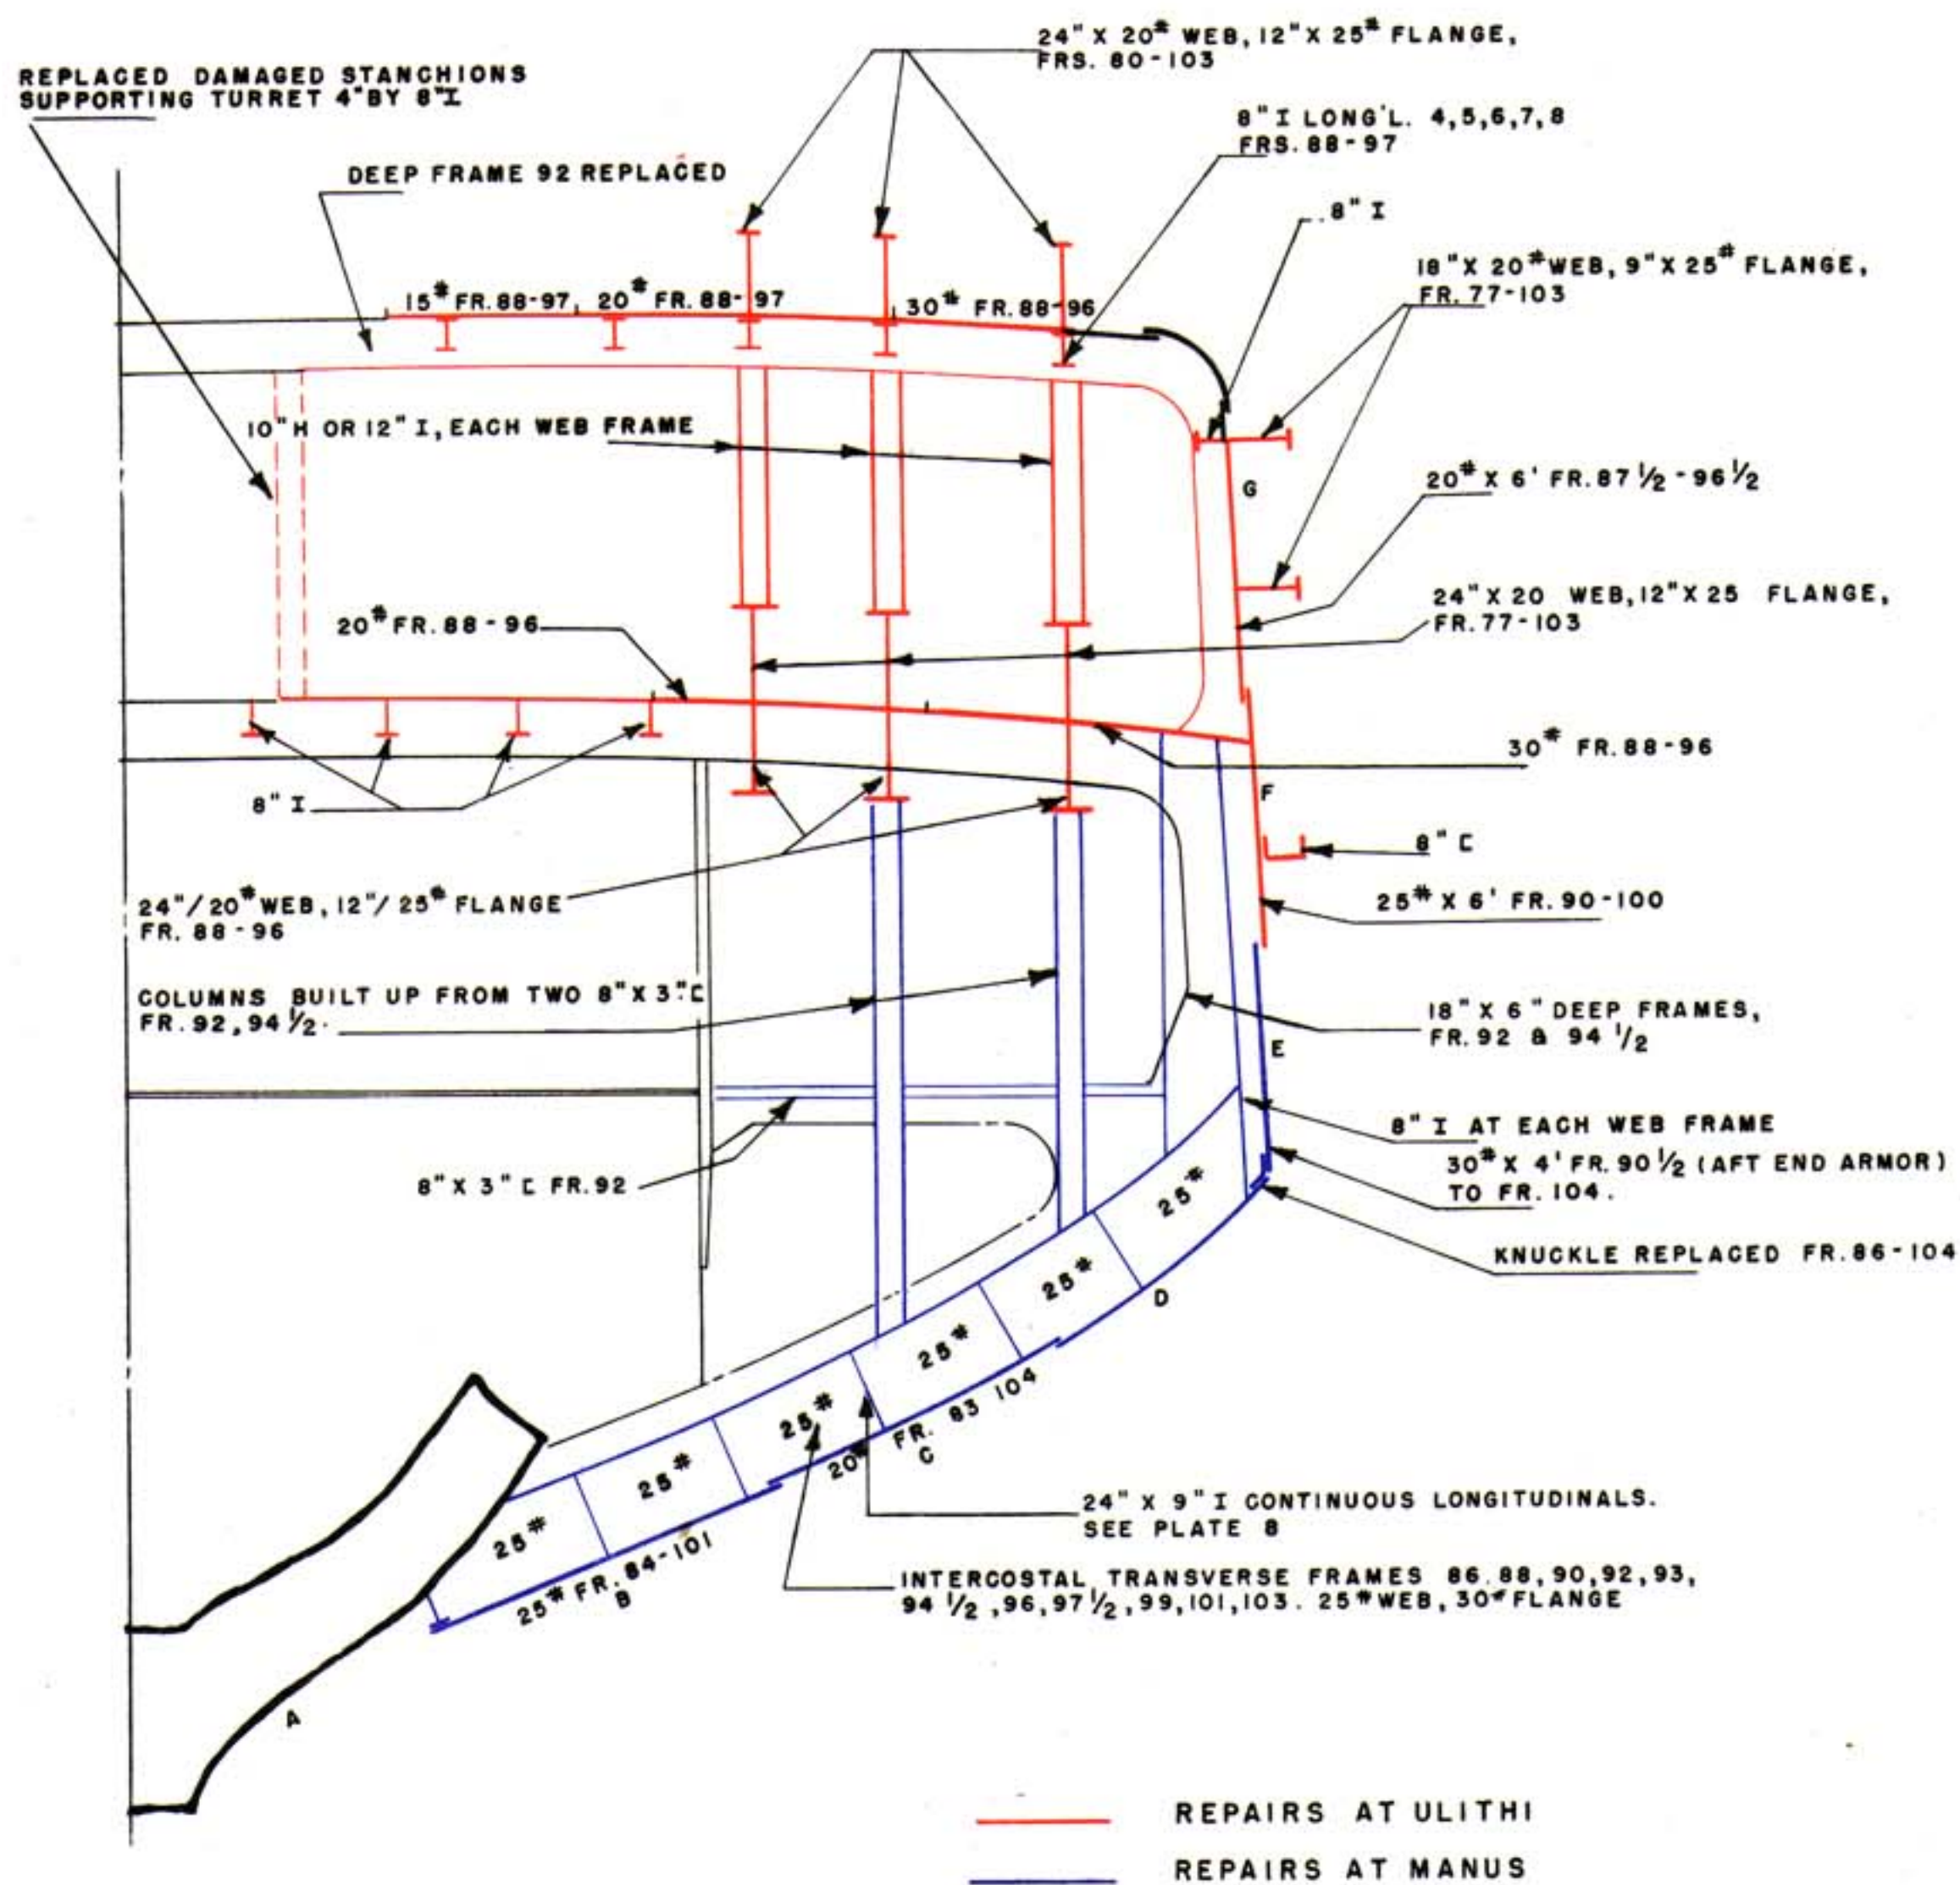
TEMPORARY STRUCTURAL REPAIRS TO TORPEDO DAMAGE U.S.S. RENO CL 96

24\" X 12\" GIRDERS HAVE 8' LONG TAPERED BRACKETS EACH END, STRAPPED BUTT WELDS AND BRACKETS AT EACH TRANSVERSE FRAME AND BULKHEAD.

The section modulus of the damaged section was calculated using information obtained from examination of the underwater body by divers. This calculation indicated that it would be possible to restore about 75% of the strength of the intact section. As shown on [Plate 6](#), damaged areas of the main and 2nd decks were replaced and two shell wrapper plates were installed below the port sheer atrake. Additional large longitudinals were installed on the shell and main and 2nd decks (Photos [4](#), [5](#)). These girders extended about 30' beyond each end of the damaged area. Their ends were tapered over a length of 8' and anti-tripping brackets were installed in way of each transverse structural member. In order to improve stiffness and transverse strength in way of the damage, a damaged section of bulkhead 96 was replaced and bulkheads 88 and 96 were strengthened by adding vertical bracketed 8" channel sections in way of existing stiffeners. Web frame 92 was replaced and 10" H columns were installed between the deep main and second deck longitudinals at each transverse web frame ([Photo 5](#)). 8" I stanchions were installed to replace damaged stanchions supporting turret 4. Holding bulkheads 77 in B-3 and 103 in C-412 and C-311AC were shored.

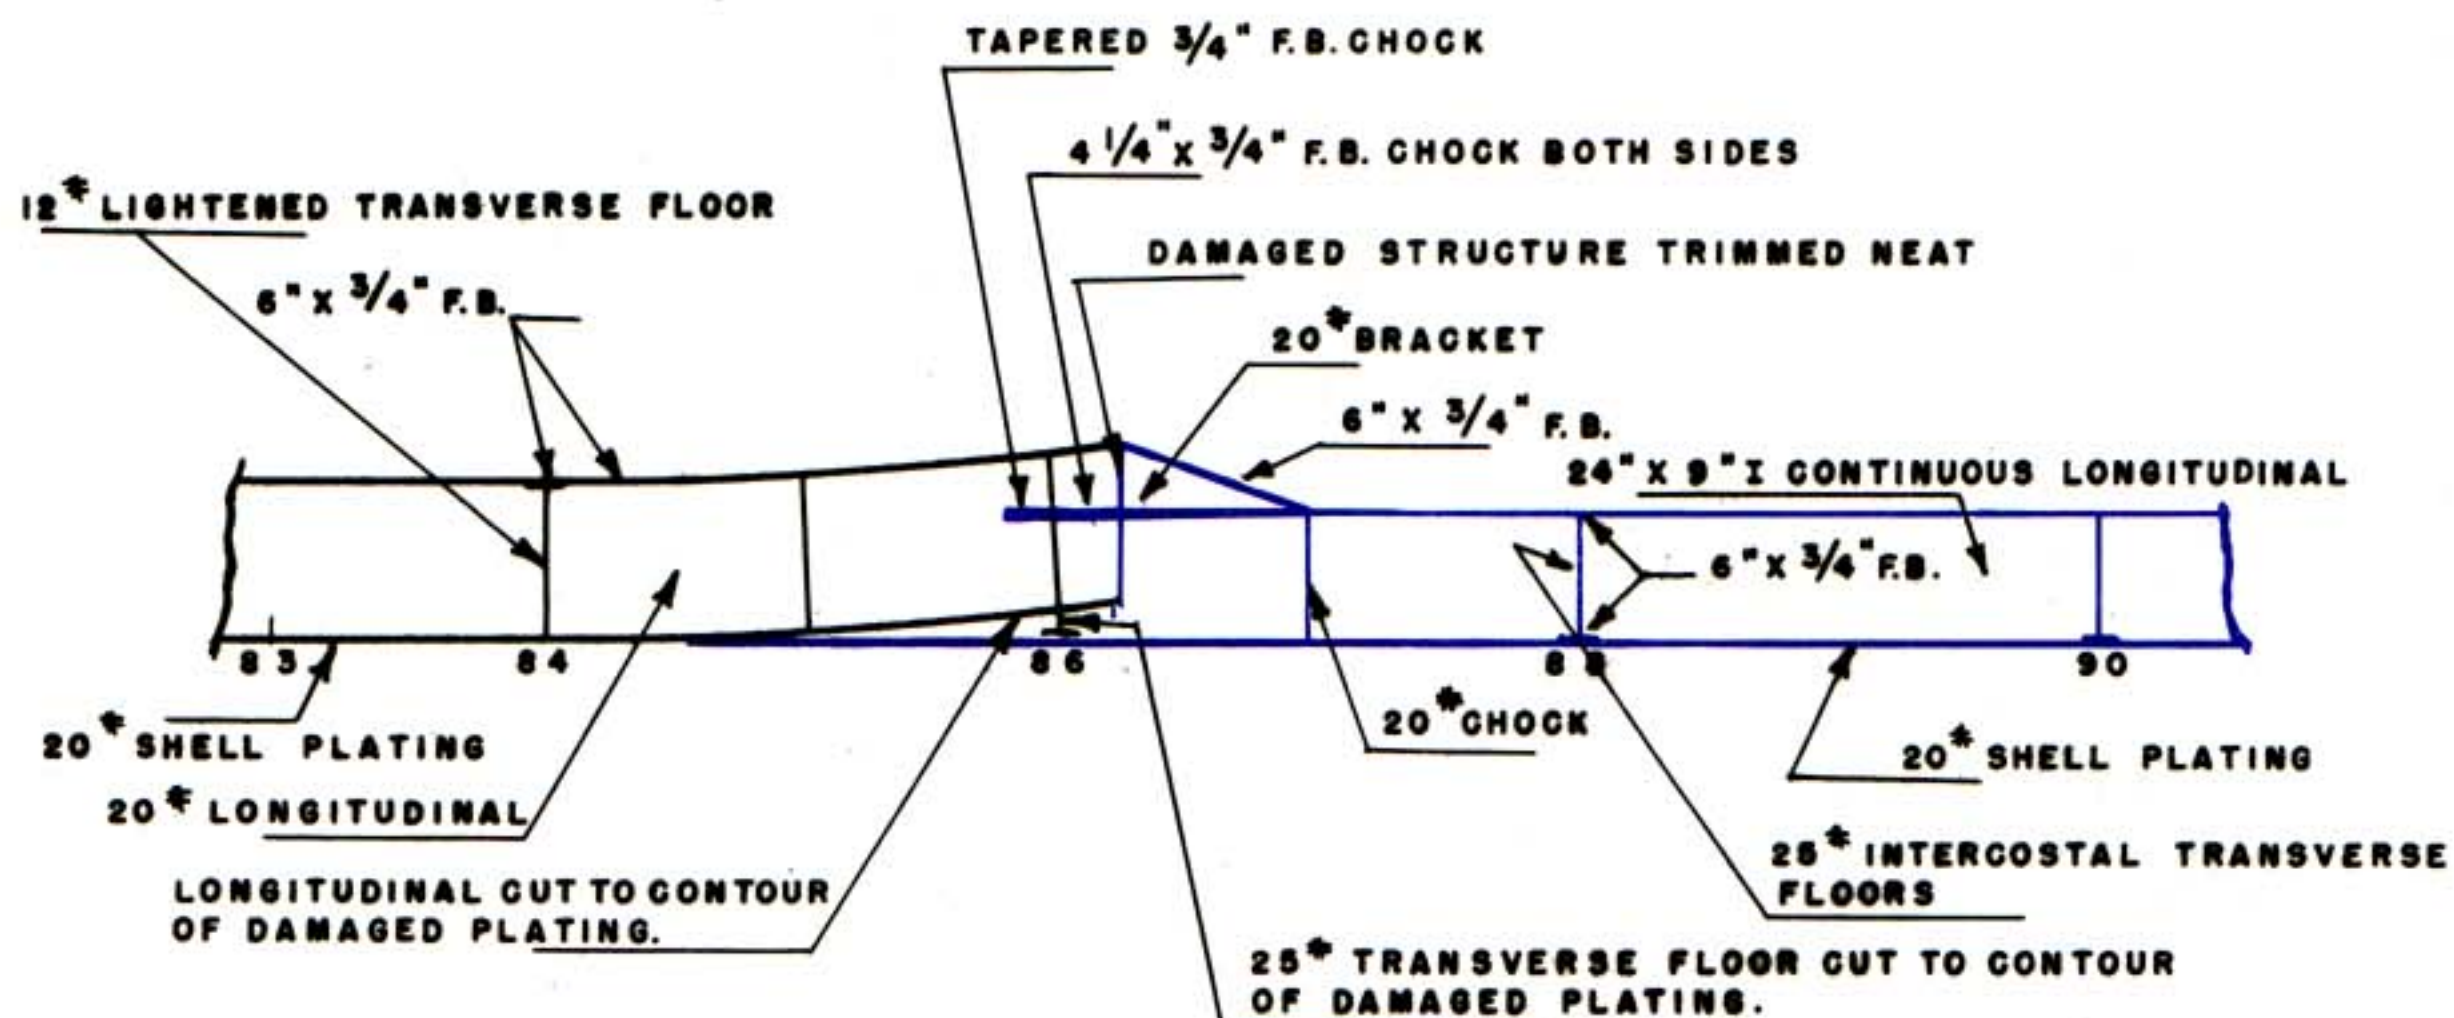
TYPICAL DETAIL IN WAY OF CONNECTION
OF REPLACEMENT LONGITUDINAL
TO ORIGINAL STRUCTURE

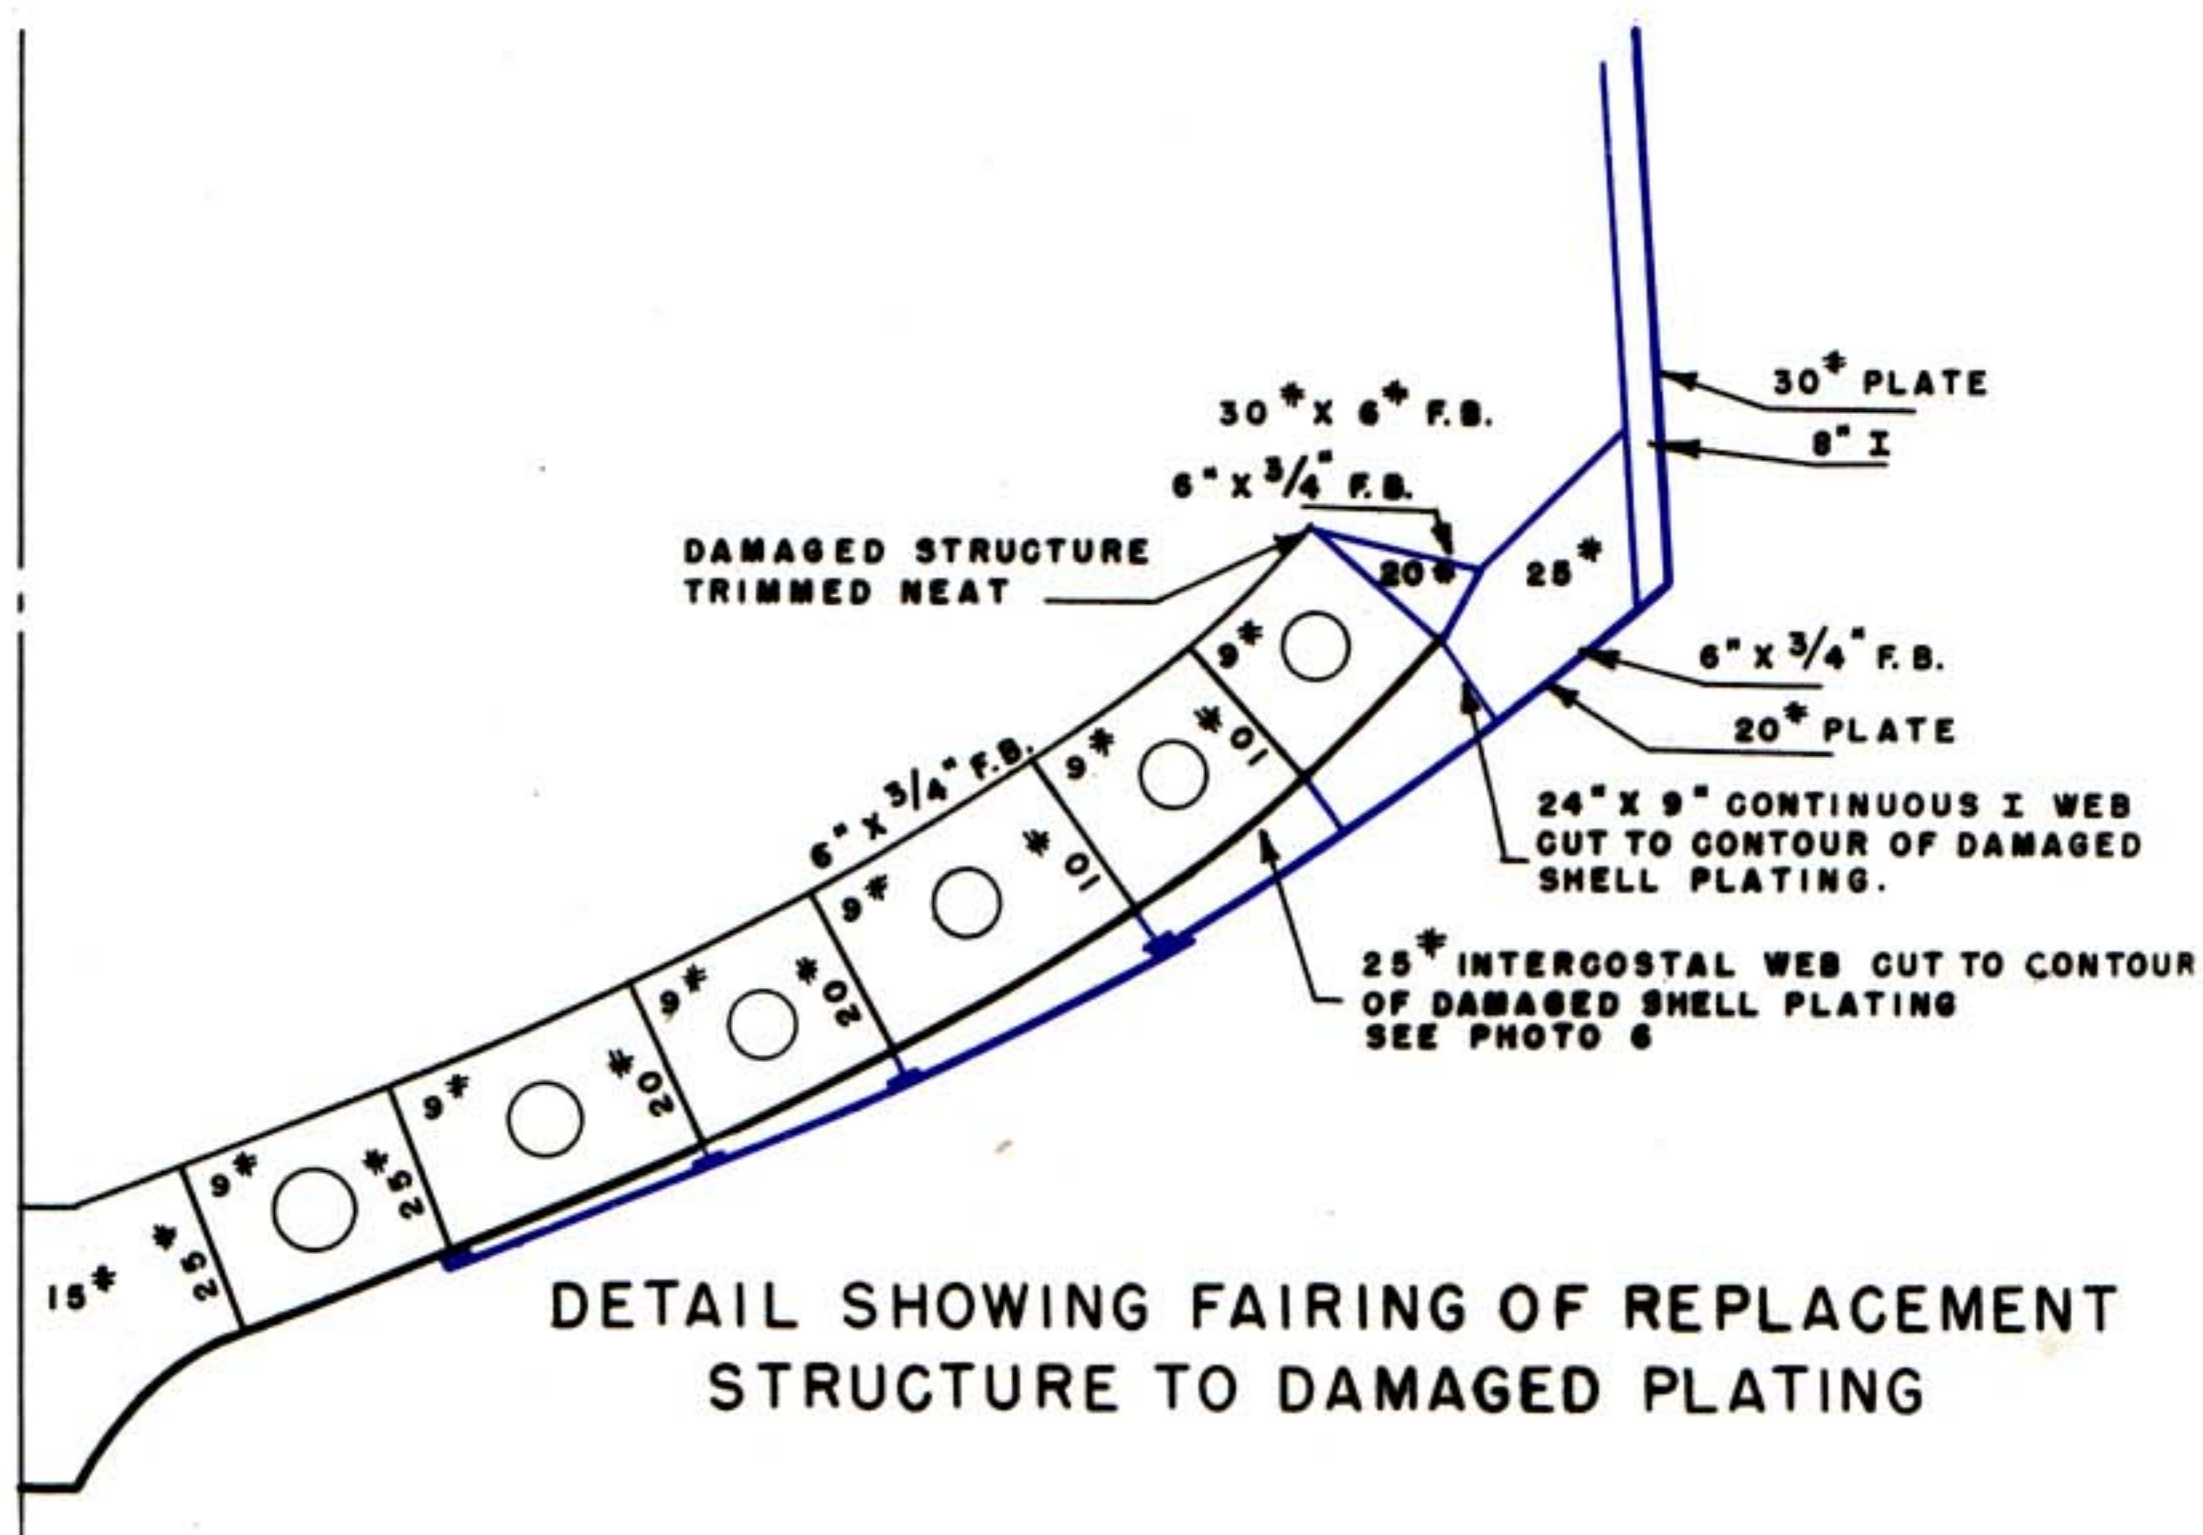
REPAIRS AT MANUS

DETAIL SHOWING FAIRING OF REPLACEMENT
STRUCTURE TO DAMAGED PLATING

3. After completion of these repairs, RENO was towed to Manus and drydocked in AHSD 2, where temporary repairs to the underwater body were made by WHITNEY (AD4), Navy Repair Unit 3205 and RENO. The care taken to align replacement members with original structure and to achieve continuity in way of all connections is shown in Plates [7](#), [8](#) and Photos [6](#), [7](#). Stanchions were installed at frames 90, 92 and 94 1/2 to compensate for the bulkhead which was not replaced at frame 90 and to provide additional stiffness ([Photo 8](#)).
