CONTENTS		
NAME	CAUSE OF DAMAGE	PAGE
INTRODUCTION		
ERIE (PG50)	Submarine Torpedo	5
RENO (CL96)	Submarine Torpedo	11
HOUSTON (CL-81)	Submarine Torpedo	19
CANBERRA (CA70)	Aircraft Torpedo	33
O'BRIEN (DD725)	Submarine Torpedo	39
WADLEIGH (DD689)	Mine	47
NEWCOMB (DD586)	4 Kamikaze Planes (1 Bomb)	59
KEARNY (DD432)	Submarine Torpedo	65
SELFRIIDGE (DD357)	Submarine Torpedo	69
FOOTE (DD511)	Submarine Torpedo	77
INTREPID (CV11)	Aircraft Torpedo	83
VIRBURNUM (AN57)	Mine	89

SOURCE:
National Archives & Records Administration, Seattle Branch
Record Group 181, Entry 59A-271 "13th Naval District Bremerton, Washington" General Correspondance 1947-1958
"Structural Repairs in Forward Areas During World War II" -BuShips Booklet dated December 1949.

The problem of effecting temporary repairs to damaged ships was encountered frequently during World War II and was handled with varying degrees of success. It was never feasible to make complete repairs to seriously damaged vessels in the forward area. Accordingly, repair work ordinarily was limited to that which would enable the ship to proceed to a larger repair activity and eventually to a shipyard. Repairs to machinery and electrical equipment were

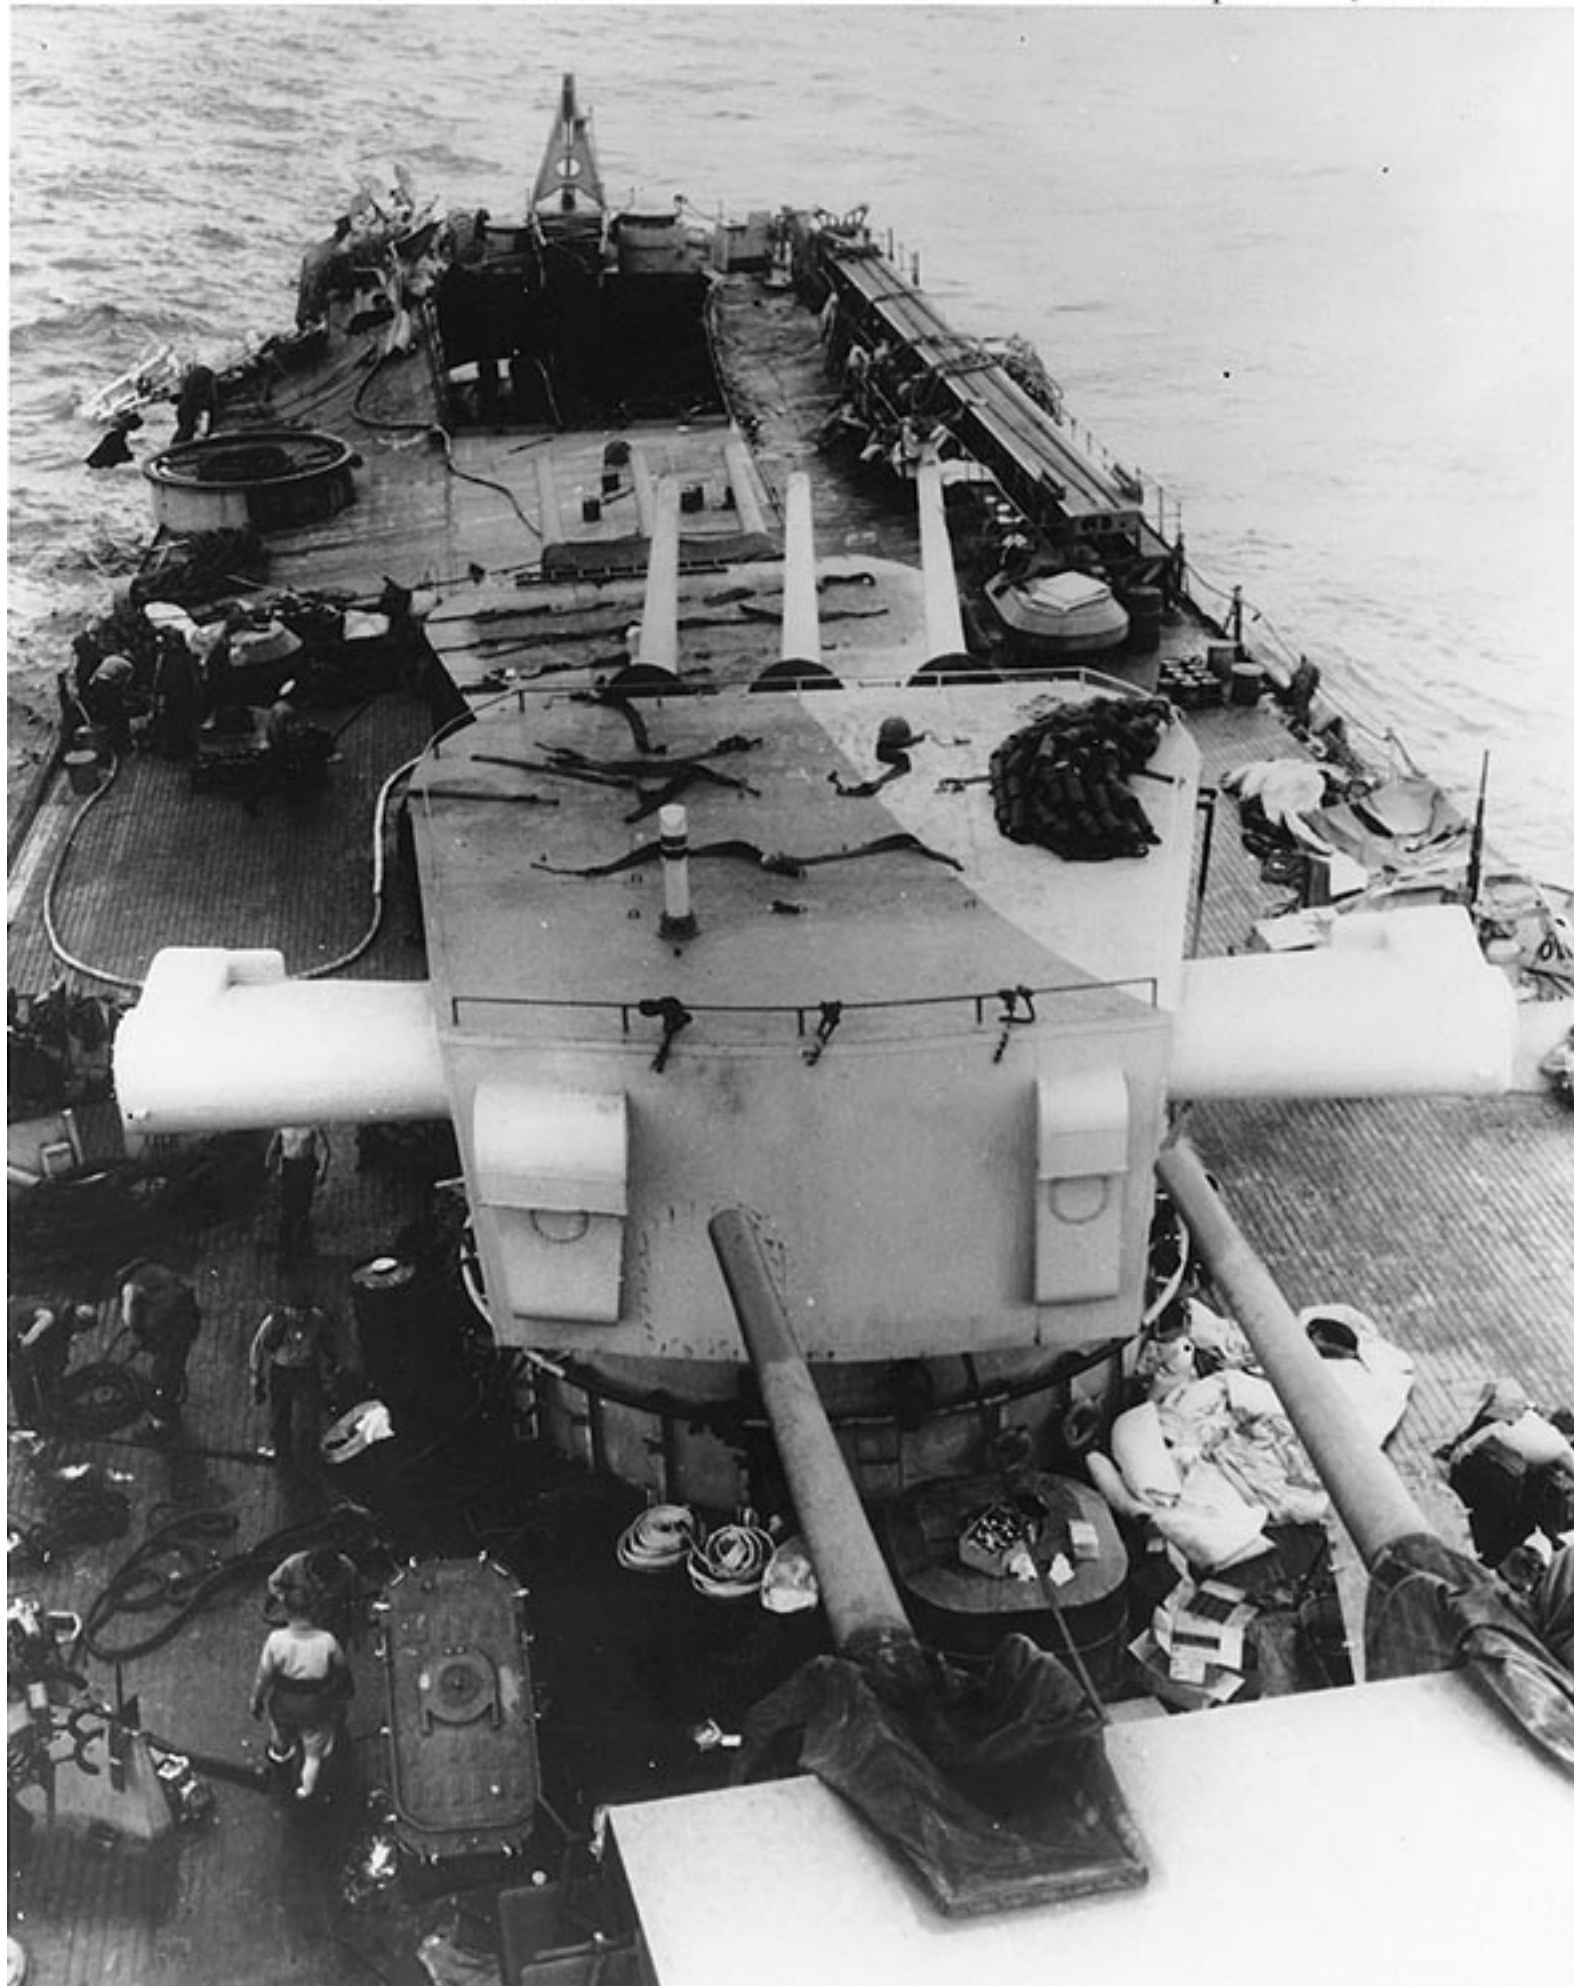
Photo # 19-N-110859 On board USS Houston after her second torpedo hit, Oct. 1944

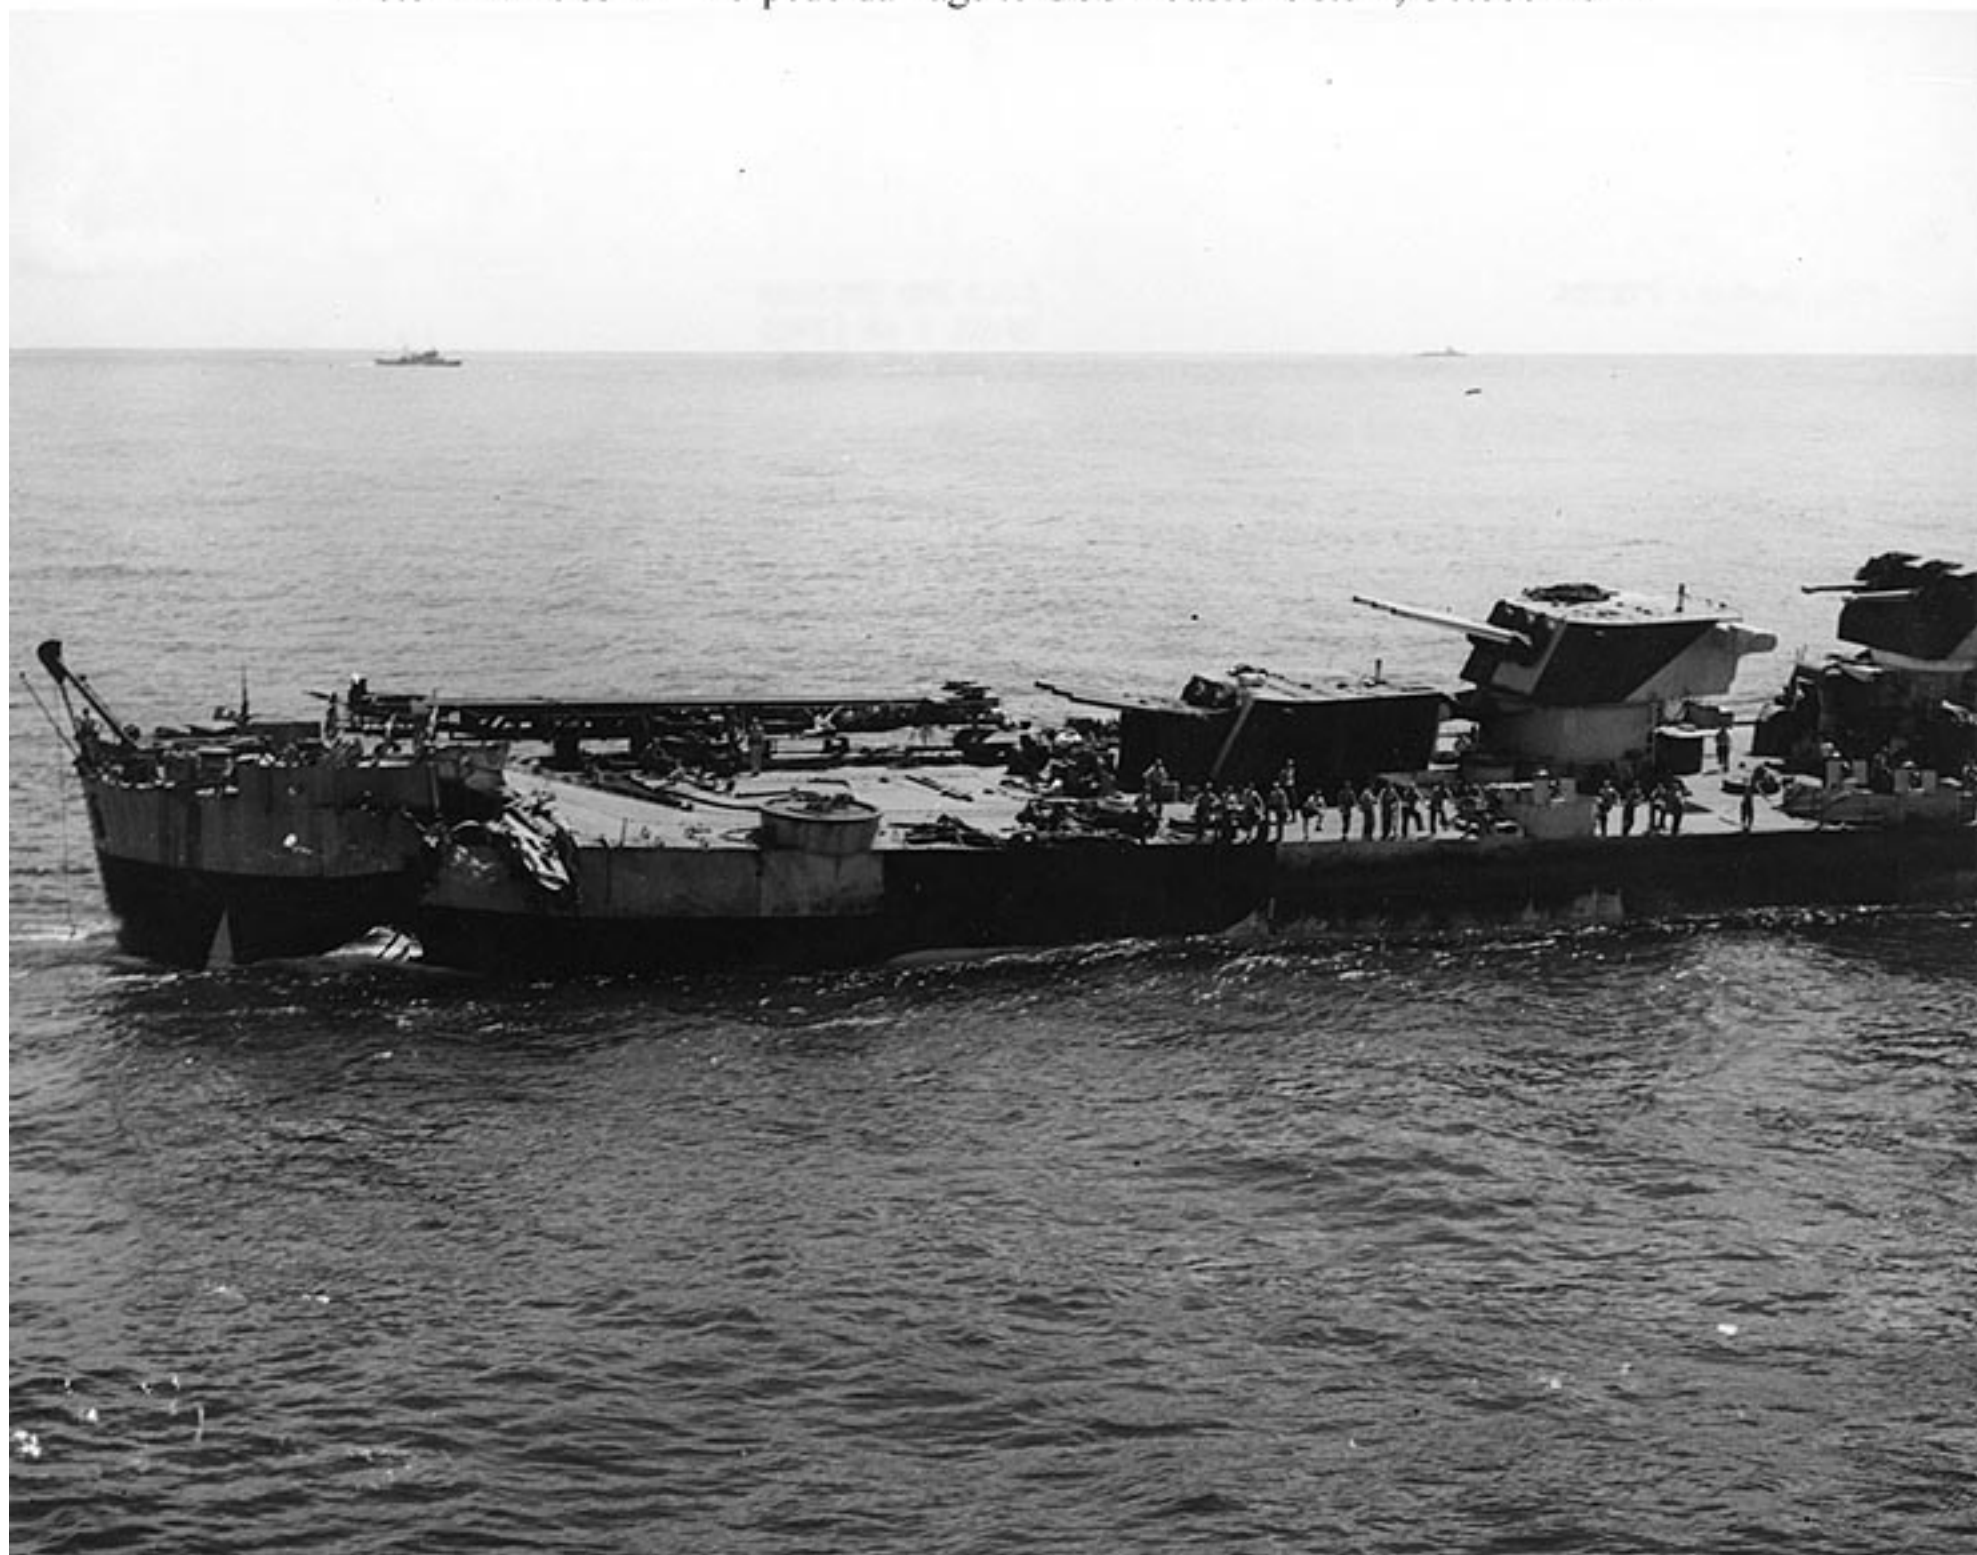
Photo # NH 98342 Torpedo damage to USS Houston's stern, October 1944

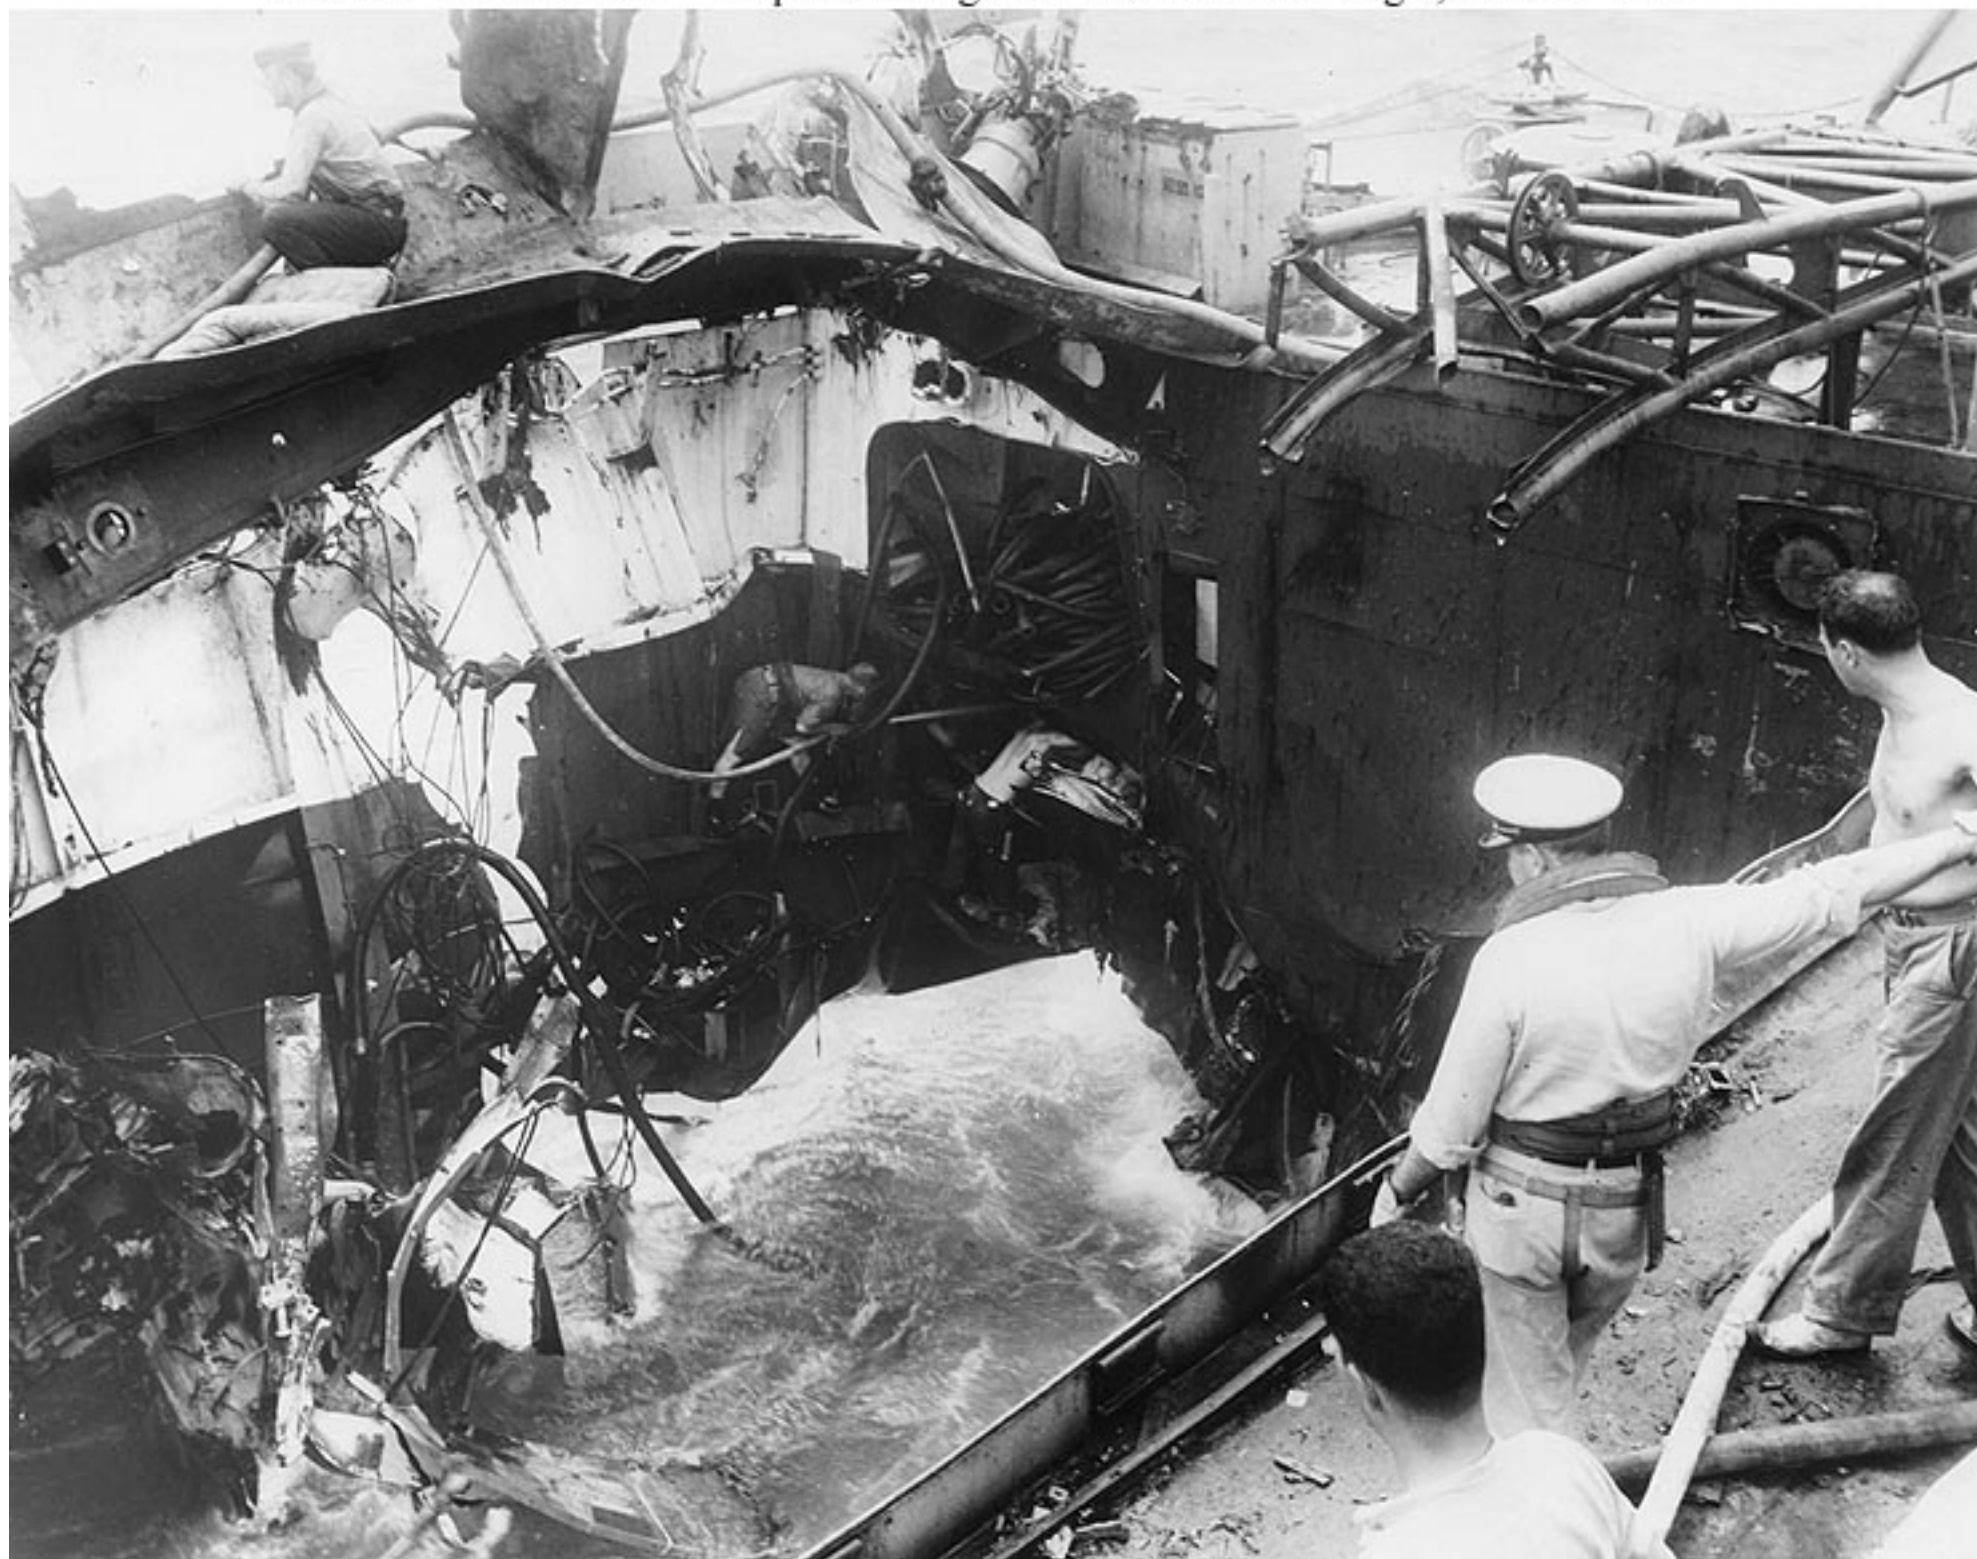
Photo # 19-N-110837 Torpedo damage to USS Houston's hangar, October 1944

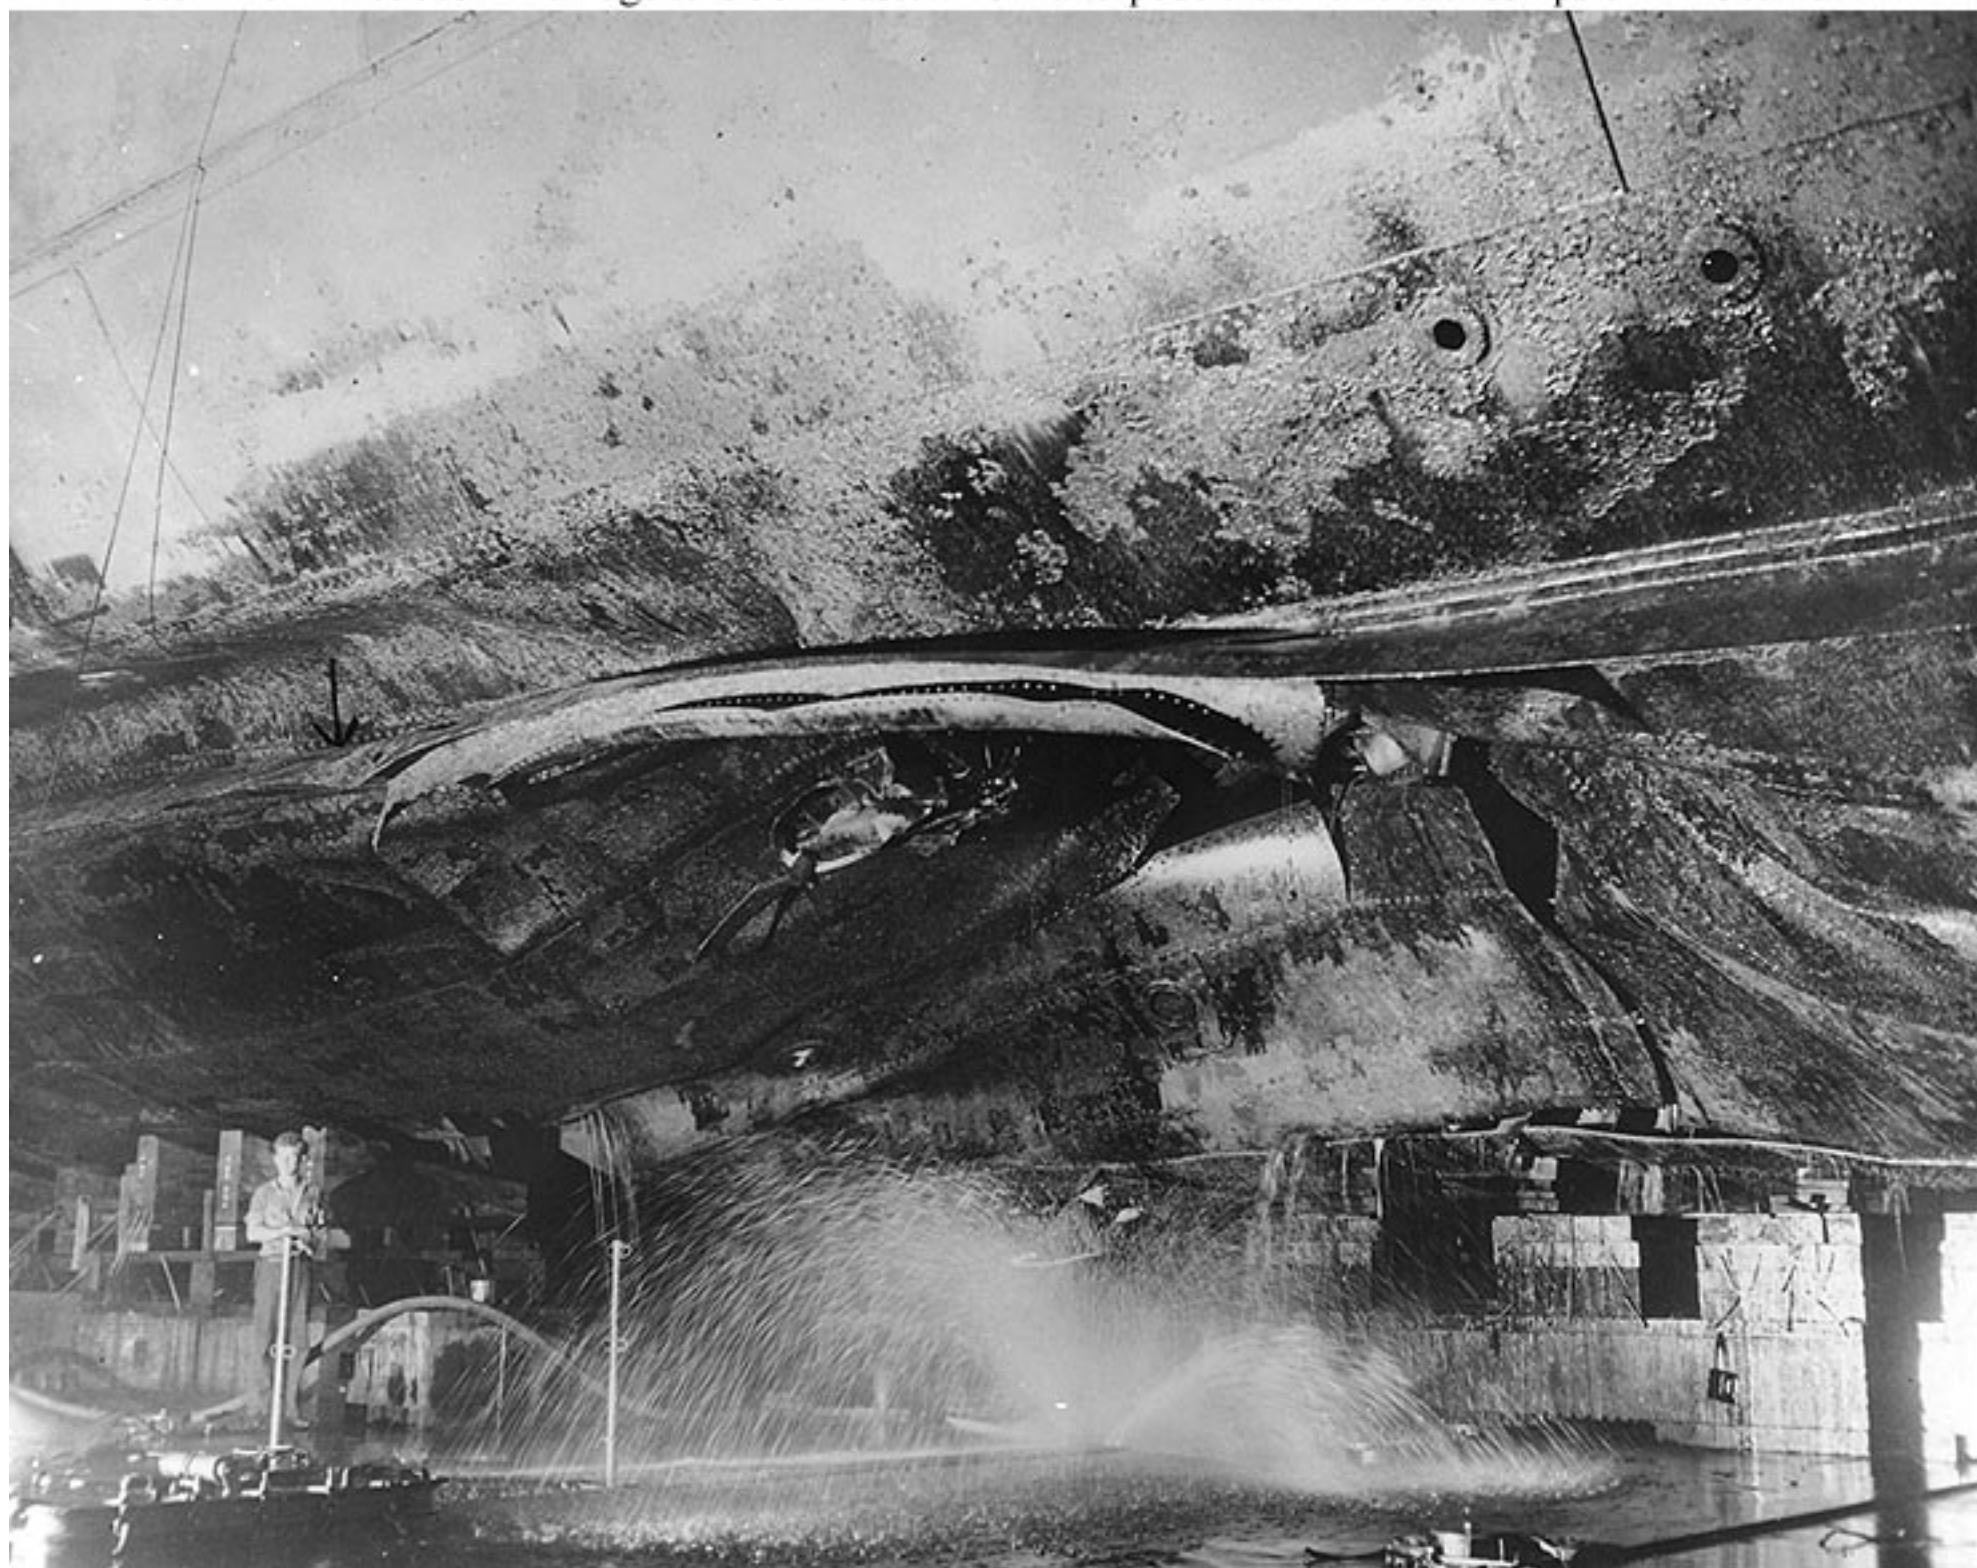
NARA Photo #: 19-N-105803
Photographed in ABSD 2 at Manus in November, 1944 after drydocking, showing amidships torpedo damage, starboard side. Note that the damage is centered inboard of the bilge keel; the massive damage in this area allowed most of the center of the ship to flood very quickly.

Photo # 19-N-105803 Damage to USS Houston from a torpedo that hit her amidships on 14 Oct. 1944

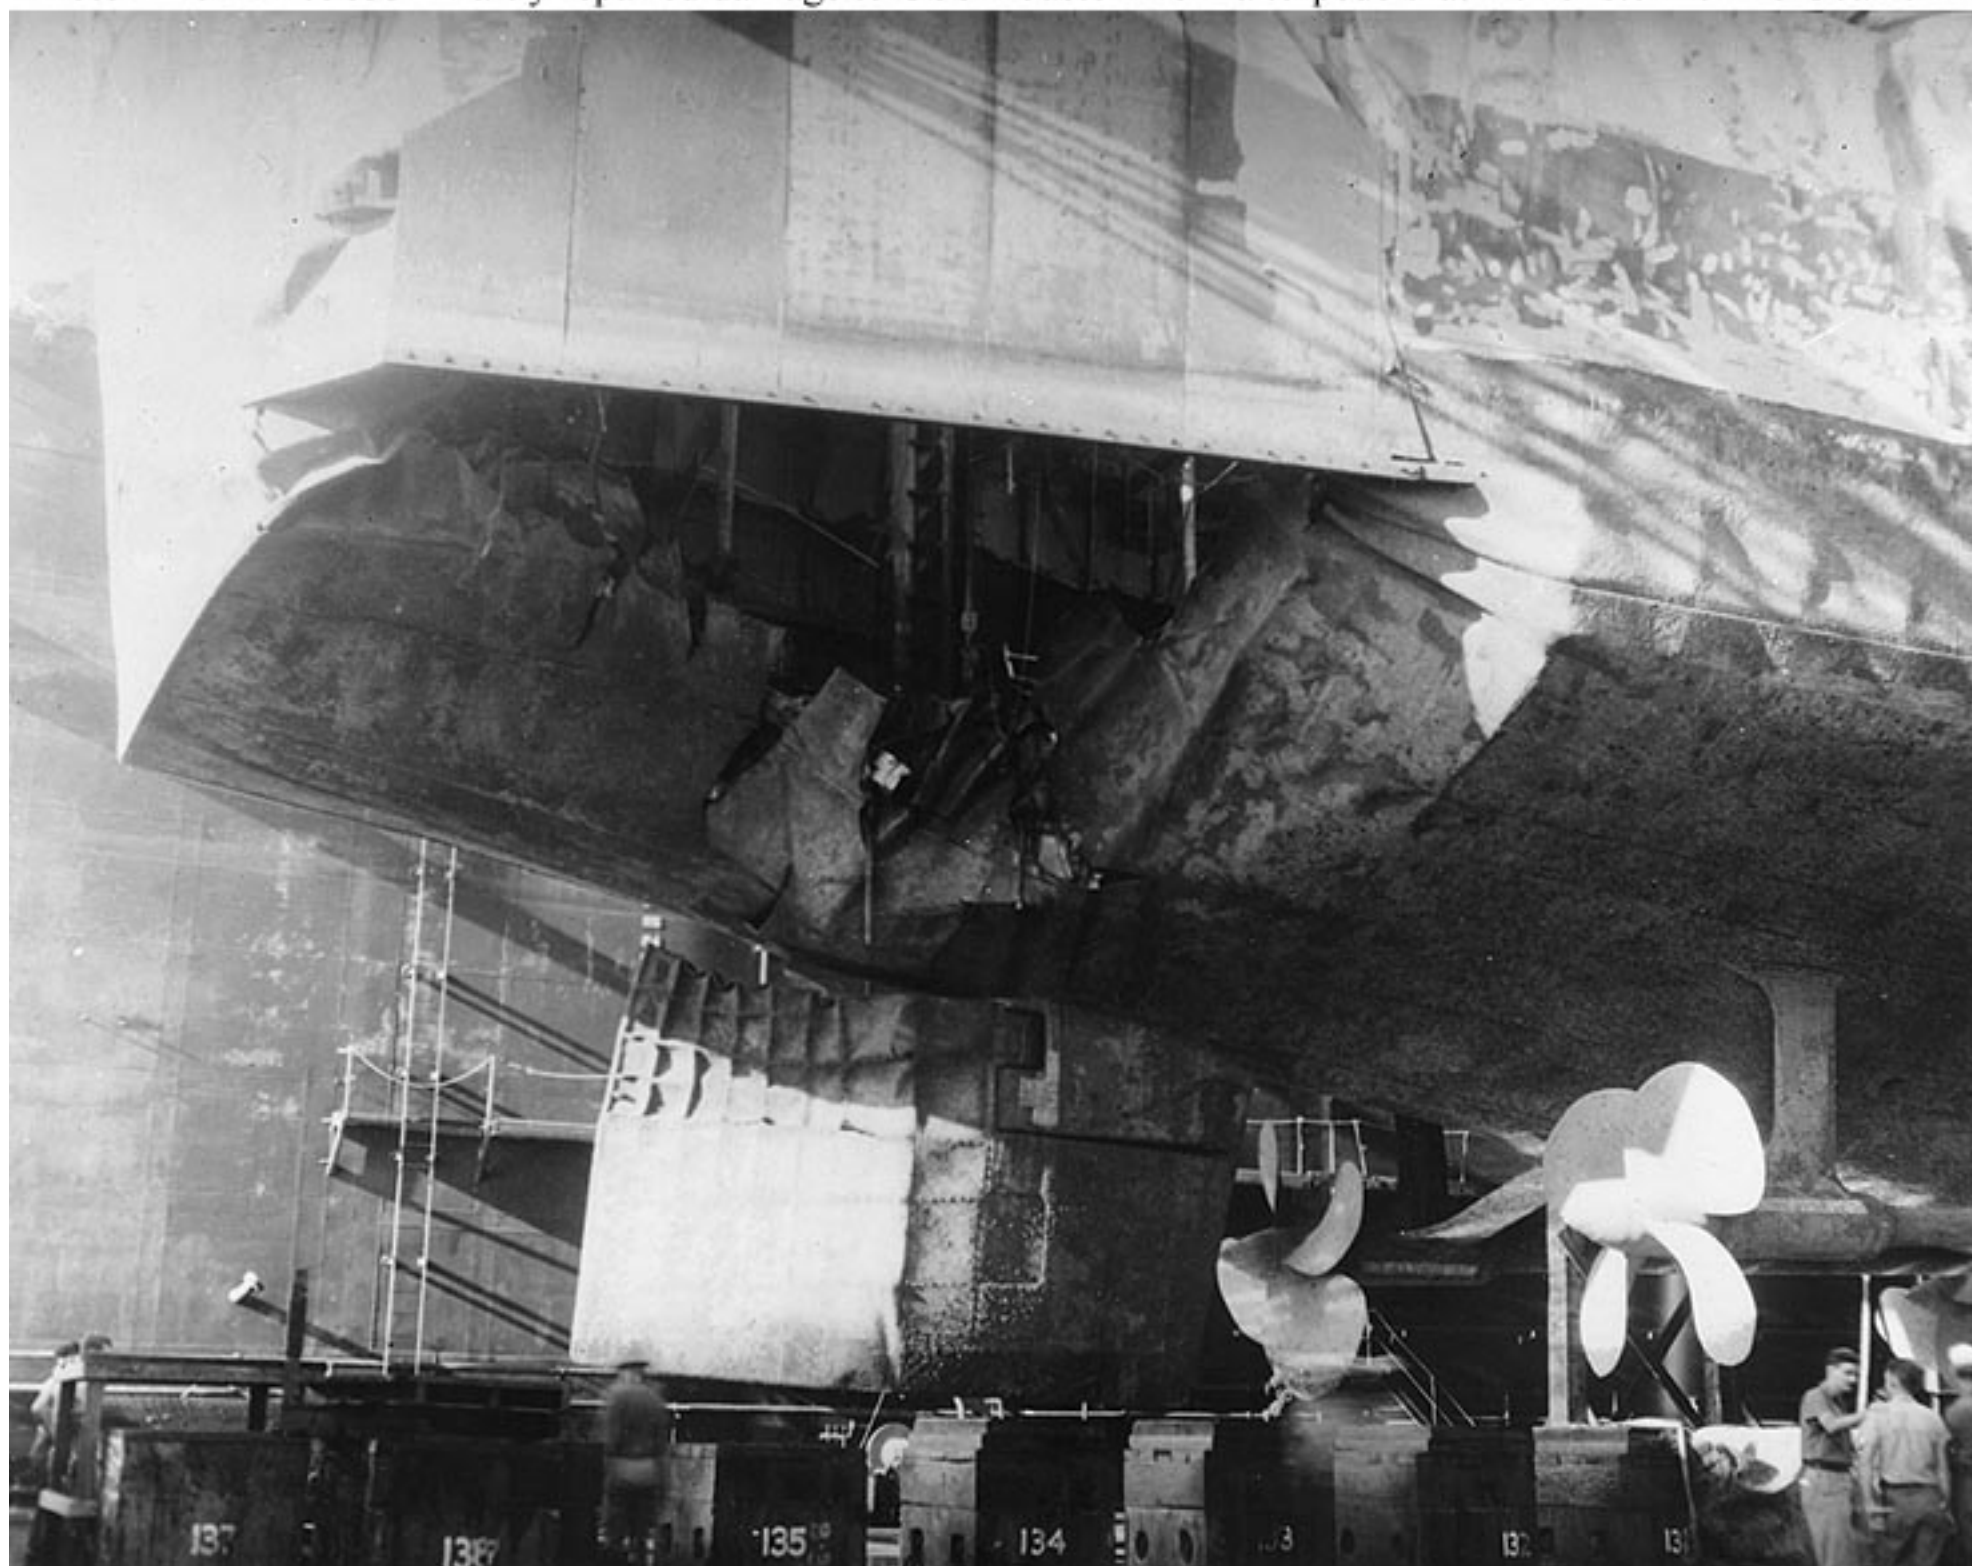
NARA Photo #: 19-N-105833
Photographed in ABSD 2 at Manus in November, 1944 after drydocking, showing partial repairs to stern. This is a cleaner scan of the same picture that Photo 23 was reprinted from.

Photo # 19-N-105833 Partly repaired damage to USS Houston from a torpedo that hit her stern on 16 Oct. 1944

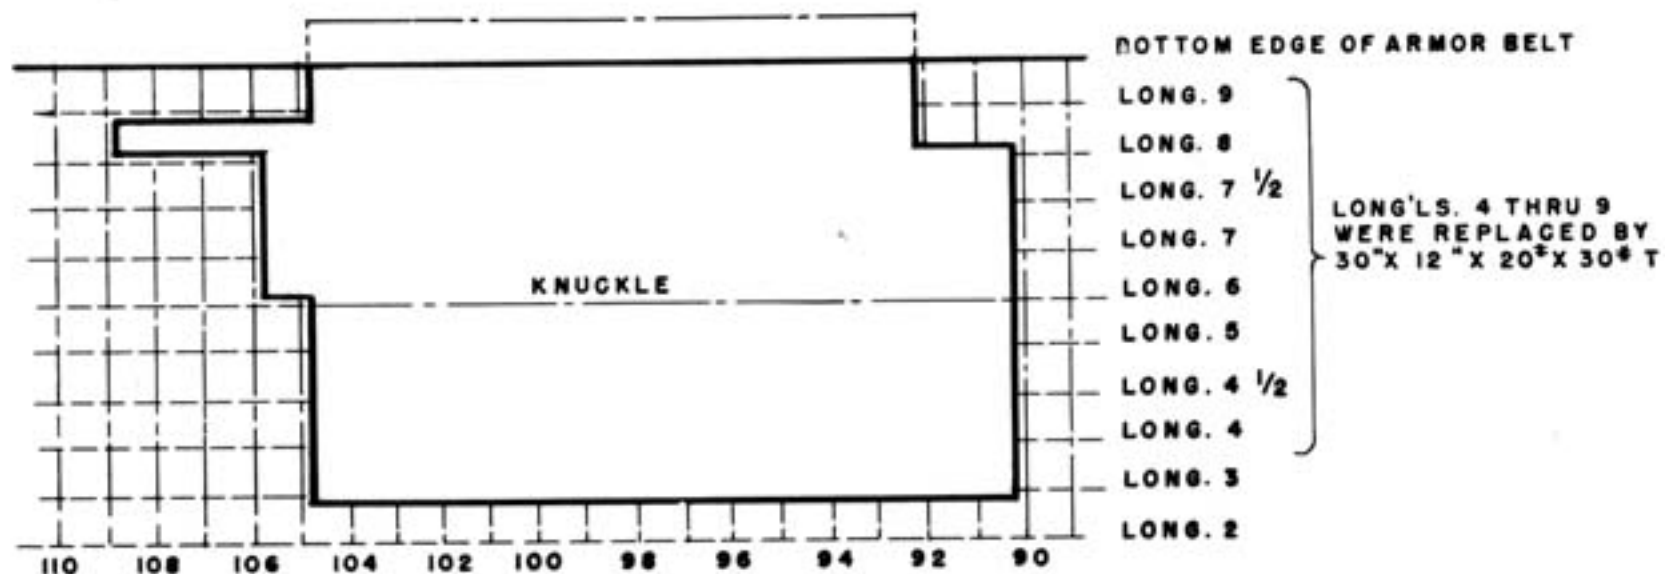
OUTLINE OF TEMPORARY PATCH

DAMAGED SHELL WITHIN
OUTLINED AREA REPLACED
BY 30# PLATE

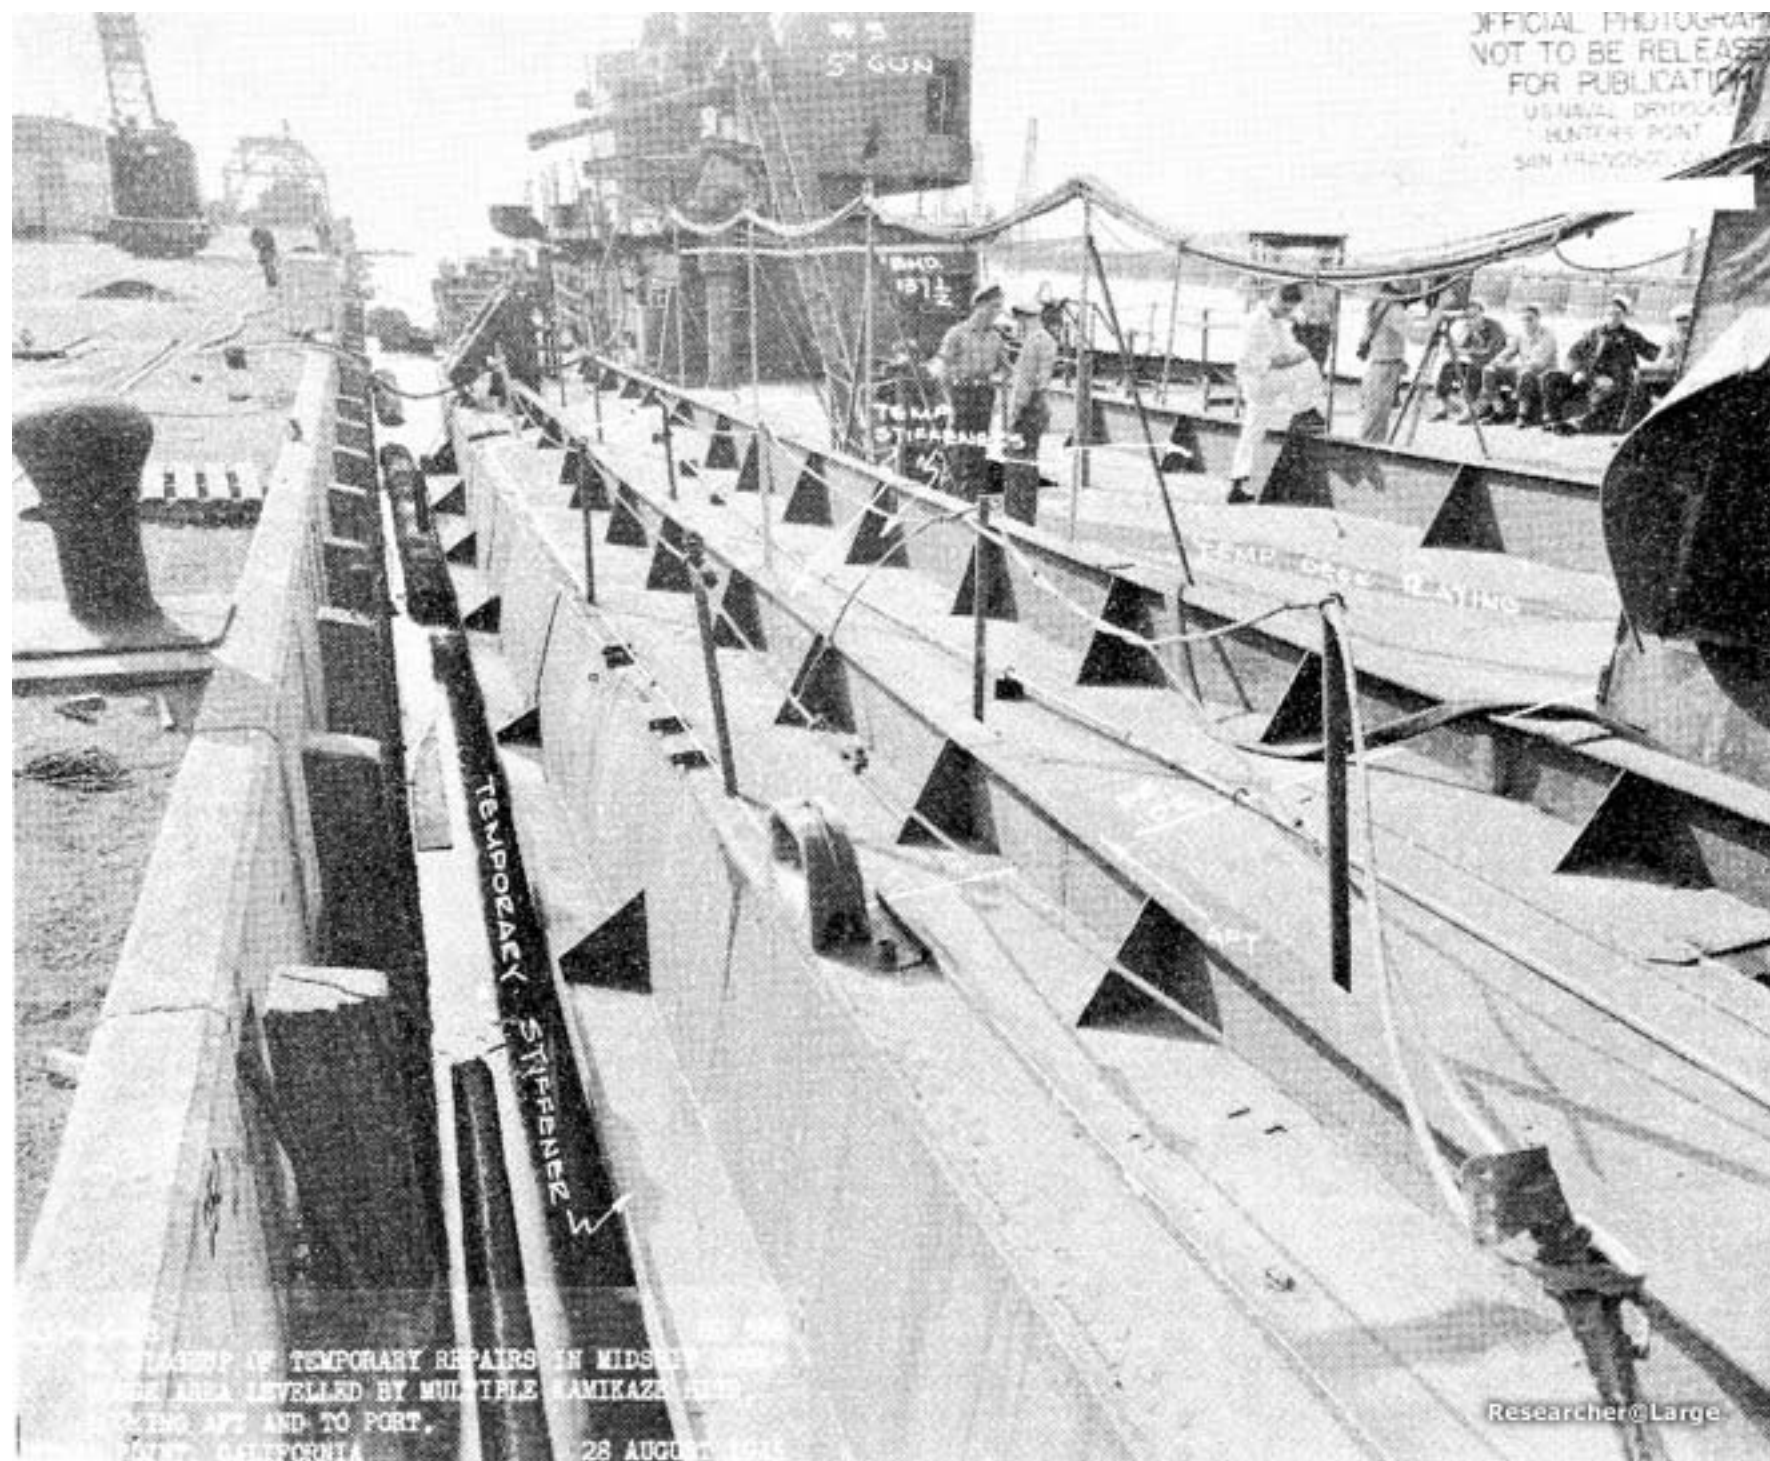
STAGNATION OF TEMPORARY REPAIRS IN MIDSHIP AREA
WAS AREA LEVELLED BY MULTIPLE SAMIKAZE HIT
MOVING AFT AND TO PORT.
HUNTERS POINT, CALIFORNIA 28 AUGUST 1945

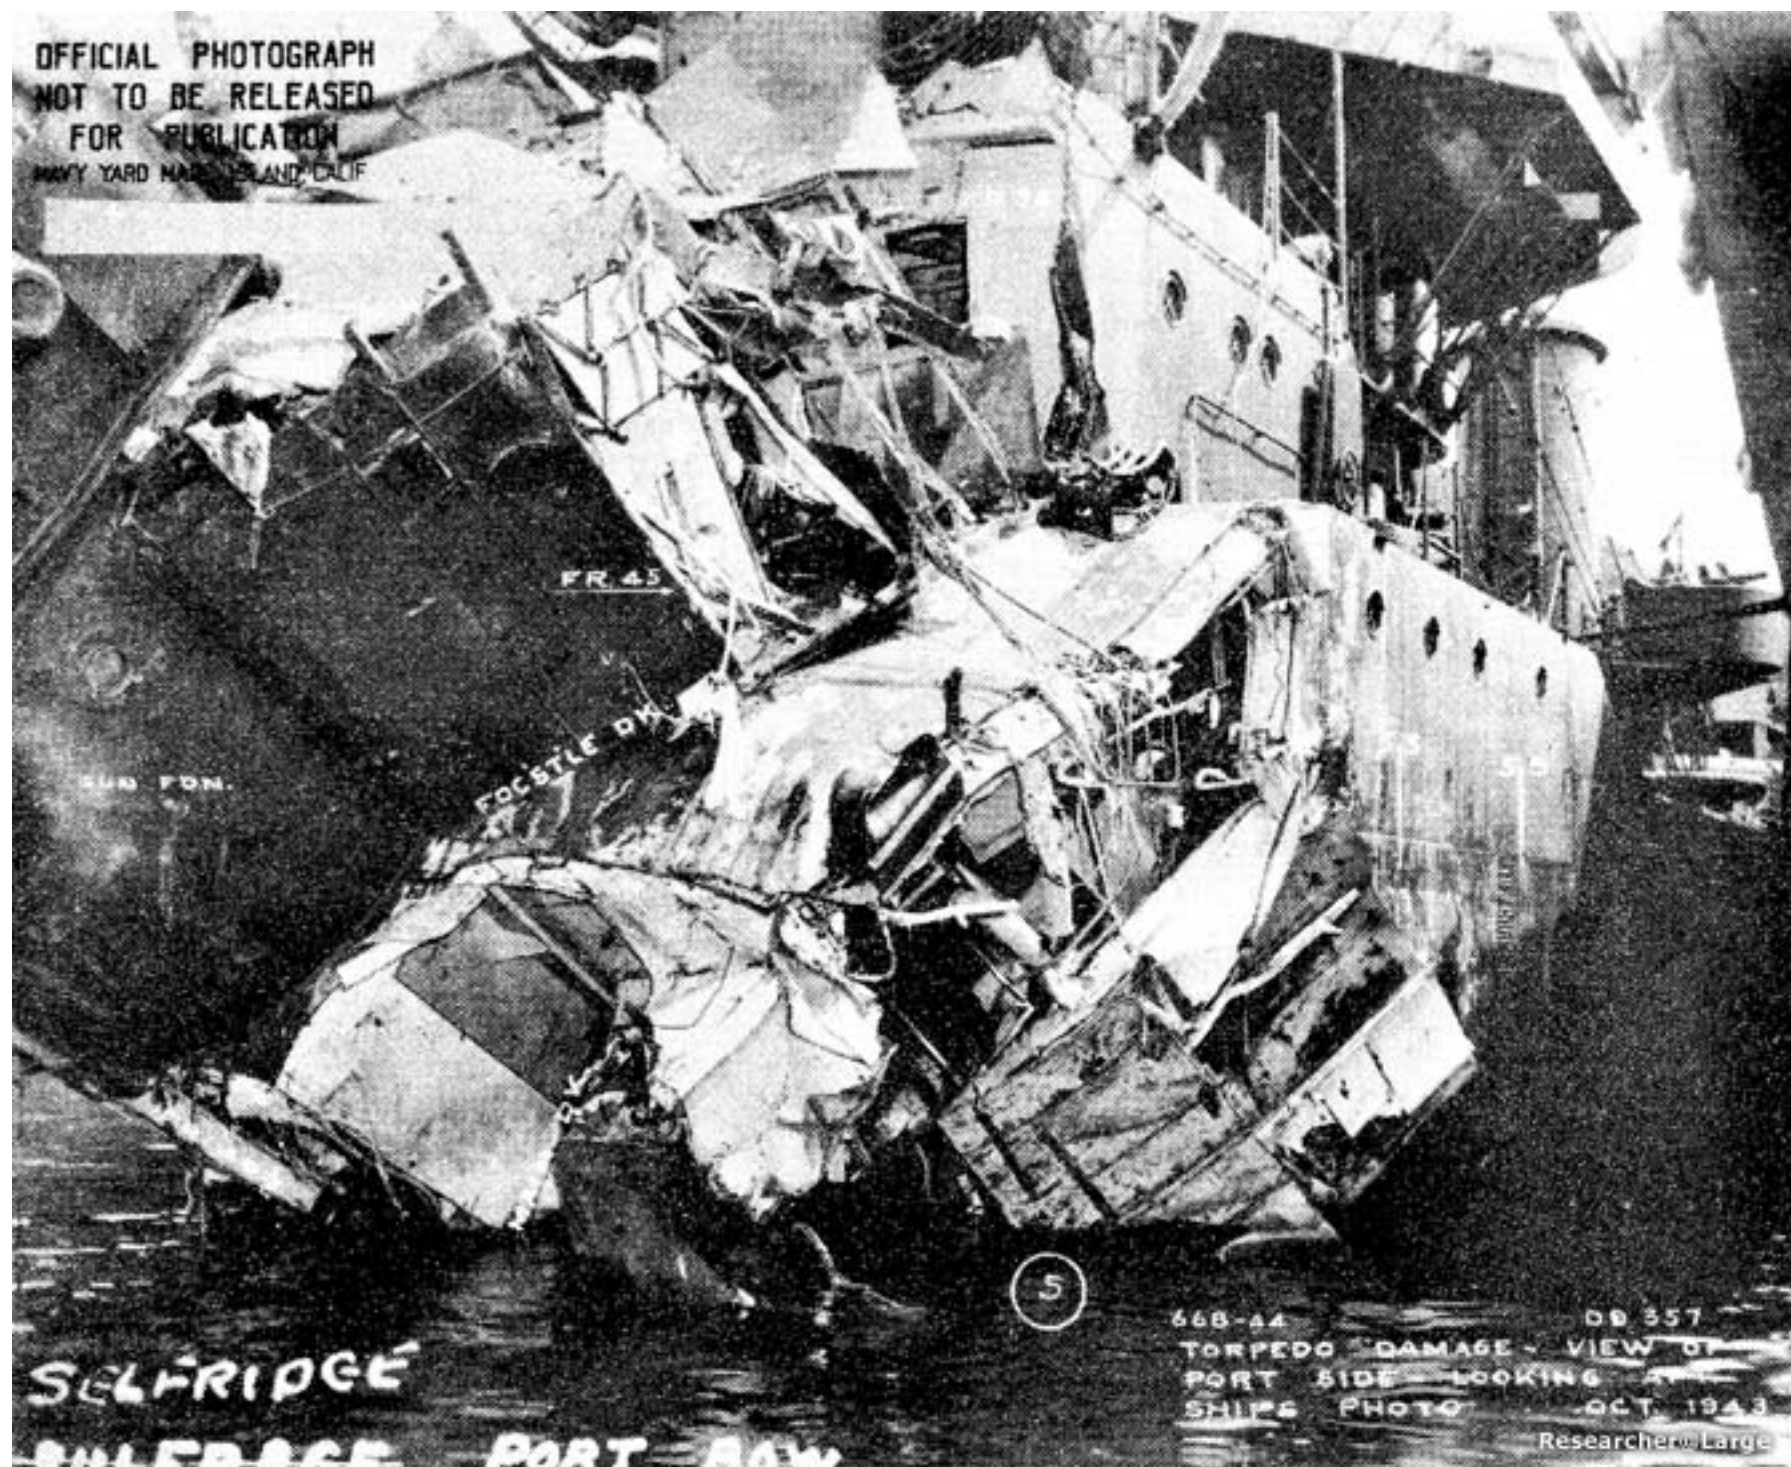
668-44 DD 357
TORPEDO DAMAGE - VIEW OF
PORT SIDE - LOOKING
SHIPS PHOTO OCT 1943
Researcher@Large
