CONTENTS		
NAME	CAUSE OF DAMAGE	PAGE
INTRODUCTION		
ERIE (PG50)	Submarine Torpedo	5
RENO (CL96)	Submarine Torpedo	11
HOUSTON (CL-81)	Submarine Torpedo	19
CANBERRA (CA70)	Aircraft Torpedo	33
O'BRIEN (DD725)	Submarine Torpedo	39
WADLEIGH (DD689)	Mine	47
NEWCOMB (DD586)	4 Kamikaze Planes (1 Bomb)	59
KEARNY (DD432)	Submarine Torpedo	65
SELFRIIDGE (DD357)	Submarine Torpedo	69
FOOTE (DD511)	Submarine Torpedo	77
INTREPID (CV11)	Aircraft Torpedo	83
VIRBURNUM (AN57)	Mine	89

SOURCE:
National Archives & Records Administration, Seattle Branch
Record Group 181, Entry 59A-271 "13th Naval District Bremerton, Washington" General Correspondance 1947-1958
"Structural Repairs in Forward Areas During World War II" -BuShips Booklet dated December 1949.

The problem of effecting temporary repairs to damaged ships was encountered frequently during World War II and was handled with varying degrees of success. It was never feasible to make complete repairs to seriously damaged vessels in the forward area. Accordingly, repair work ordinarily was limited to that which would enable the ship to proceed to a larger repair activity and eventually to a shipyard. Repairs to machinery and electrical equipment were

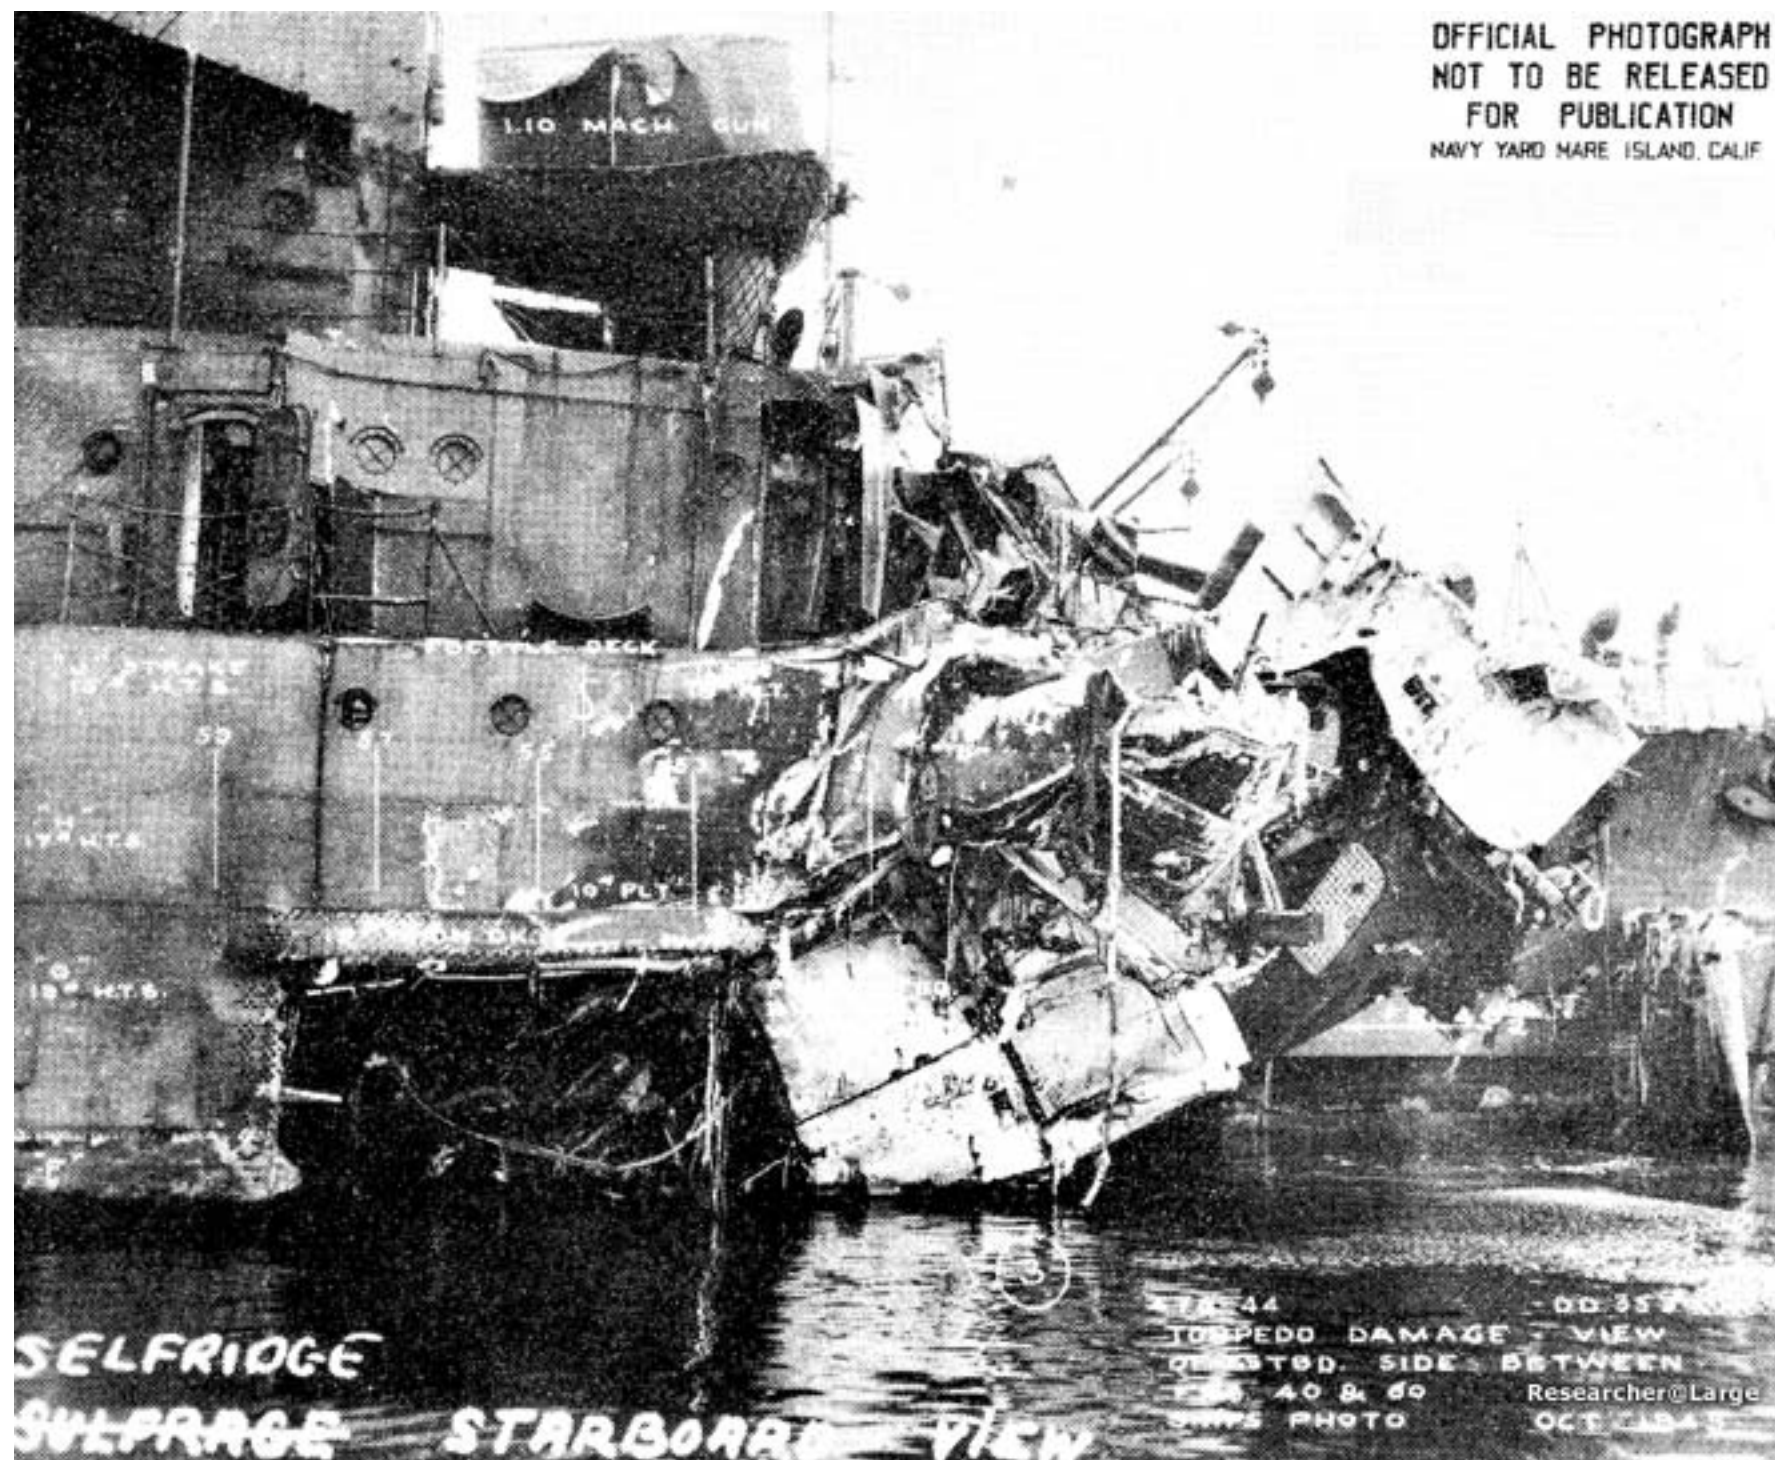
SS-44 - DD-357
TORPEDO DAMAGE - VIEW
ON STARBOARD SIDE BETWEEN
40 & 60
JAN 40 PHOTO
OCT 1945

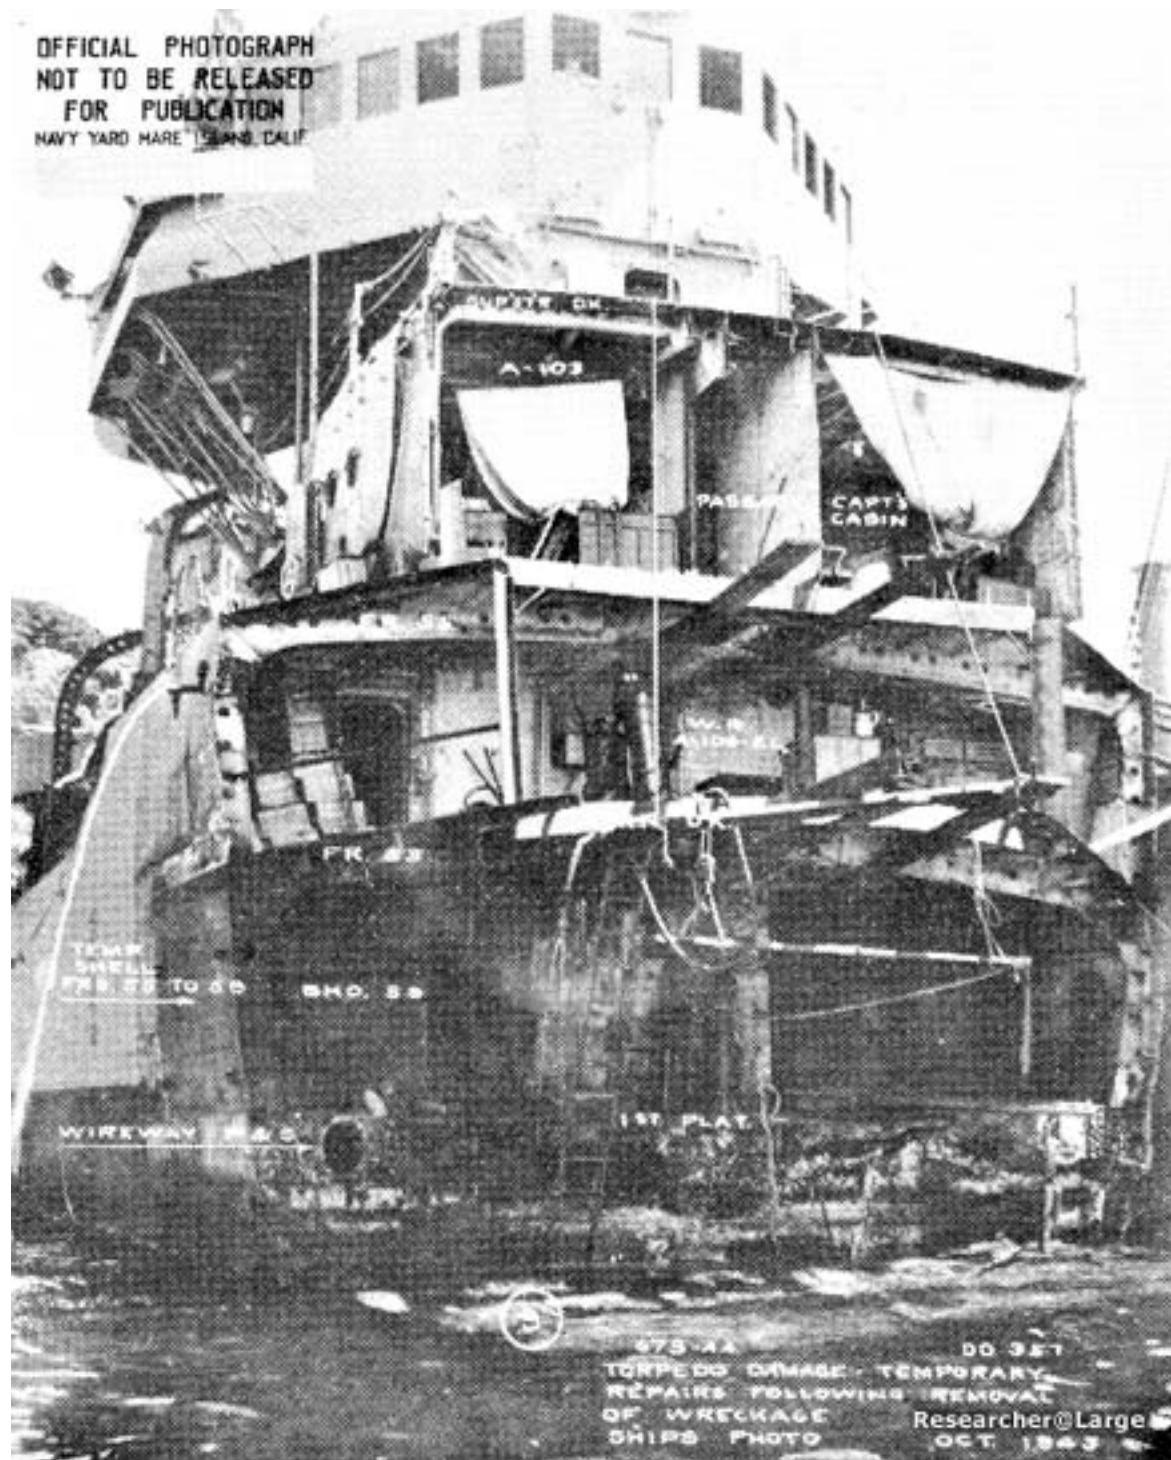
675-44 DO 351
TORPEDO DAMAGE - TEMPORARY
REPAIRS FOLLOWING REMOVAL
OF WRECKAGE
SHIPS PHOTO OCT. 1943

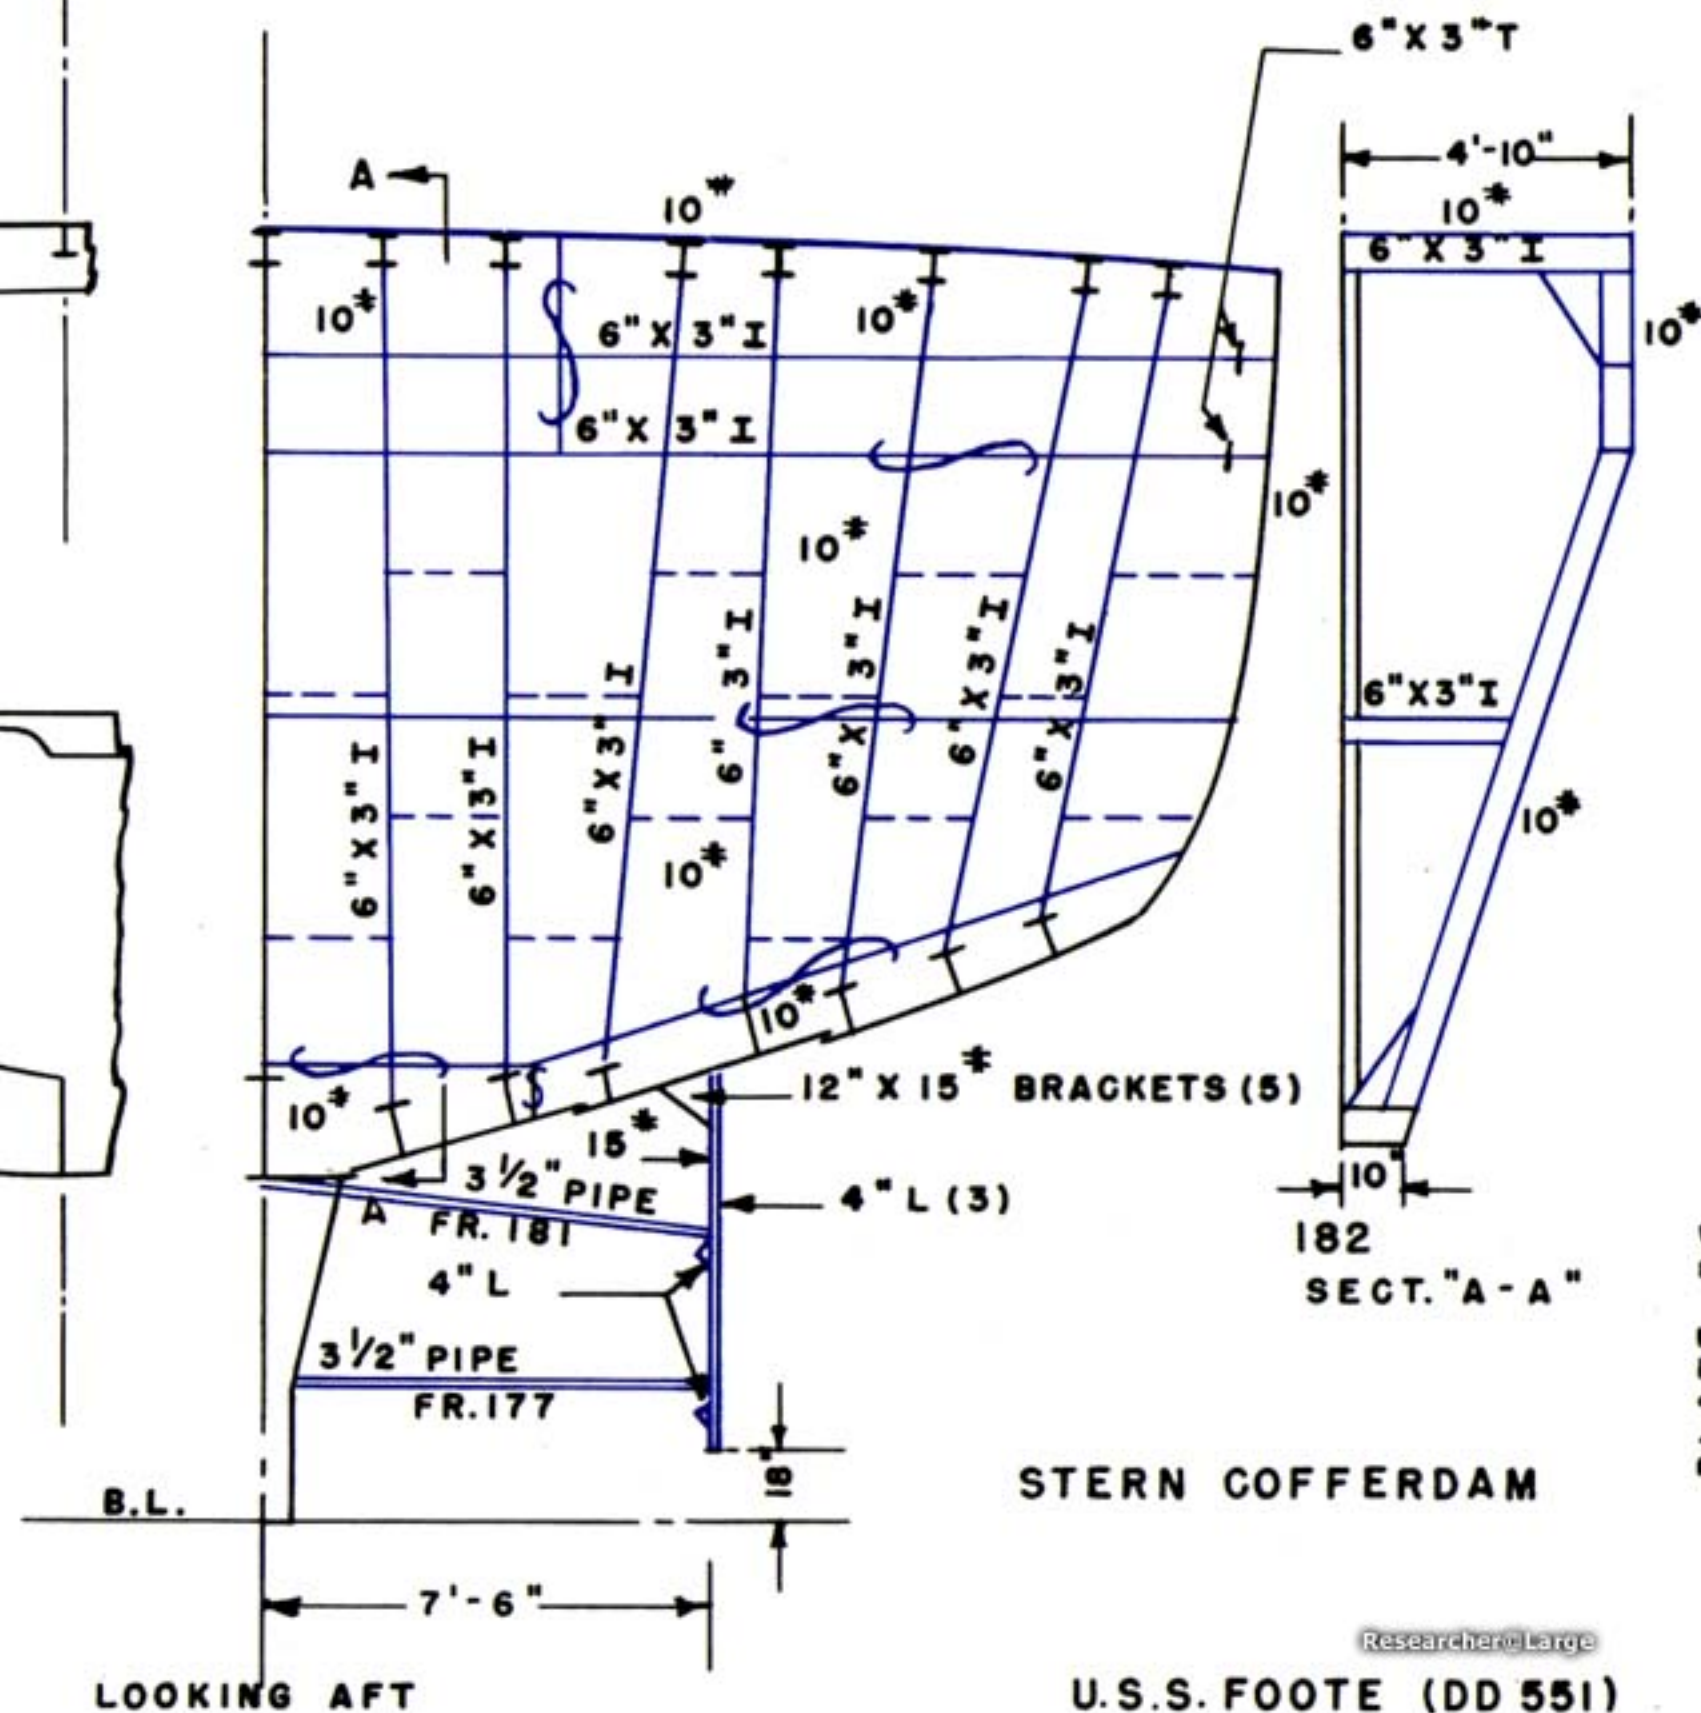
PLATE 36

10* PLATING REPLACED SHELL & MAIN DECK.
10* PLATING ON STERN COFFERDAM BULKHEAD.
6" X 3" I VERTICAL STIFFENERS & MAIN DECK LONG.
4" X 15* INTERMEDIATE LATERAL STIFFENERS.

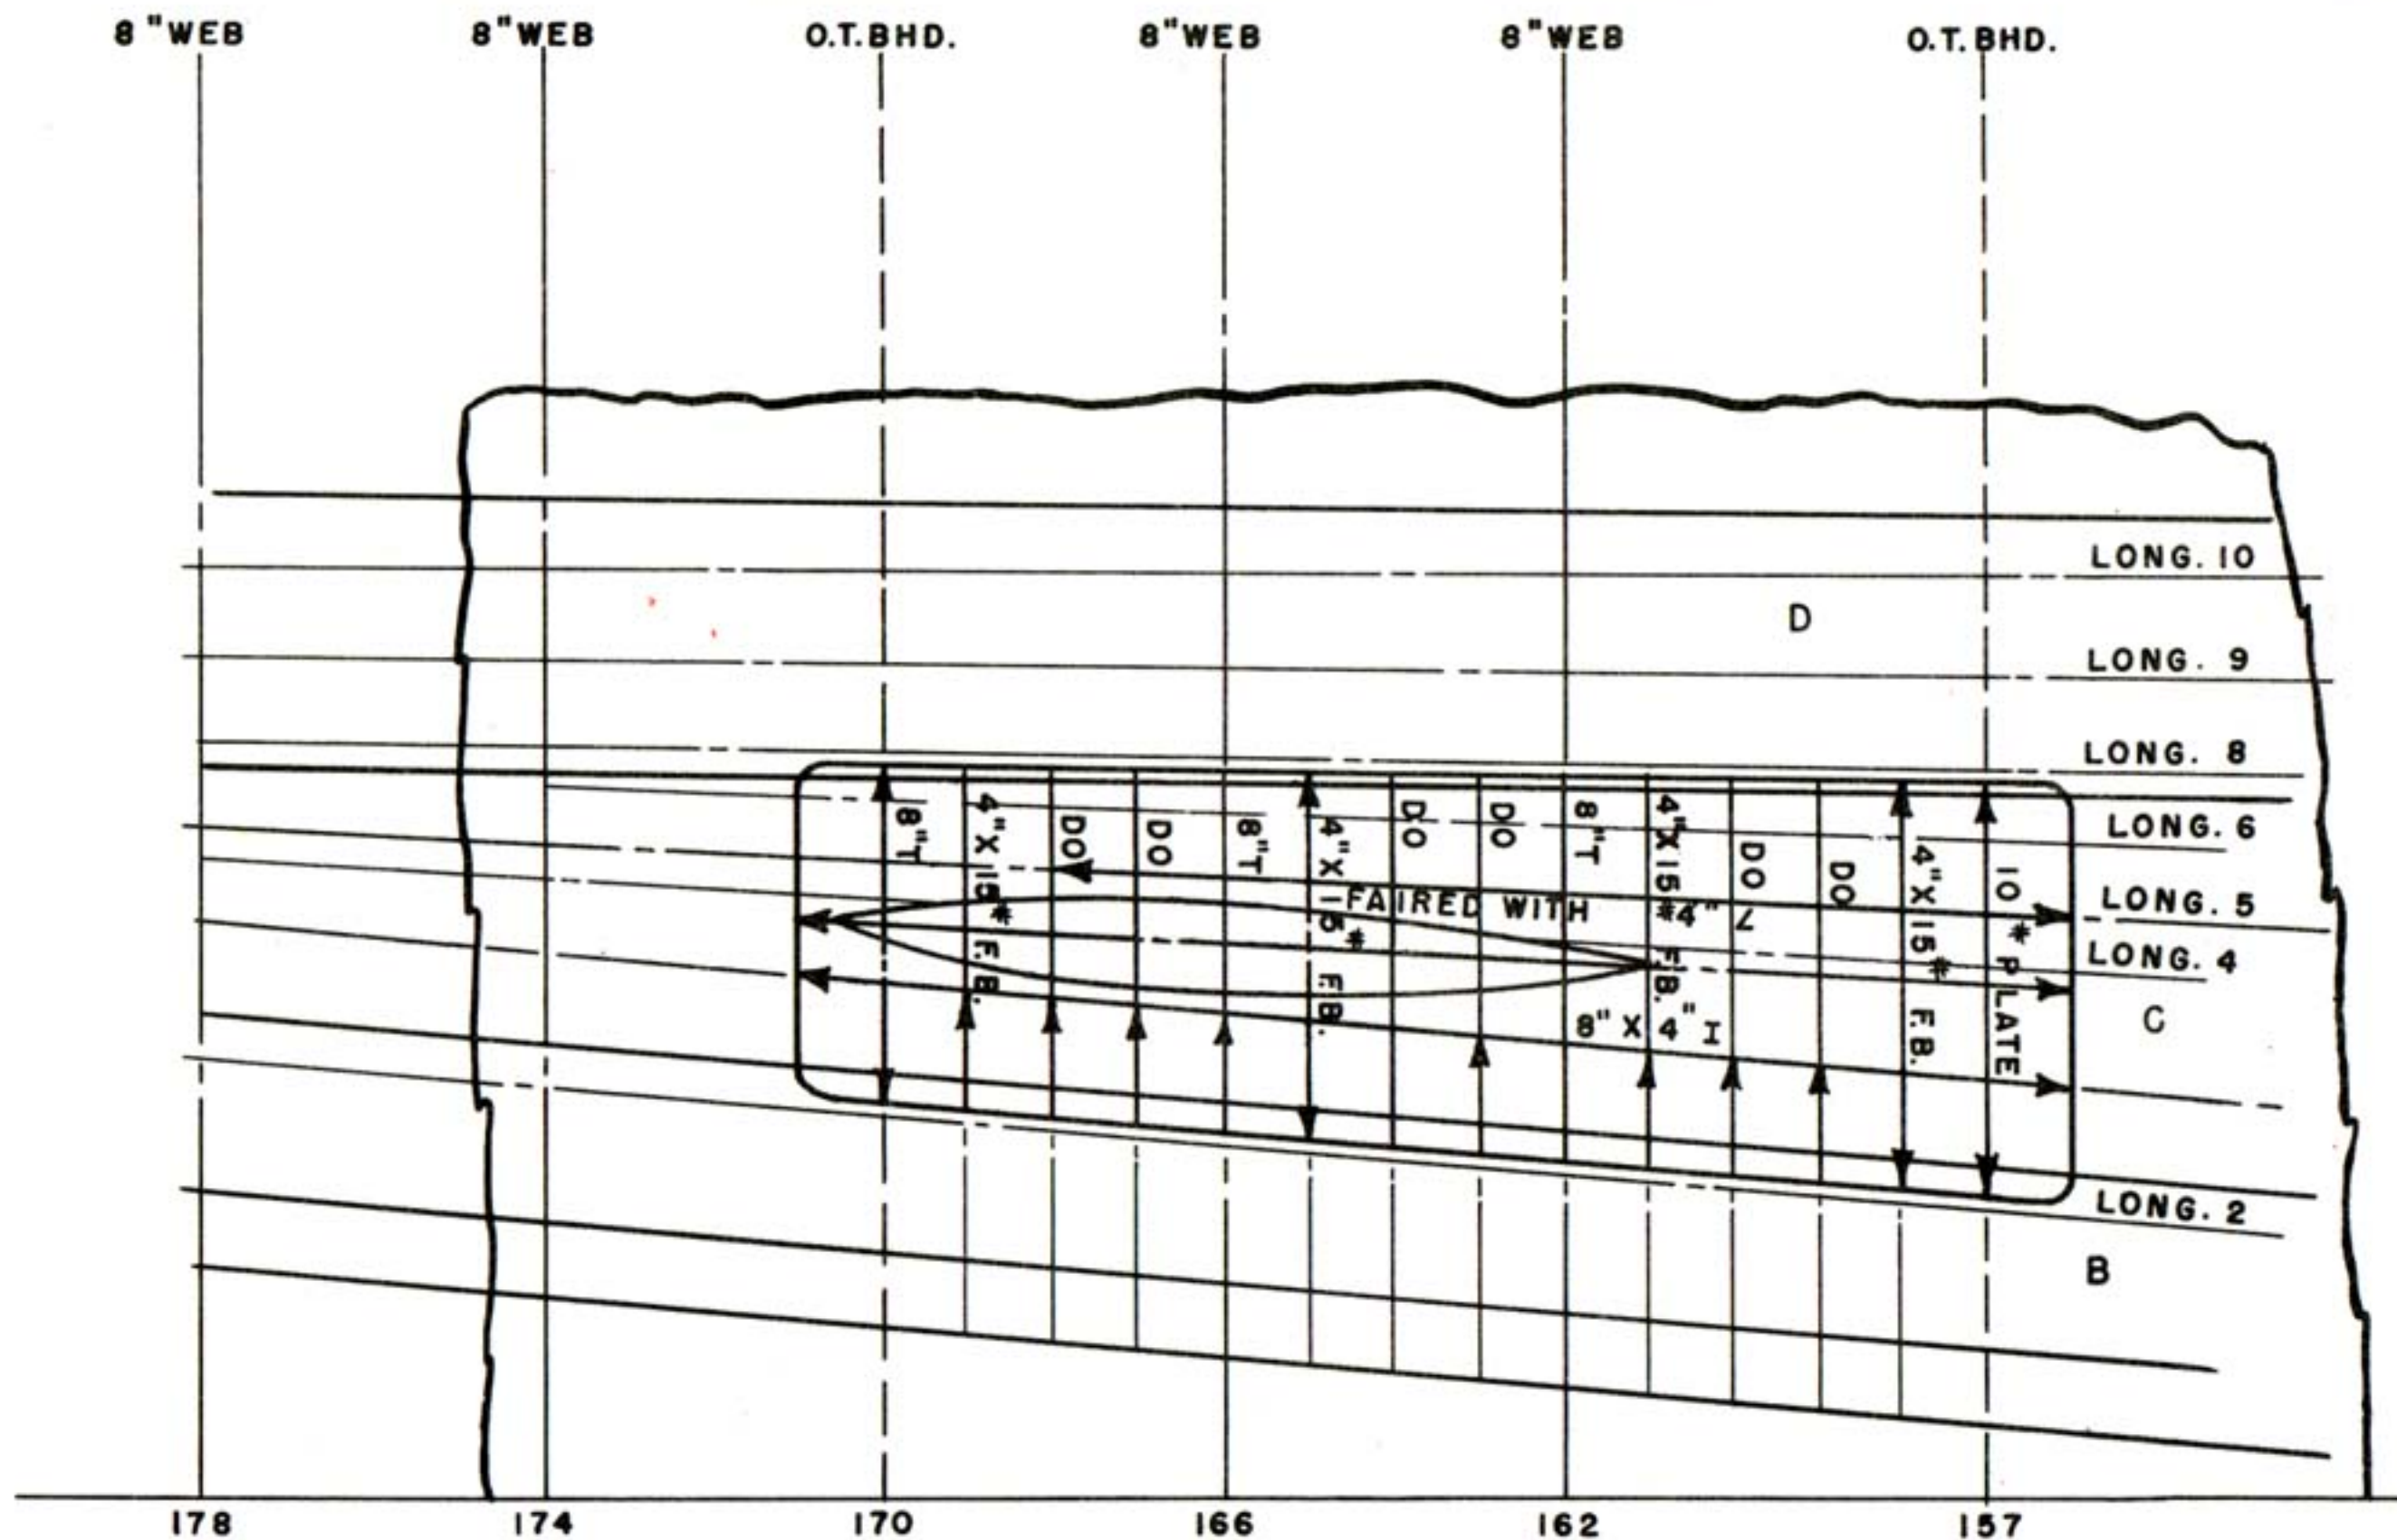
DETAIL OF REPAIR TO SHELL
IN WAY OF STARBOARD SHAFT.
