Japanese Thunderfish

By John F. De Virgilio

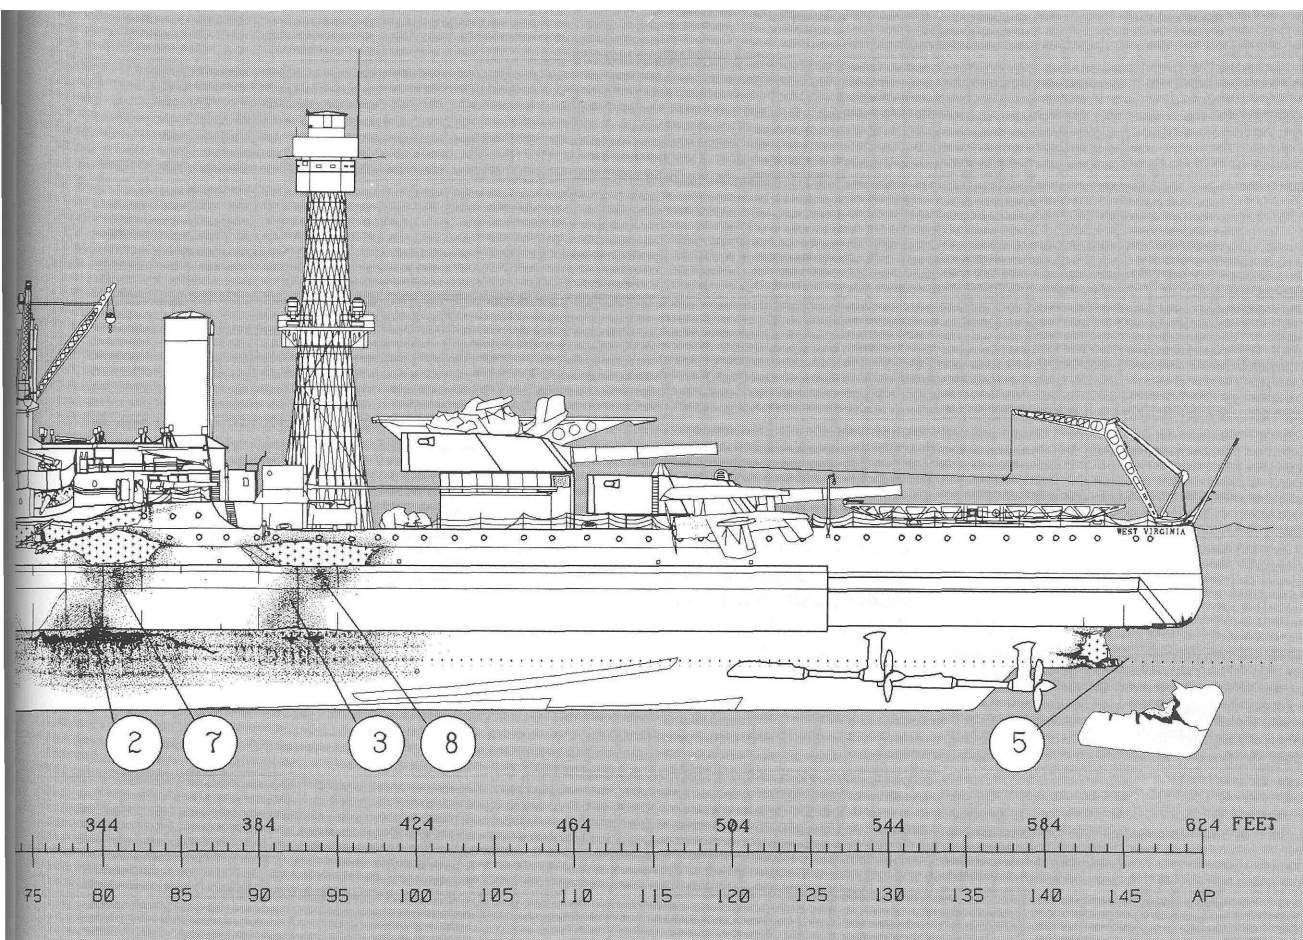
Illus. D: The *West Virginia* was heavily damaged by torpedoes but did not capsize because of timely counter-flooding and better armor protection than the *Oklahoma*'s.

The first hit on the *West Virginia* occurred at frame 46 by a torpedo running about 13 feet deep. The torpedo struck the armor belt itself, about 3 feet above the lower edge of the belt. The blast pushed in the 13.5-inch armor belt about 8 inches and left a circular warhead impact groove in the armor (see point 1 on Illustrations D & E). The thin hull plating below the armor belt was smashed inward and downward. Although the shell plating was badly crushed, it was still present to indicate no hit below the belt.

Another torpedo hit the armor belt between frames 79 and 80. The warhead exploded about 5 feet up from the lower edge of the armor belt. The resulting water hammer smashed in the shell plat-

ing below the belt (see point 2 on Illustrations D & E). A further torpedo also struck the lower portion of the armor belt at frame 92. The impact point of this hit was approximately 7 feet up from the armor belt's lower edge at frame 92. The blast pushed in the lower half of the armor belt plate approximately 10 inches and smashed in the shell plating below the belt (see point 3 on Illustrations D & E).

Similarly, another torpedo hit on the lower half of the armor belt at the armor belt joint of frame 70. This torpedo left a circular scar about 5 feet up from the lower edge of the 13.5-inch armor belt. Again, the thinner shell plating below the armor belt was smashed inward and downward (see point 4 on Illustrations D & E).
