CONTENTS		
NAME	CAUSE OF DAMAGE	PAGE
INTRODUCTION		
ERIE (PG50)	Submarine Torpedo	5
RENO (CL96)	Submarine Torpedo	11
HOUSTON (CL-81)	Submarine Torpedo	19
CANBERRA (CA70)	Aircraft Torpedo	33
O'BRIEN (DD725)	Submarine Torpedo	39
WADLEIGH (DD689)	Mine	47
NEWCOMB (DD586)	4 Kamikaze Planes (1 Bomb)	59
KEARNY (DD432)	Submarine Torpedo	65
SELFRIIDGE (DD357)	Submarine Torpedo	69
FOOTE (DD511)	Submarine Torpedo	77
INTREPID (CV11)	Aircraft Torpedo	83
VIRBURNUM (AN57)	Mine	89

SOURCE:
National Archives & Records Administration, Seattle Branch
Record Group 181, Entry 59A-271 "13th Naval District Bremerton, Washington" General Correspondance 1947-1958
"Structural Repairs in Forward Areas During World War II" -BuShips Booklet dated December 1949.

The problem of effecting temporary repairs to damaged ships was encountered frequently during World War II and was handled with varying degrees of success. It was never feasible to make complete repairs to seriously damaged vessels in the forward area. Accordingly, repair work ordinarily was limited to that which would enable the ship to proceed to a larger repair activity and eventually to a shipyard. Repairs to machinery and electrical equipment were

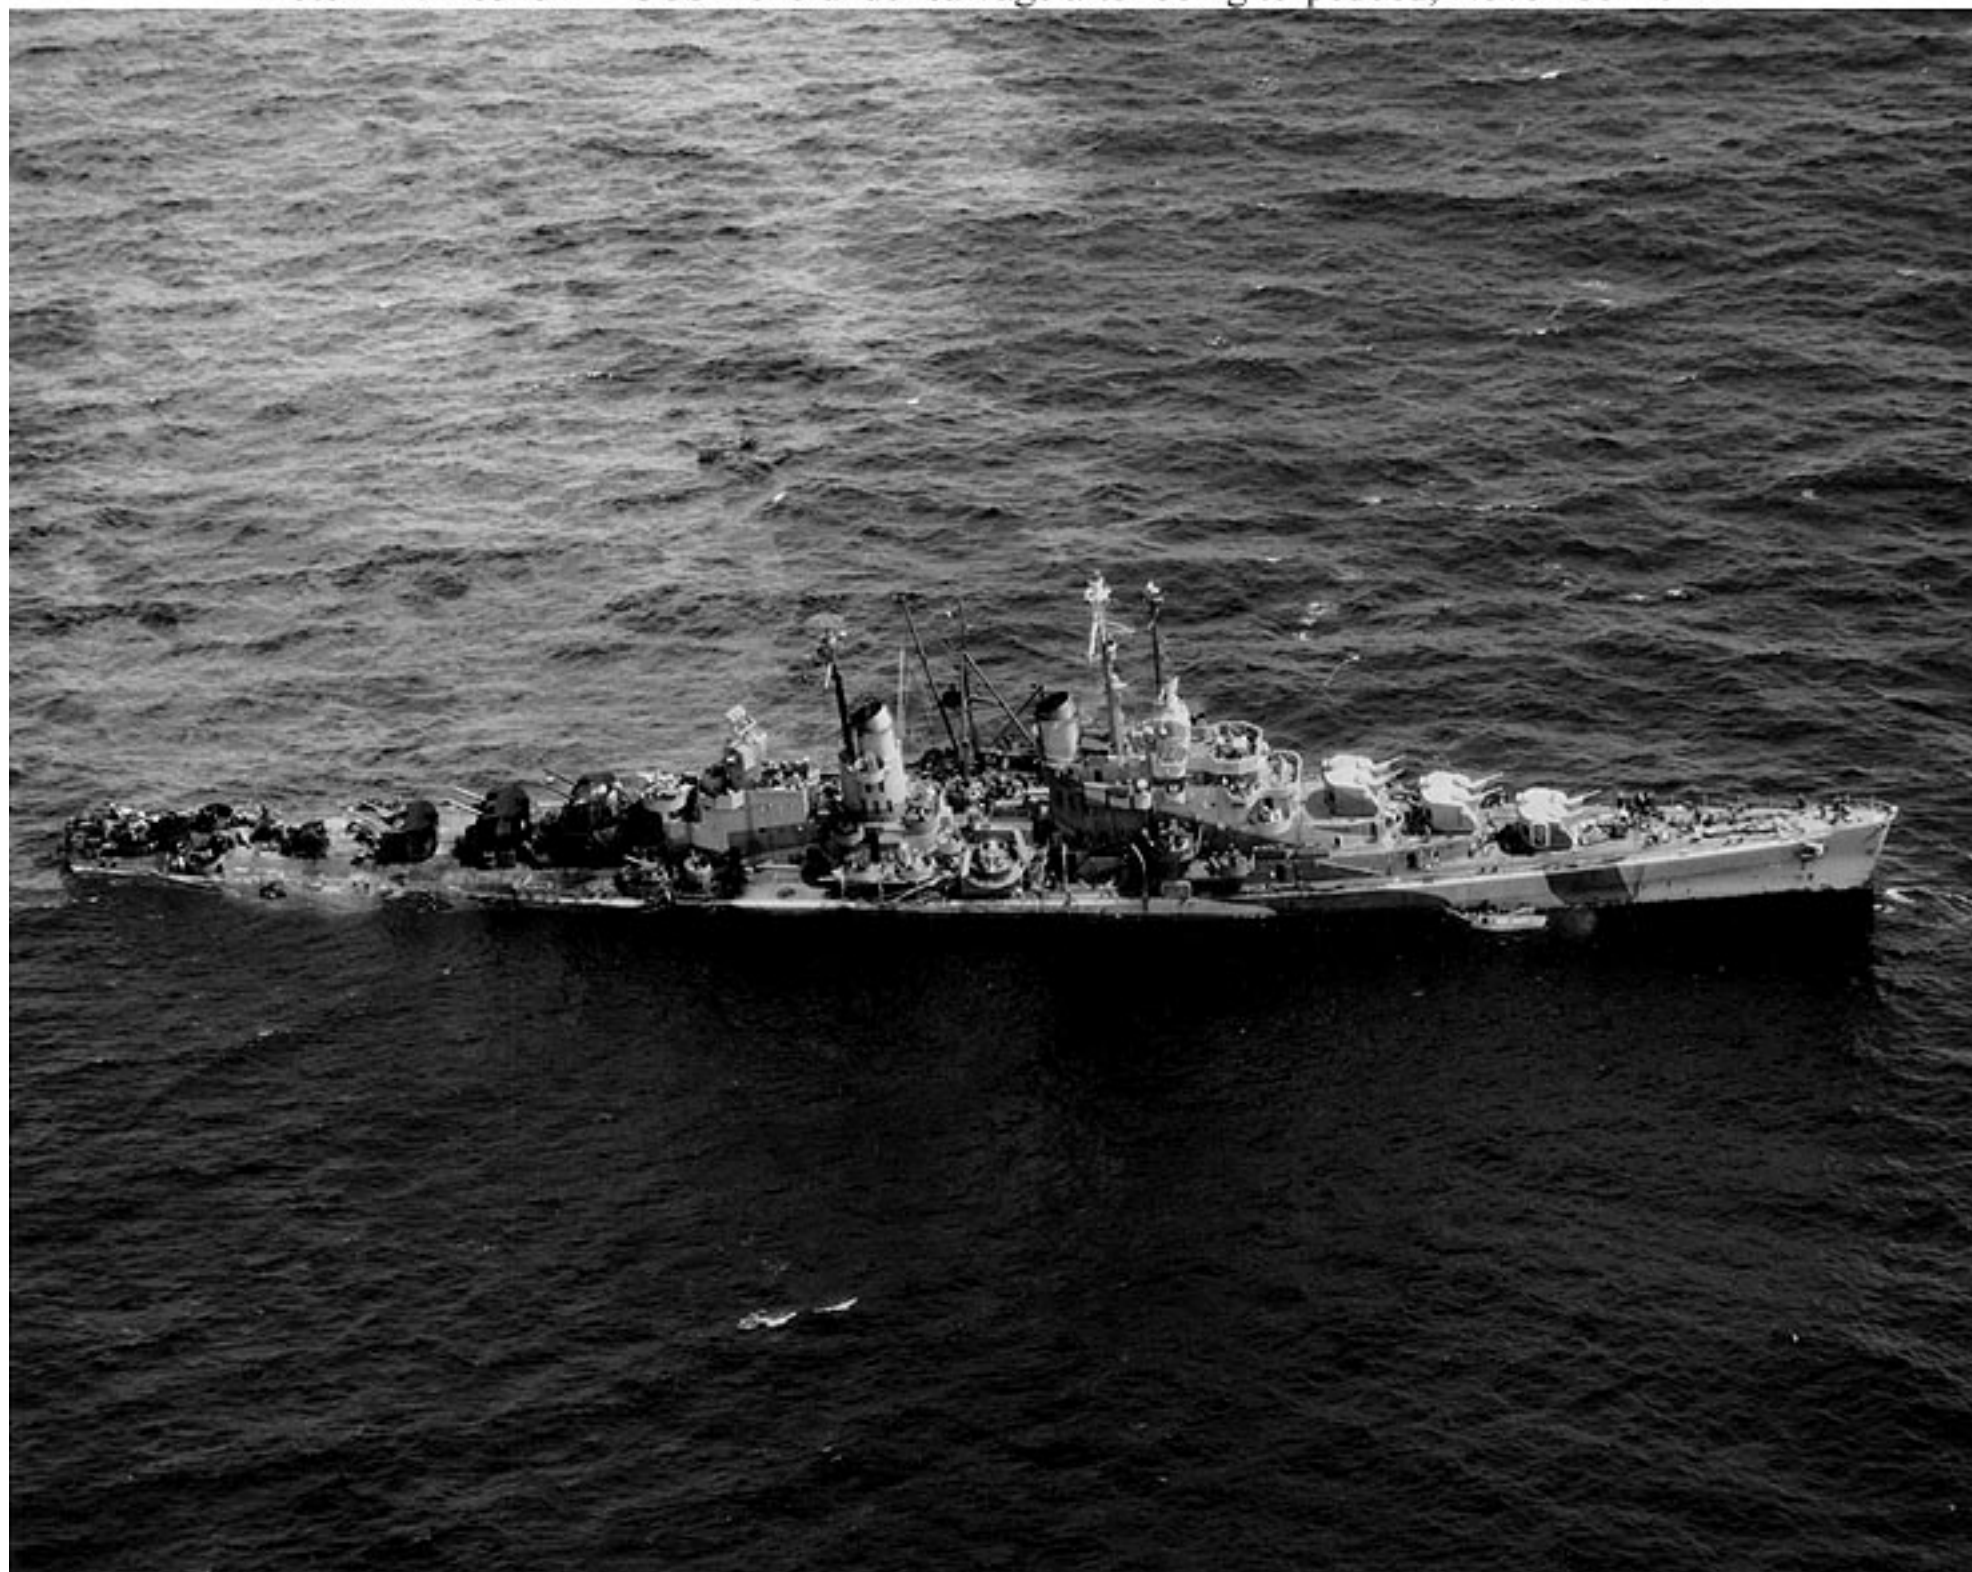
Photo # NH 63431 USS Reno under salvage after being torpedoed, November 1944

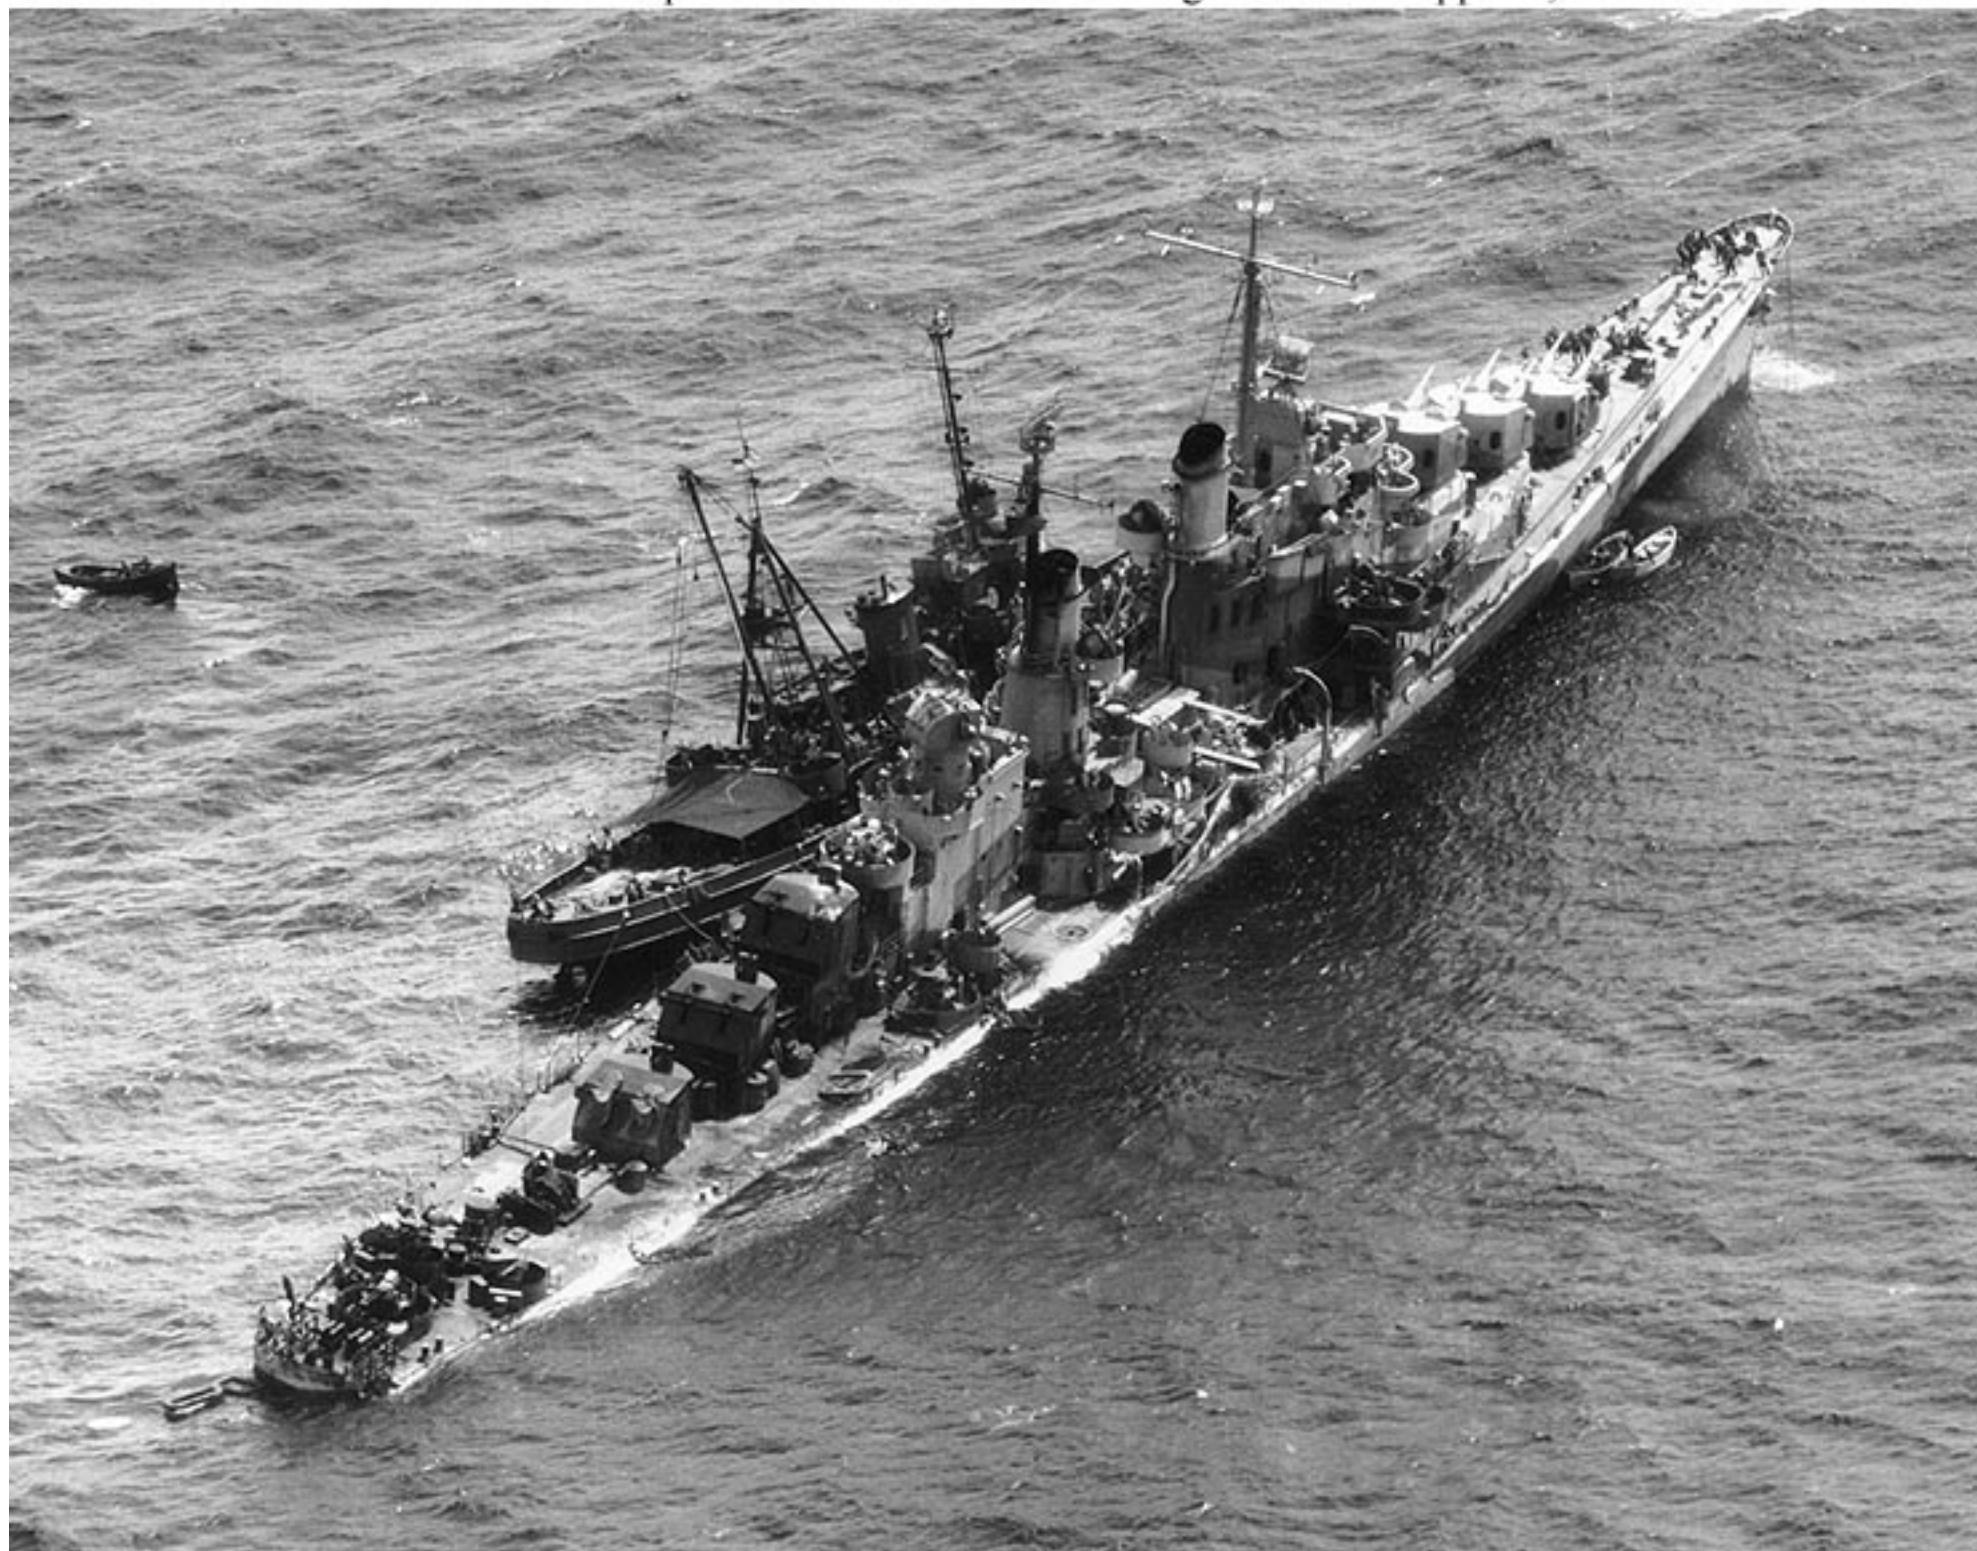
Photo # NH 98473 Torpedoed USS Reno under salvage off the Philippines, Nov. 1944

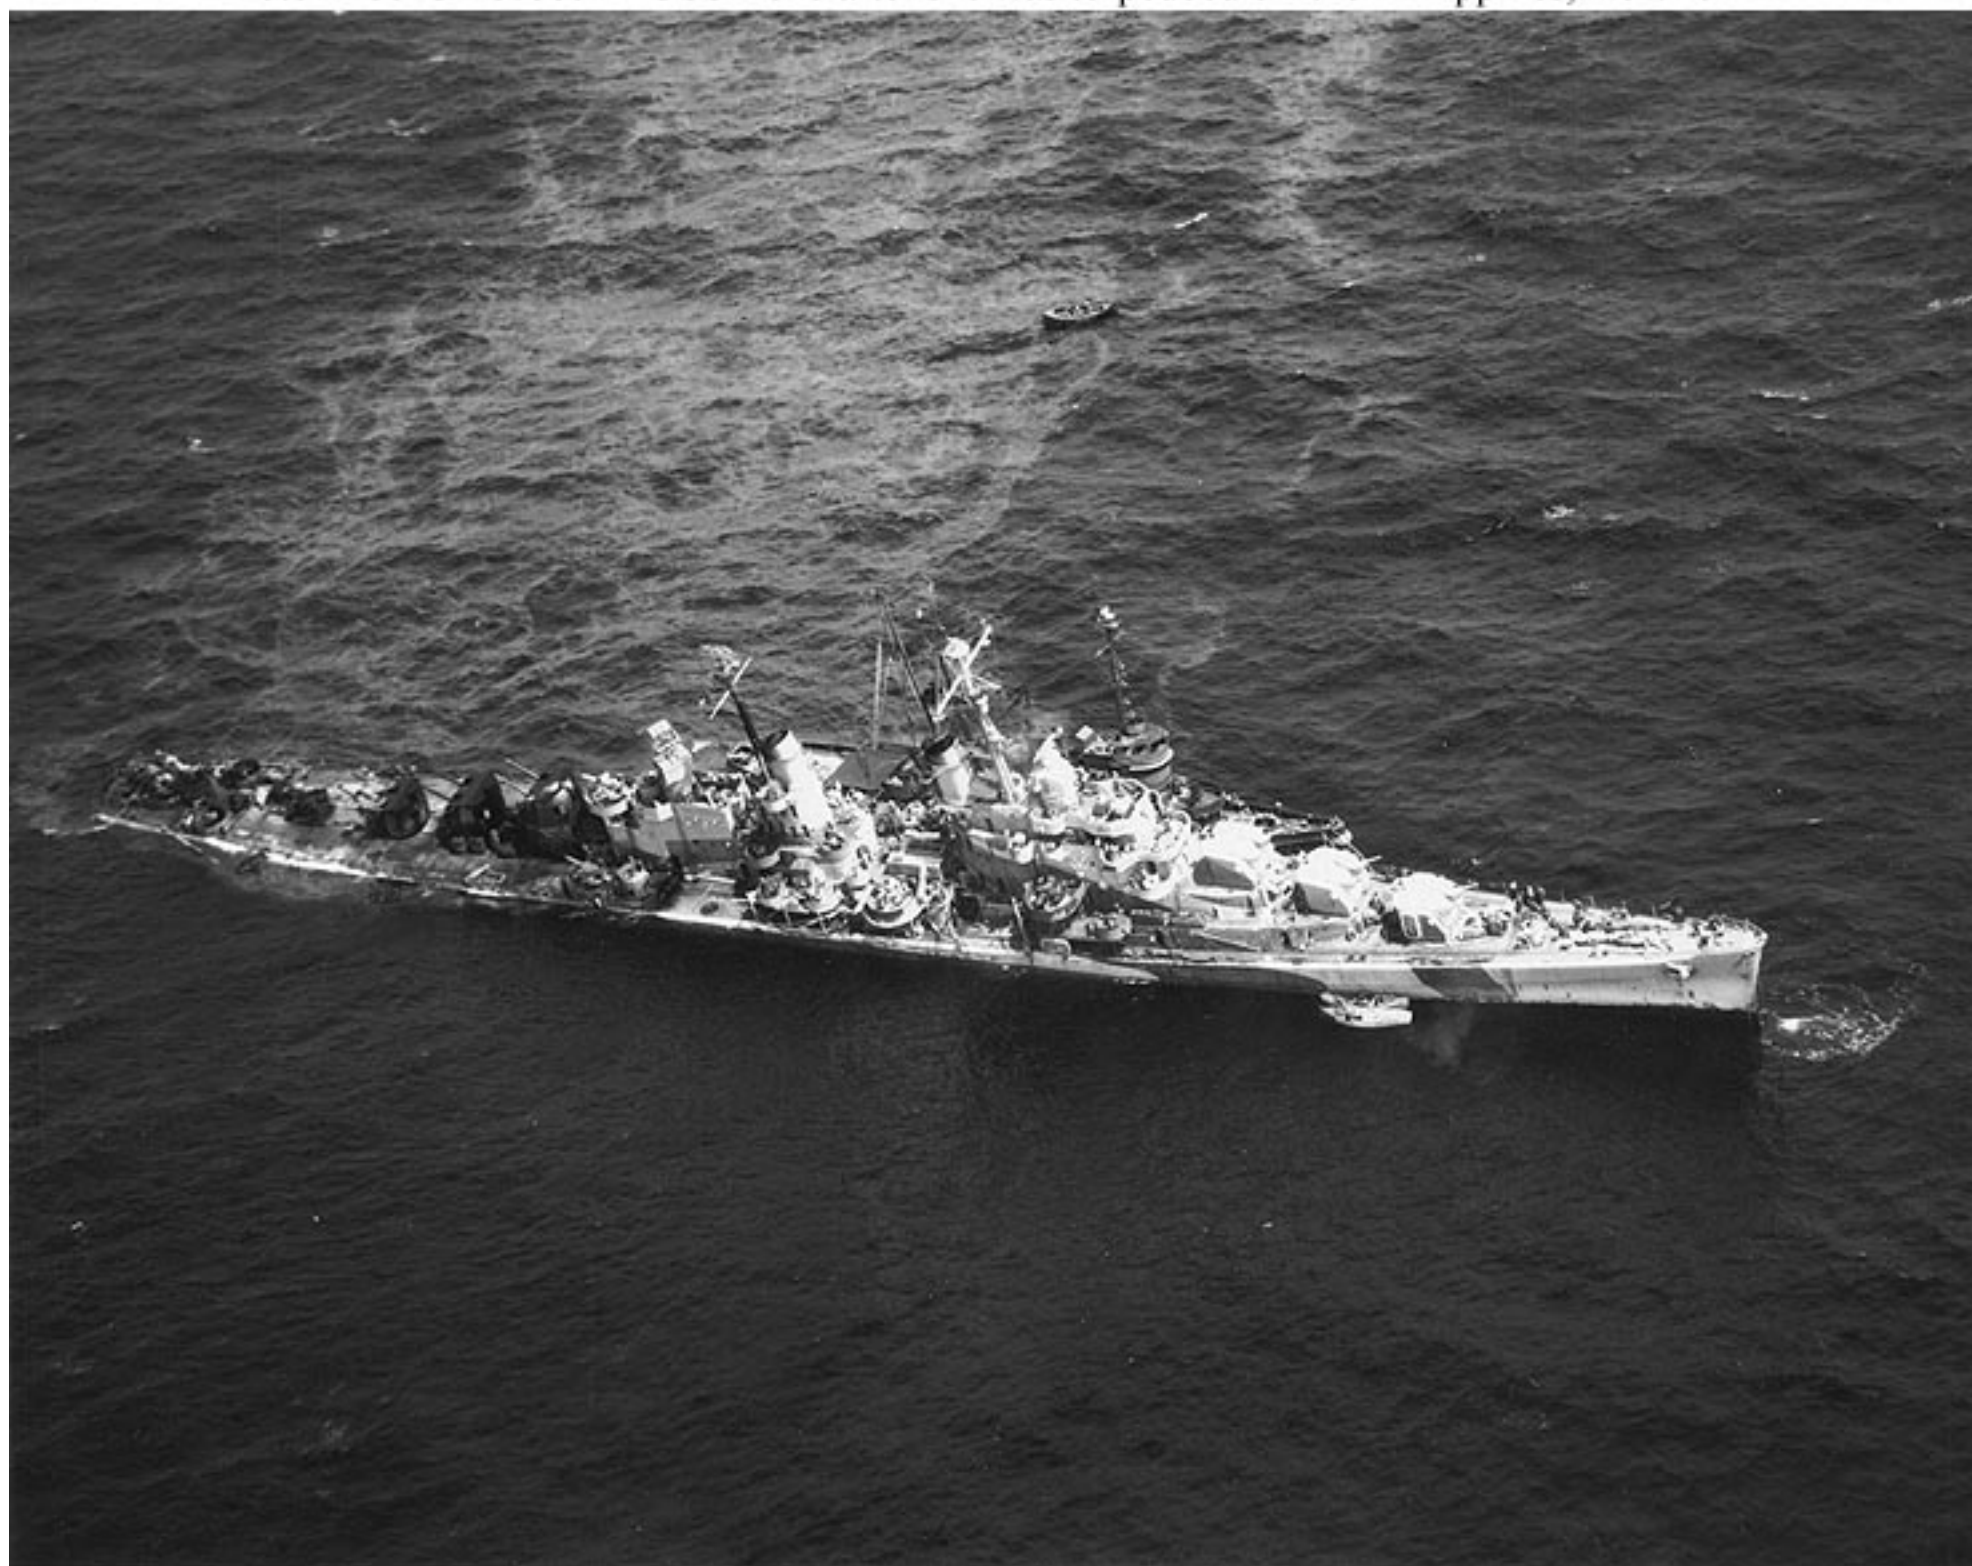
Photo # 80-G-287559 USS Reno after she was torpedoed off the Philippines, Nov. 1944

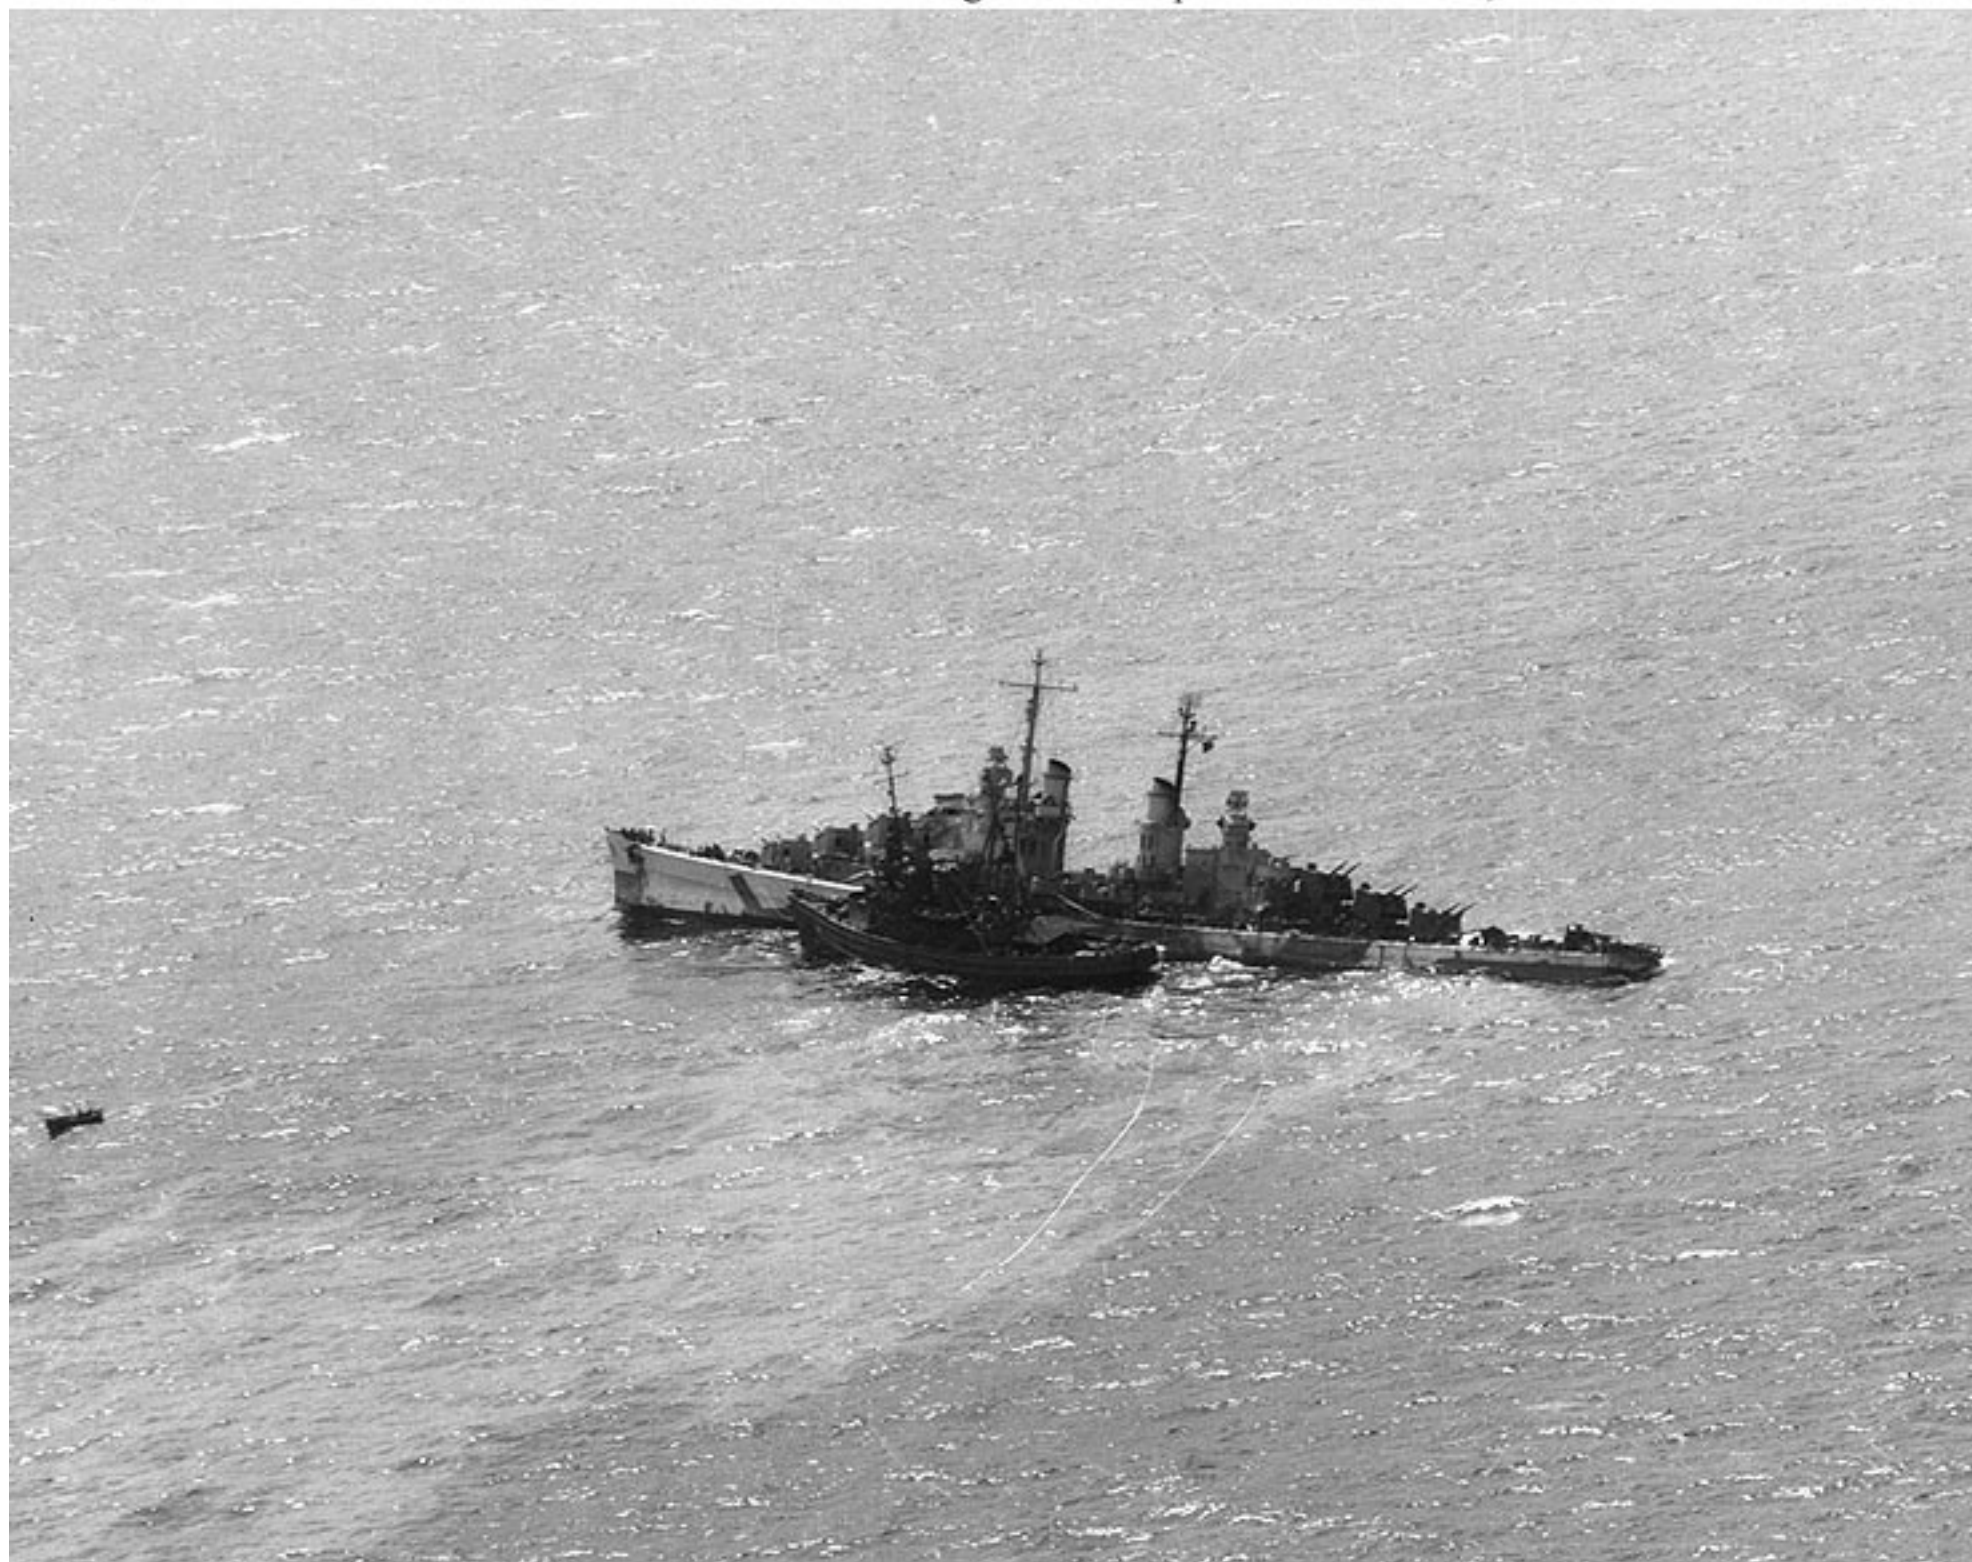
Photo # 80-G-287568 USS Zuni alongside the torpedoed USS Reno, Nov. 1944

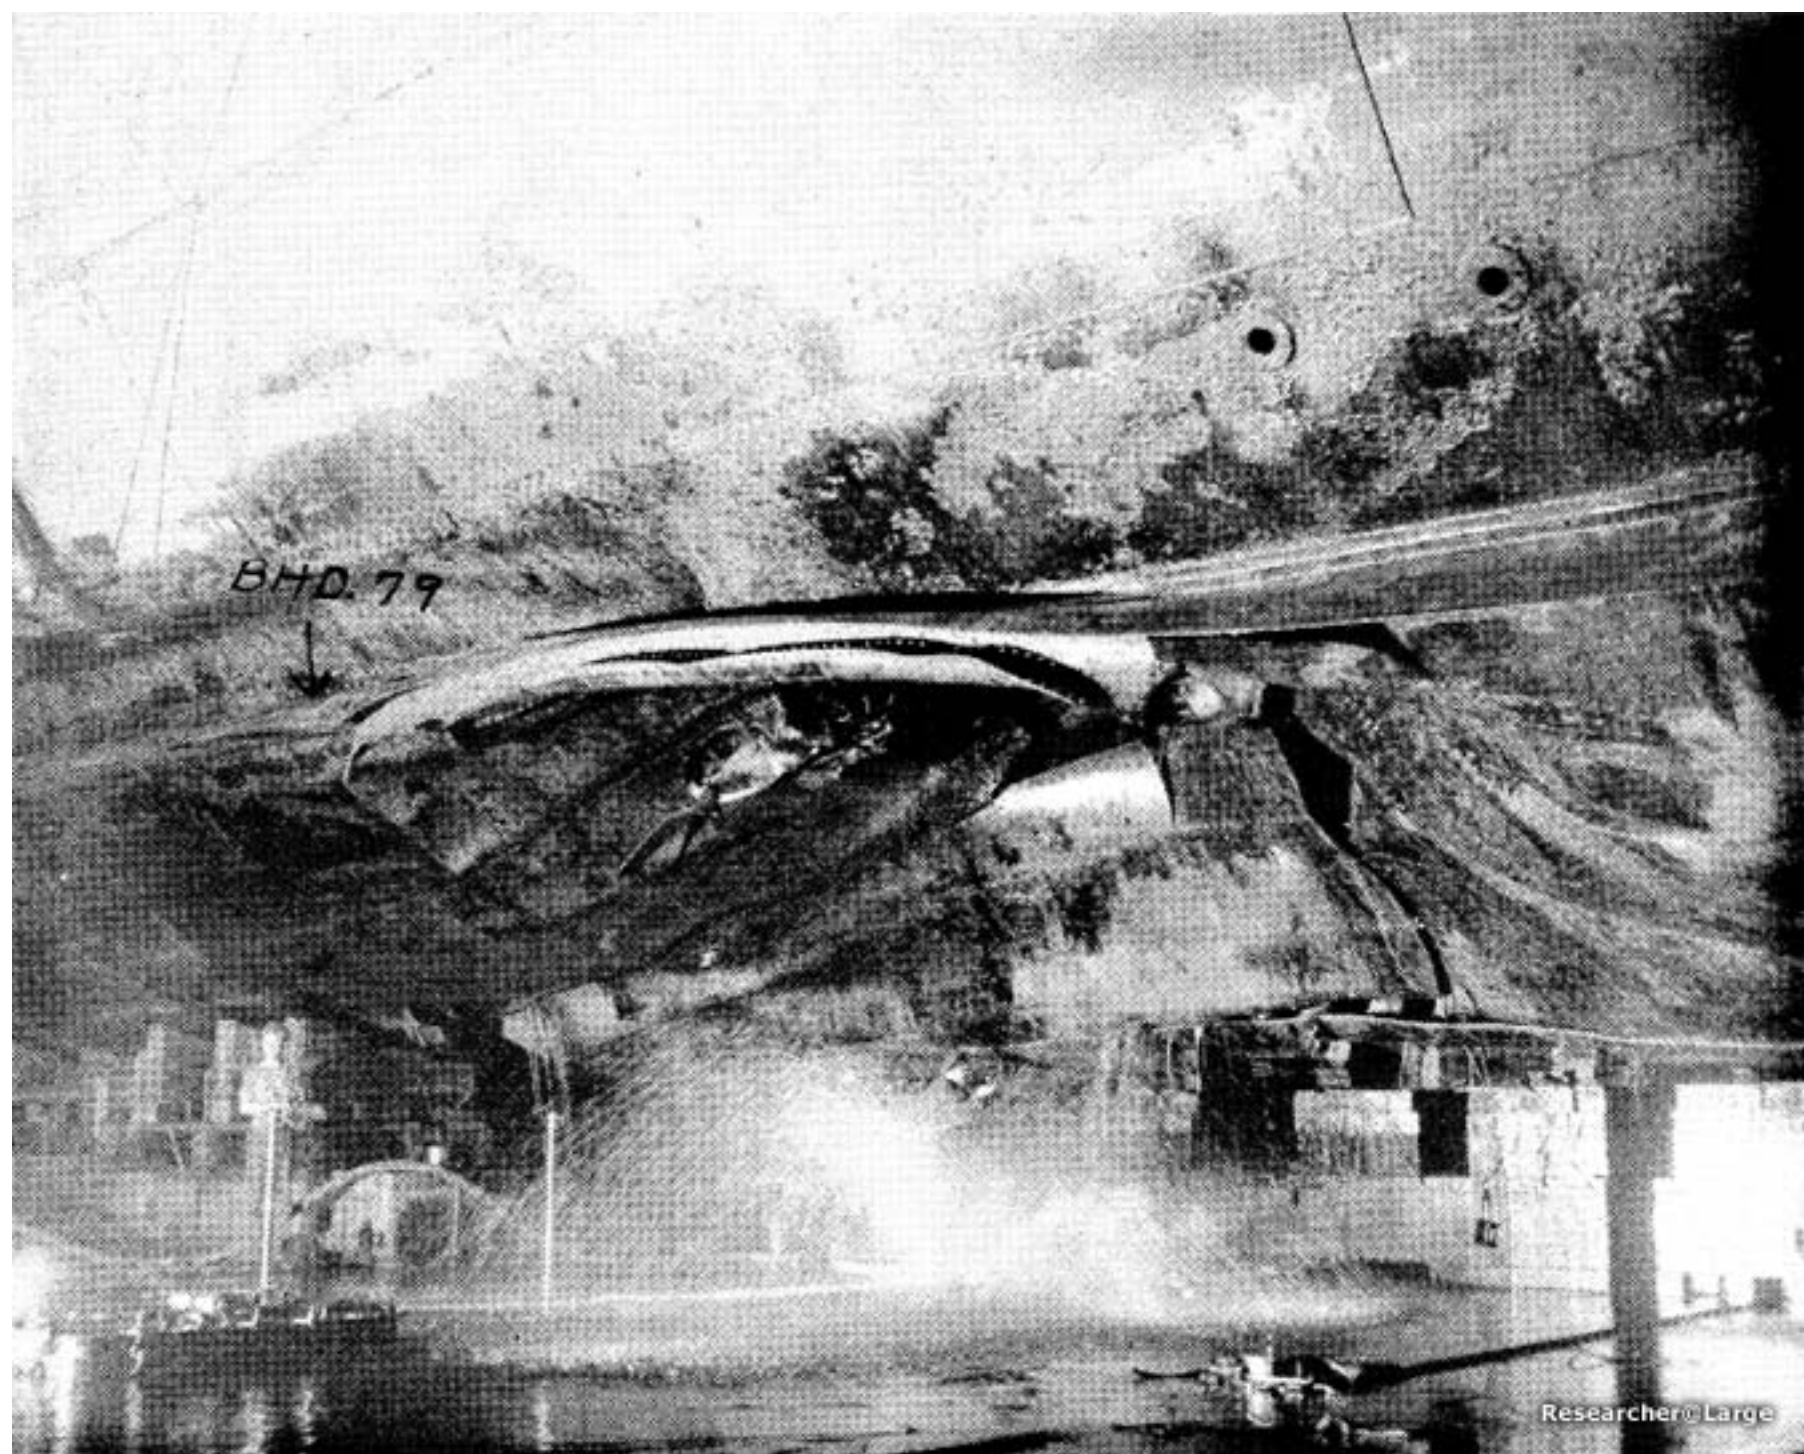
NARA Photo #: 19-N-105803
Photographed in ABSD 2 at Manus in November, 1944 after drydocking, showing amidships torpedo damage, starboard side. Note that the damage is centered inboard of the bilge keel; the massive damage in this area allowed most of the center of the ship to flood very quickly.

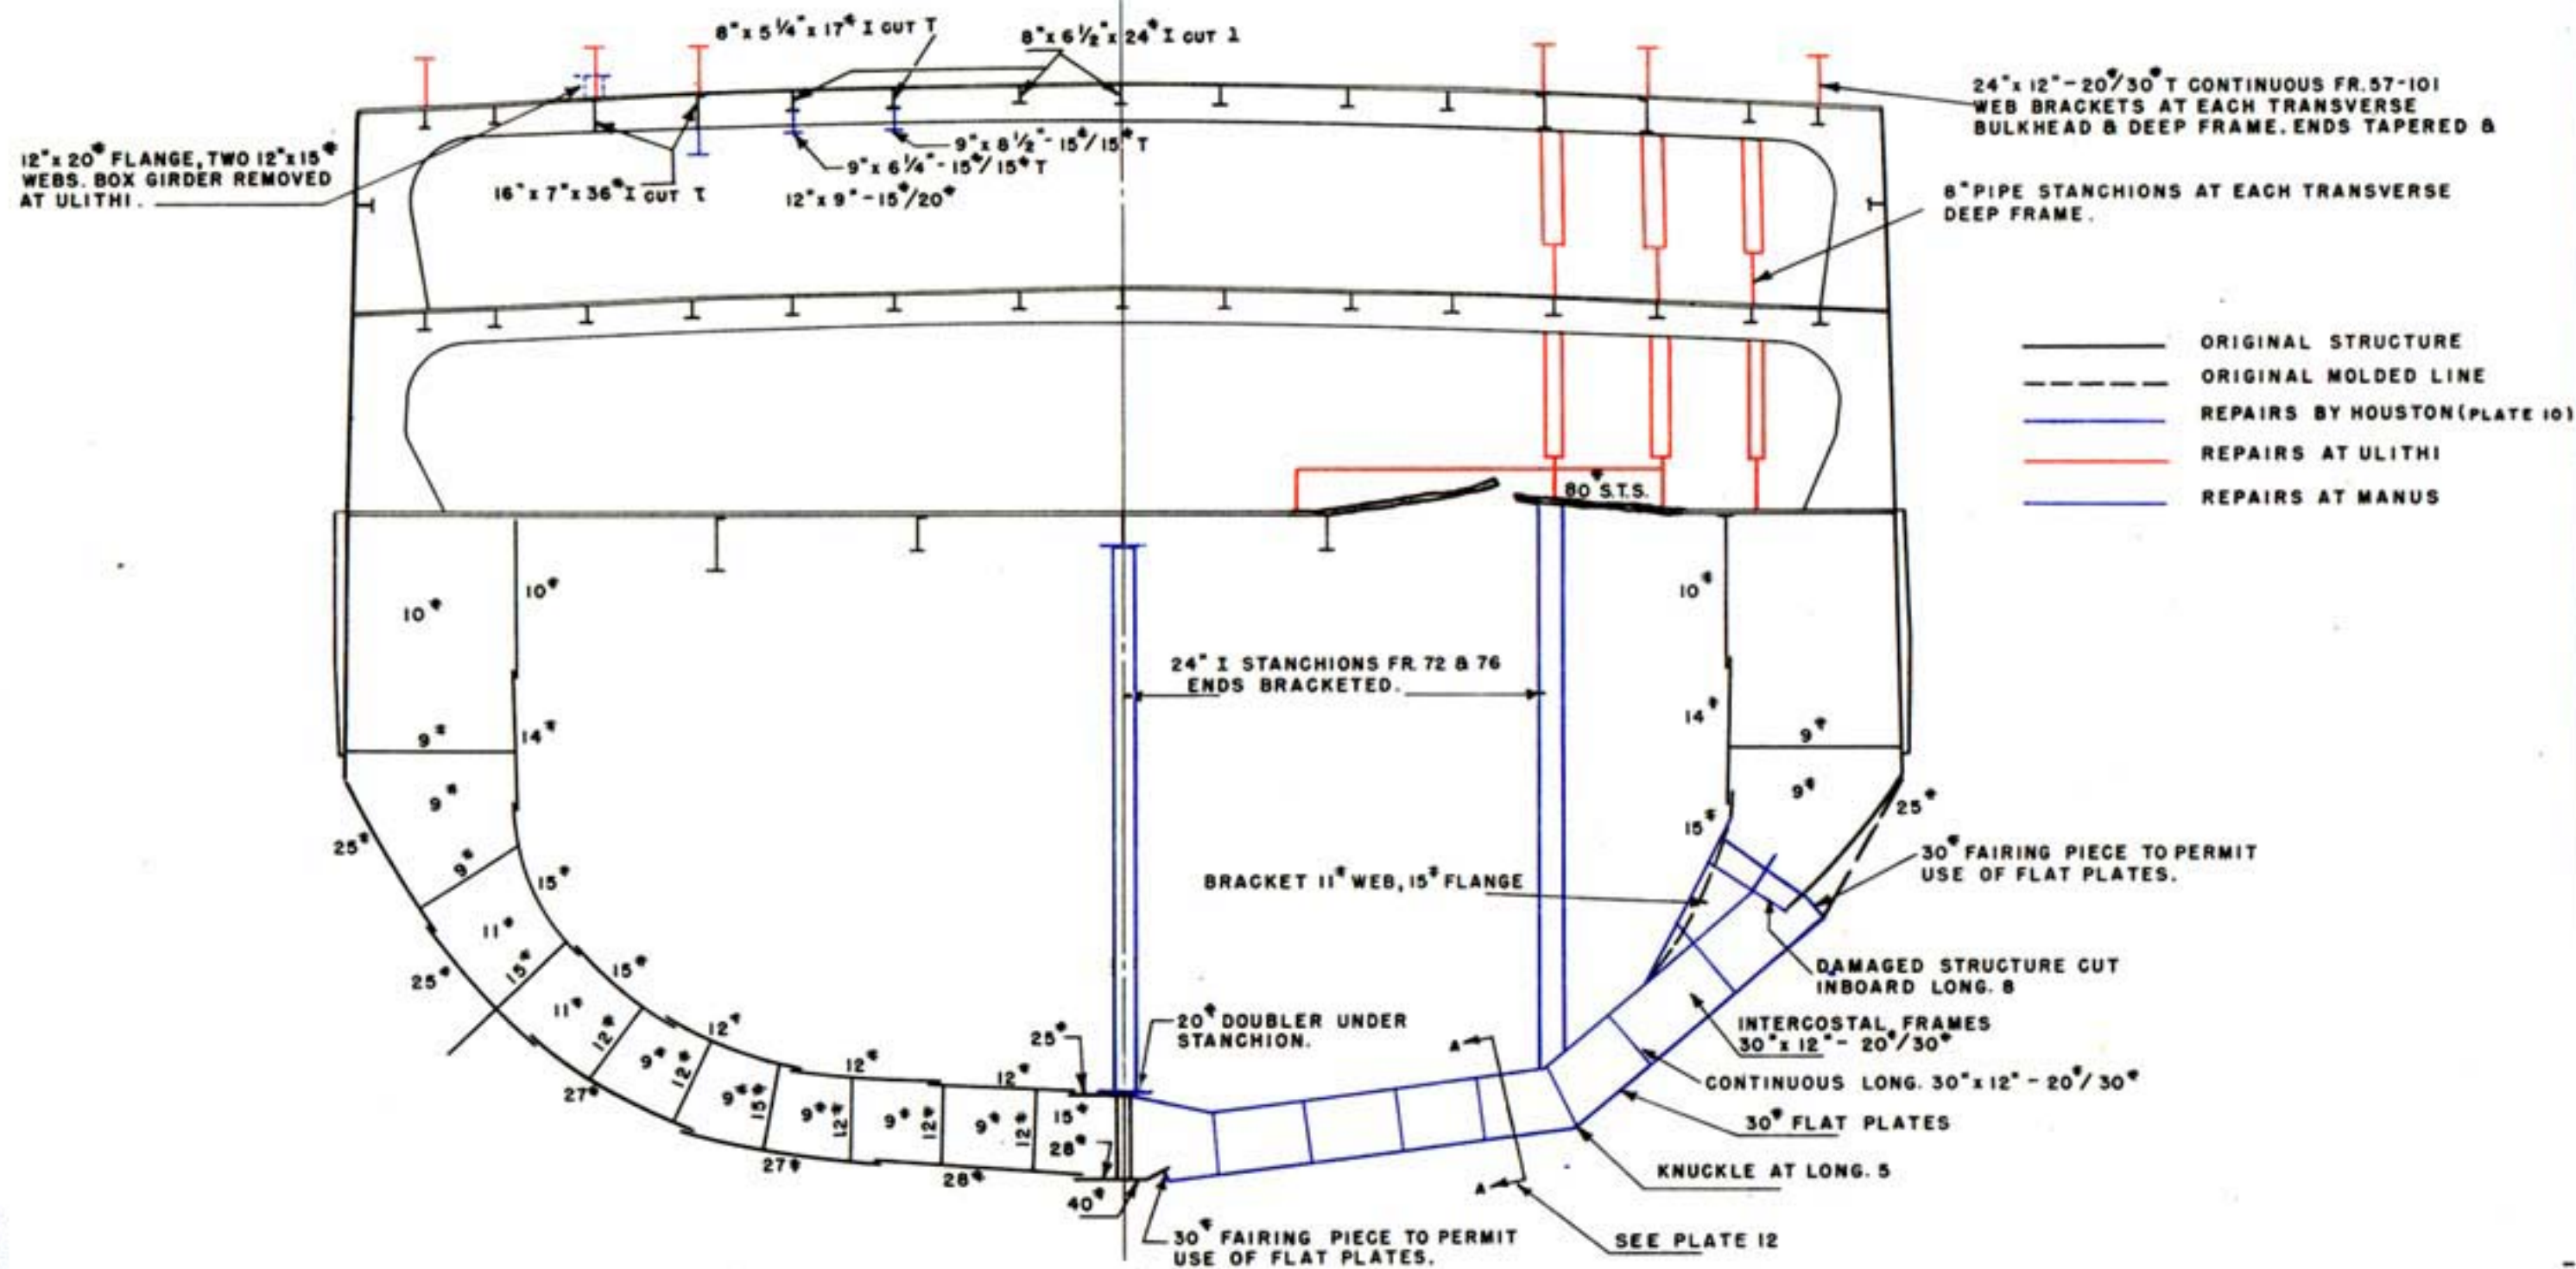
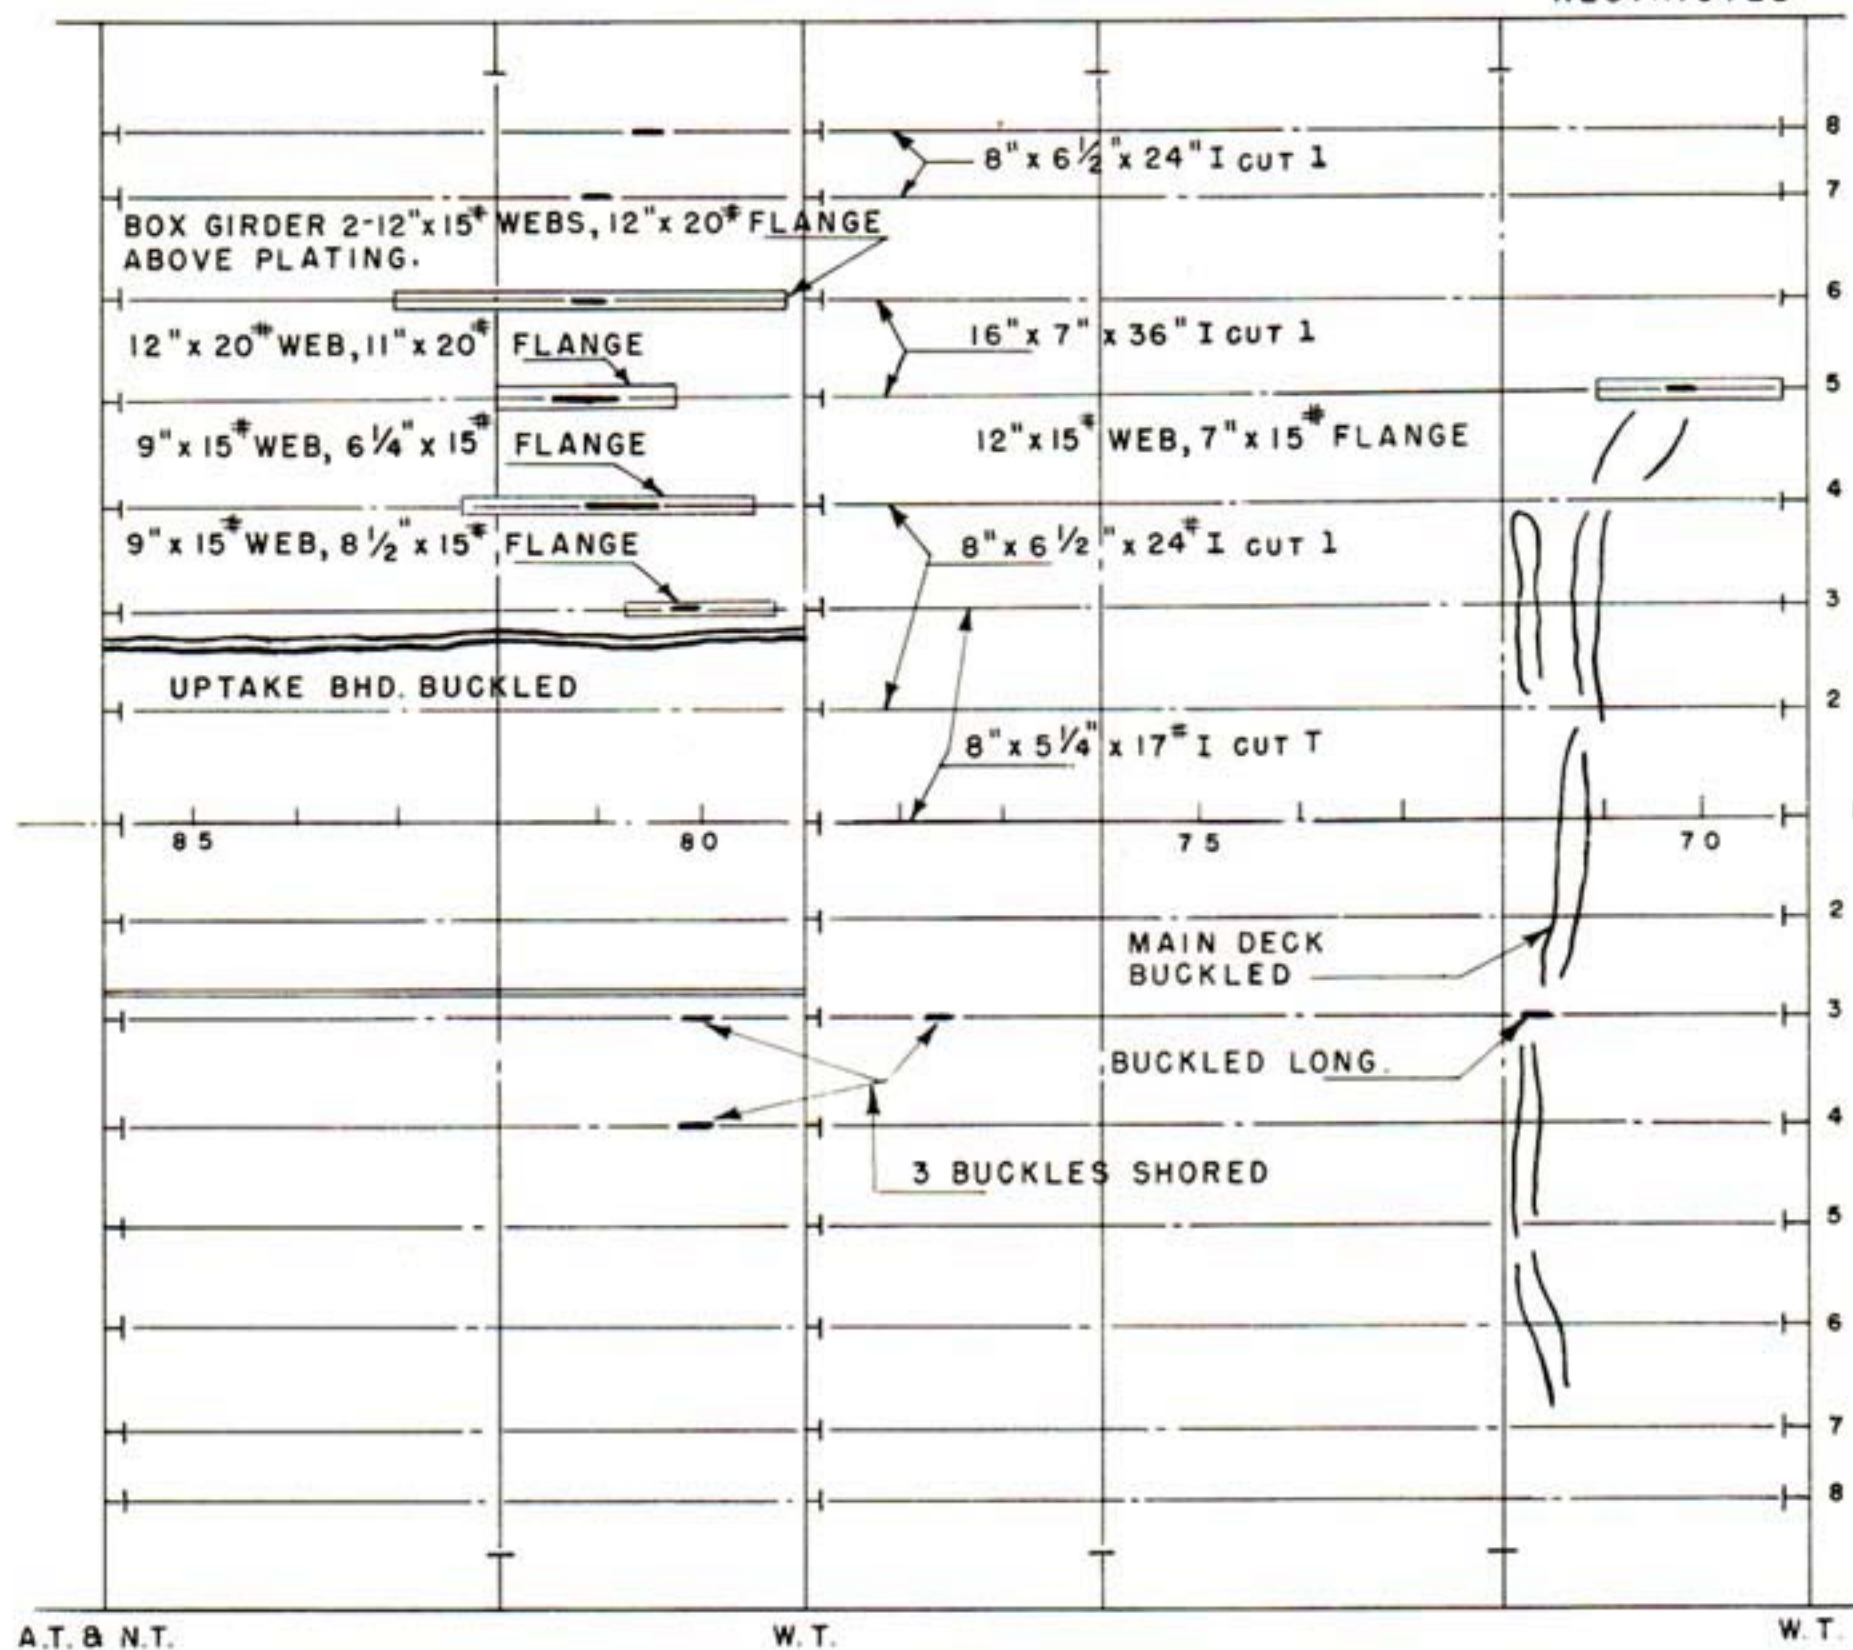
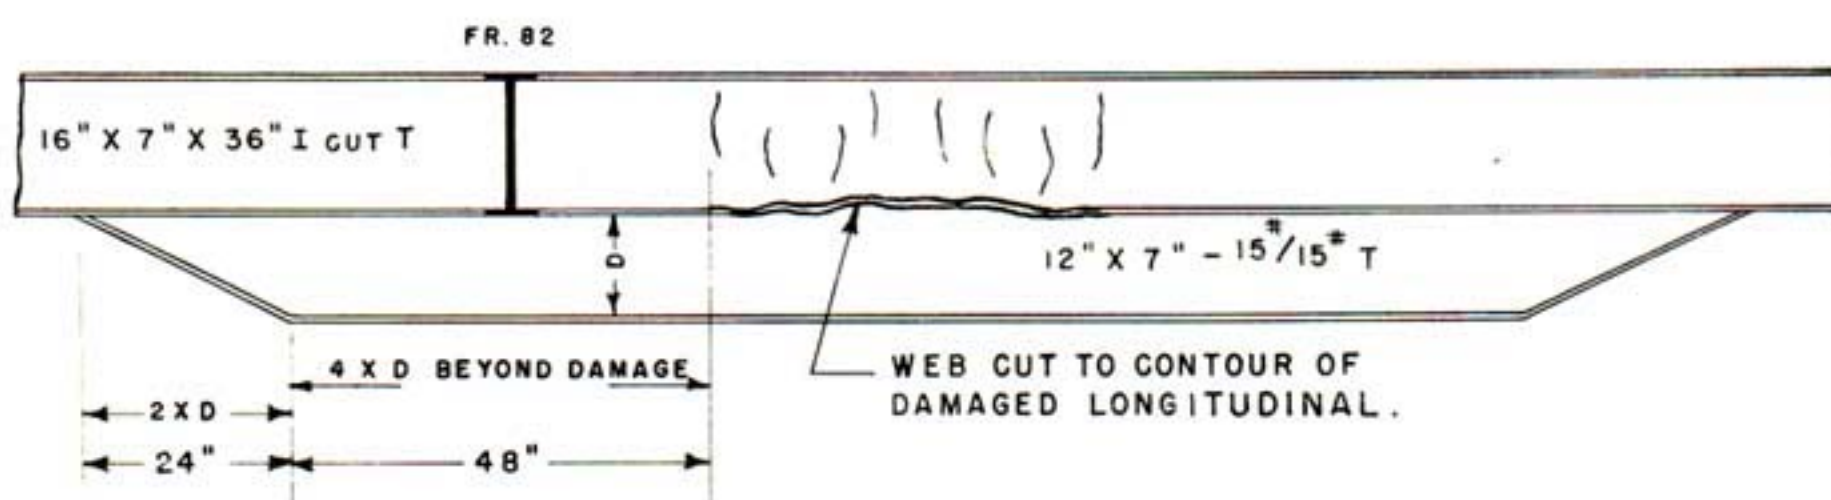
PLATE 11 Researcher Large

SECTION AT FRAME 80
LOOKING FWD.

- (b) Improving longitudinal and local strength.
- (1) HECTOR (AR7), assisted by HOUSTON, undertook structural repairs to compensate insofar as possible for the loss in longitudinal strength. 24" T longitudinals were installed on the main, 2nd, and 3rd decks as shown on Plate 11. The 2nd and 3rd deck longitudinals, in conjunction with the #11s, were intended to form a deep box girder bridging the damaged area to increase the rigidity of the hull and insure that the available strength members would develop their maximum strength. The 2nd and 3rd deck longitudinals, being near the neutral axis, were much less effective than were those on the main deck in increasing the moment of inertia of the section; in this instance a 2nd deck longitudinal was 44% and a 3rd deck longitudinal was 10% as effective as one on the main deck. These repairs added 252 square inches of material to the section and raised the neutral axis 11". The section moduli to the main deck and keel were restored to 91% and 58% of their respective intact values.

- (a) Midship Area (Plates 11 and 12)
- (1) Shell plating, longitudinals, transverse frames, and inner bottom were cut away between frames 70 and 79 and from the keel to #8 longitudinal (Photos 17 and 18). At frame 79, the shell plating was about 11" inboard of the molded line. Longitudinals 1 to 5 and the associated inner bottom were cut away back to frame 81 and then restored to their original strength. Welded straps were fitted on both sides of the crack in the vertical keel at frame 74 1/2 30" x 12" - 20#/30# welded T replacement longitudinals were installed between frames 70 and 79 (Photo 19). Deep transverse frames were replaced by intercostal 30" x 12" - 20#/30# welded T's. 30# shell plating was installed in two flat sections with a knuckle at longitudinal 5 (Photo 20).

STRUCTURAL REPAIRS TO MAIN DECK BY SHIPS FORCE
