CONTENTS		
NAME	CAUSE OF DAMAGE	PAGE
INTRODUCTION		
ERIE (PG50)	Submarine Torpedo	5
RENO (CL96)	Submarine Torpedo	11
HOUSTON (CL-81)	Submarine Torpedo	19
CANBERRA (CA70)	Aircraft Torpedo	33
O'BRIEN (DD725)	Submarine Torpedo	39
WADLEIGH (DD689)	Mine	47
NEWCOMB (DD586)	4 Kamikaze Planes (1 Bomb)	59
KEARNY (DD432)	Submarine Torpedo	65
SELFRIIDGE (DD357)	Submarine Torpedo	69
FOOTE (DD511)	Submarine Torpedo	77
INTREPID (CV11)	Aircraft Torpedo	83
VIRBURNUM (AN57)	Mine	89

SOURCE:
National Archives & Records Administration, Seattle Branch
Record Group 181, Entry 59A-271 "13th Naval District Bremerton, Washington" General Correspondance 1947-1958
"Structural Repairs in Forward Areas During World War II" -BuShips Booklet dated December 1949.

The problem of effecting temporary repairs to damaged ships was encountered frequently during World War II and was handled with varying degrees of success. It was never feasible to make complete repairs to seriously damaged vessels in the forward area. Accordingly, repair work ordinarily was limited to that which would enable the ship to proceed to a larger repair activity and eventually to a shipyard. Repairs to machinery and electrical equipment were

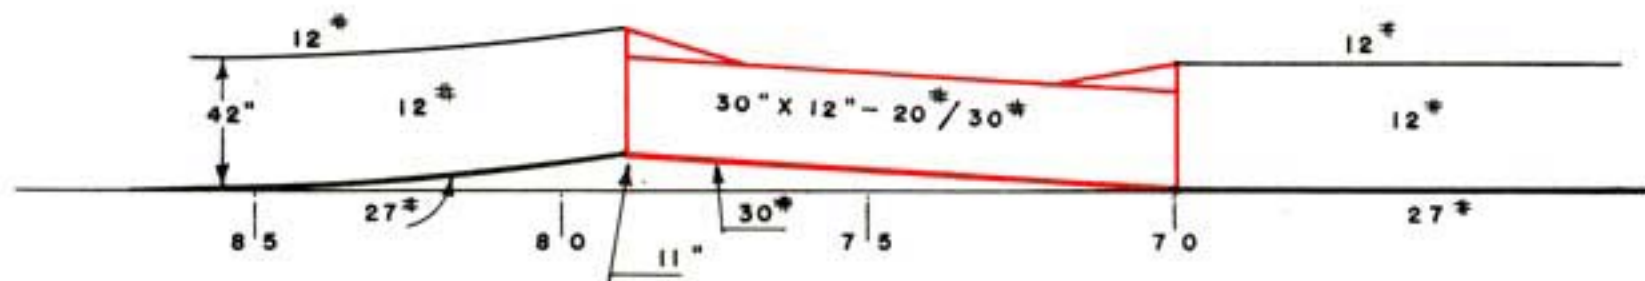
PLATE 12

SECTION "A A" SHOWING METHOD OF CONNECTING LONGITUDINAL
REPLACEMENT GIRDER

- (a) Midship Area (Plates 11 and 12)
- (1) Shell plating, longitudinals, transverse frames, and inner bottom were cut away between frames 70 and 79 and from the keel to #8 longitudinal (Photos 17 and 18). At frame 79, the shell plating was about 11" inboard of the molded line. Longitudinals 1 to 5 and the associated inner bottom were cut away back to frame 81 and then restored to their original strength. Welded straps were fitted on both sides of the crack in the vertical keel at frame 74 1/2 30" x 12" - 20#/30# welded T replacement longitudinals were installed between frames 70 and 79 (Photo 19). Deep transverse frames were replaced by intercostal 30" x 12" - 20#/30# welded T's. 30# shell plating was installed in two flat sections with a knuckle at longitudinal 5 (Photo 20).

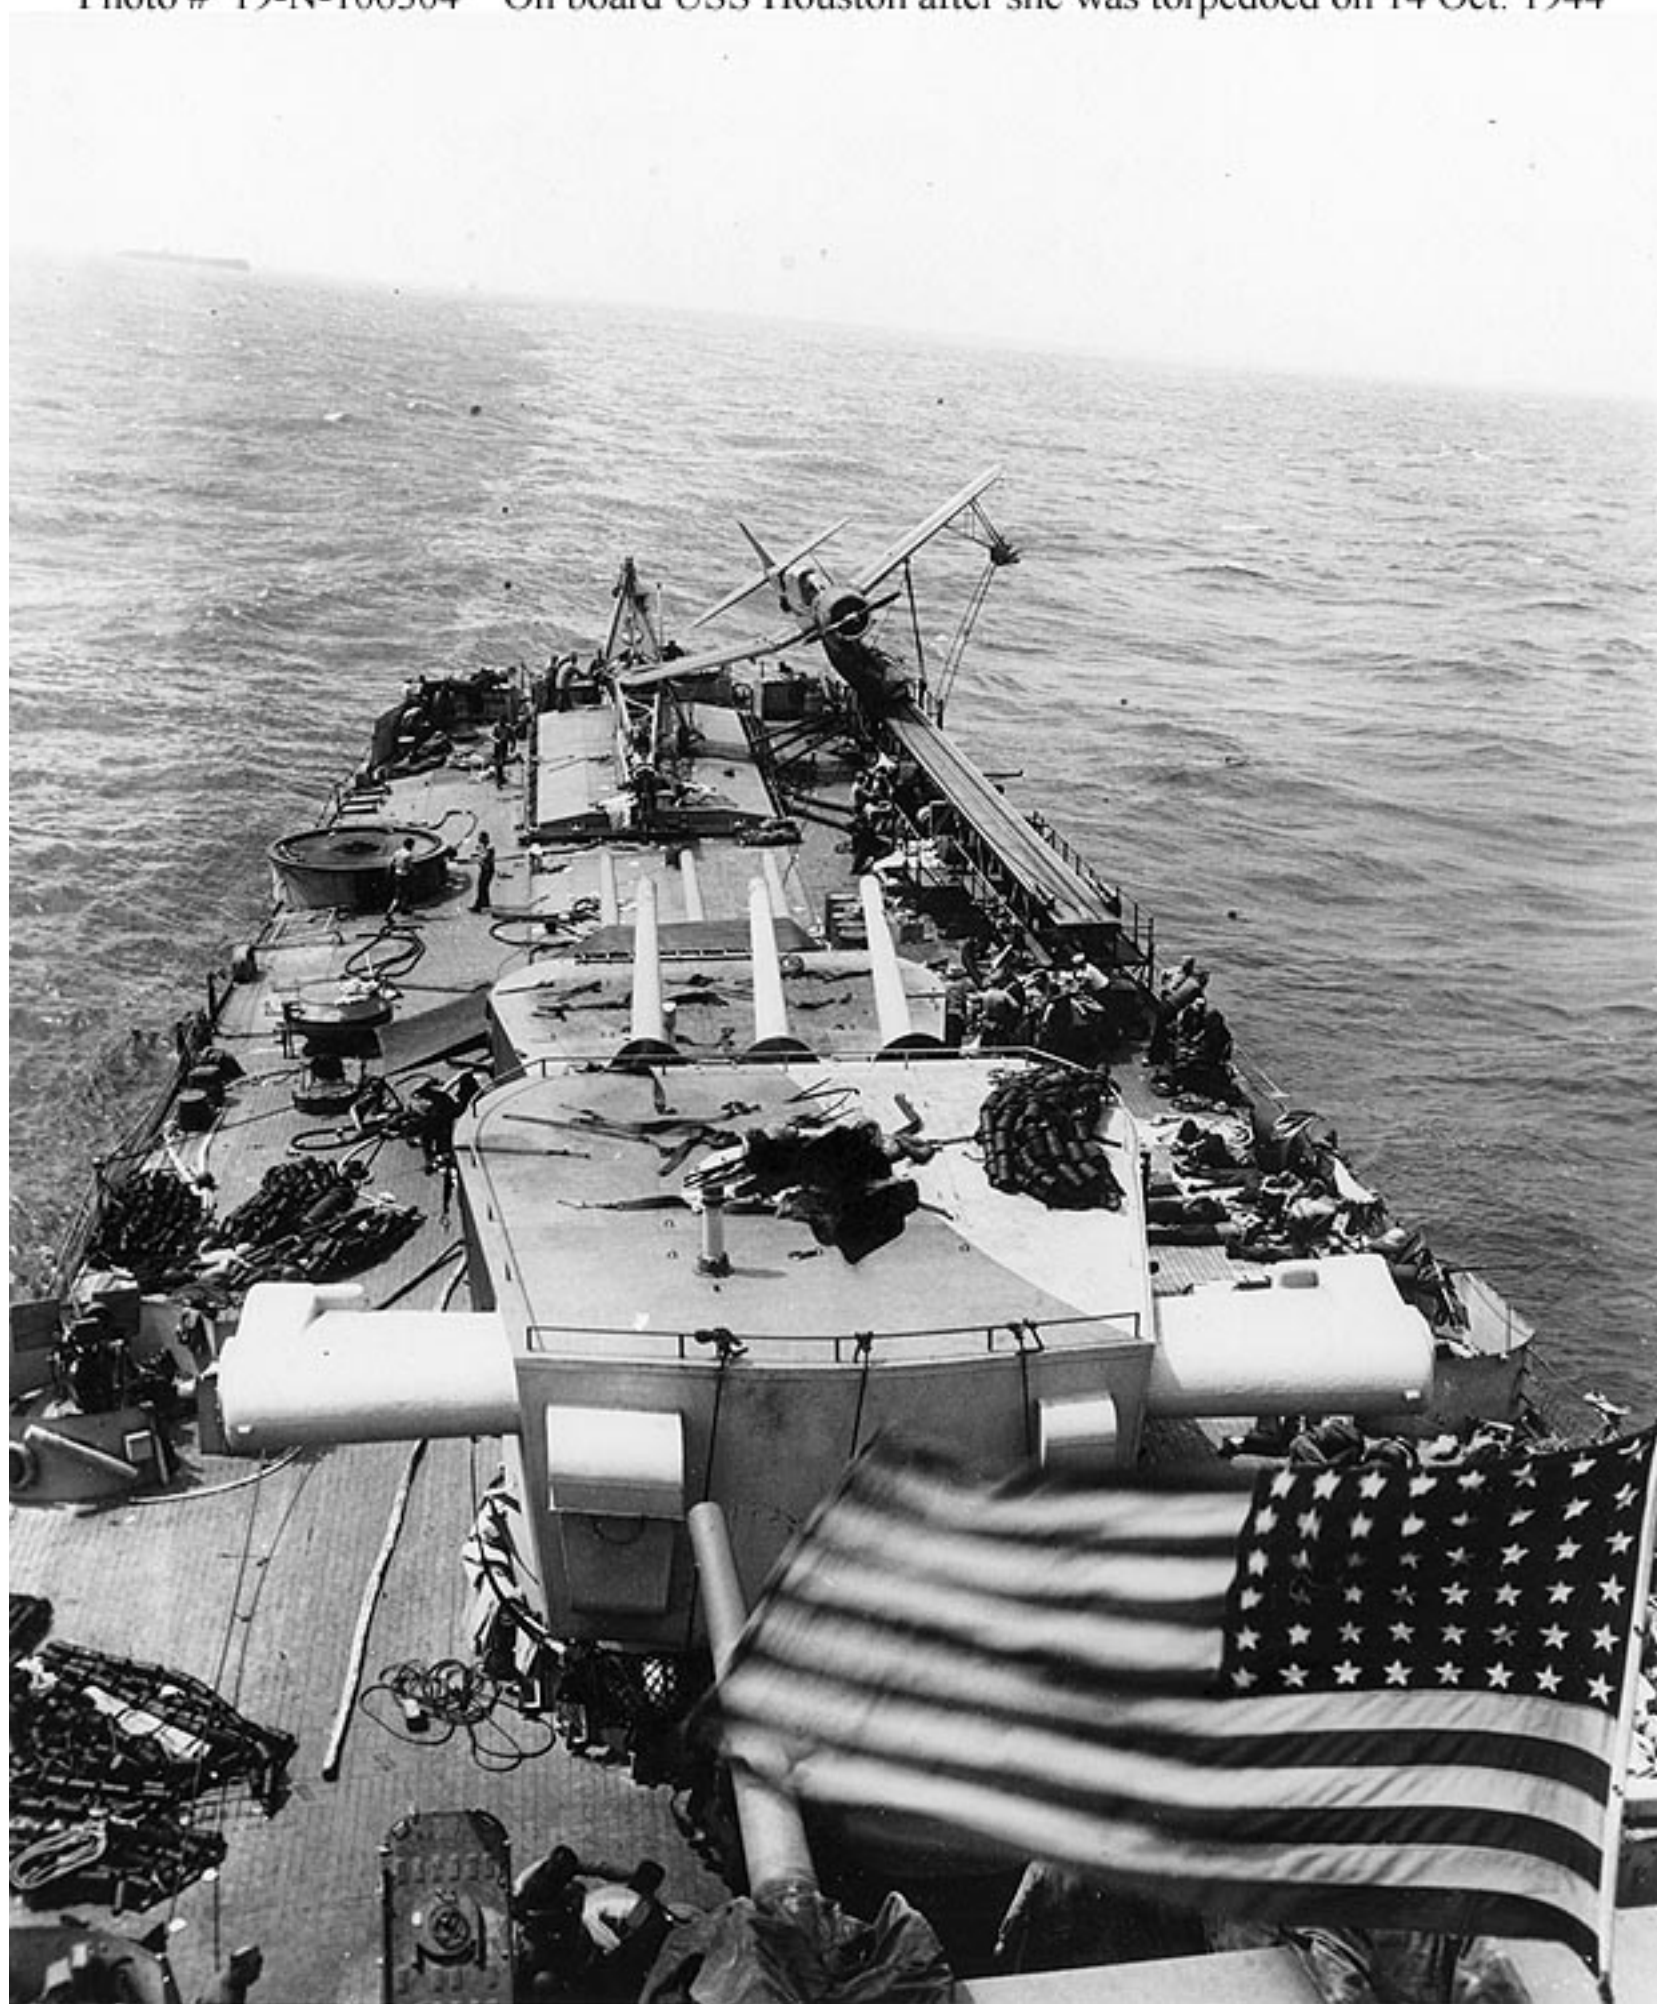
Photo # 19-N-106304 On board USS Houston after she was torpedoed on 14 Oct. 1944

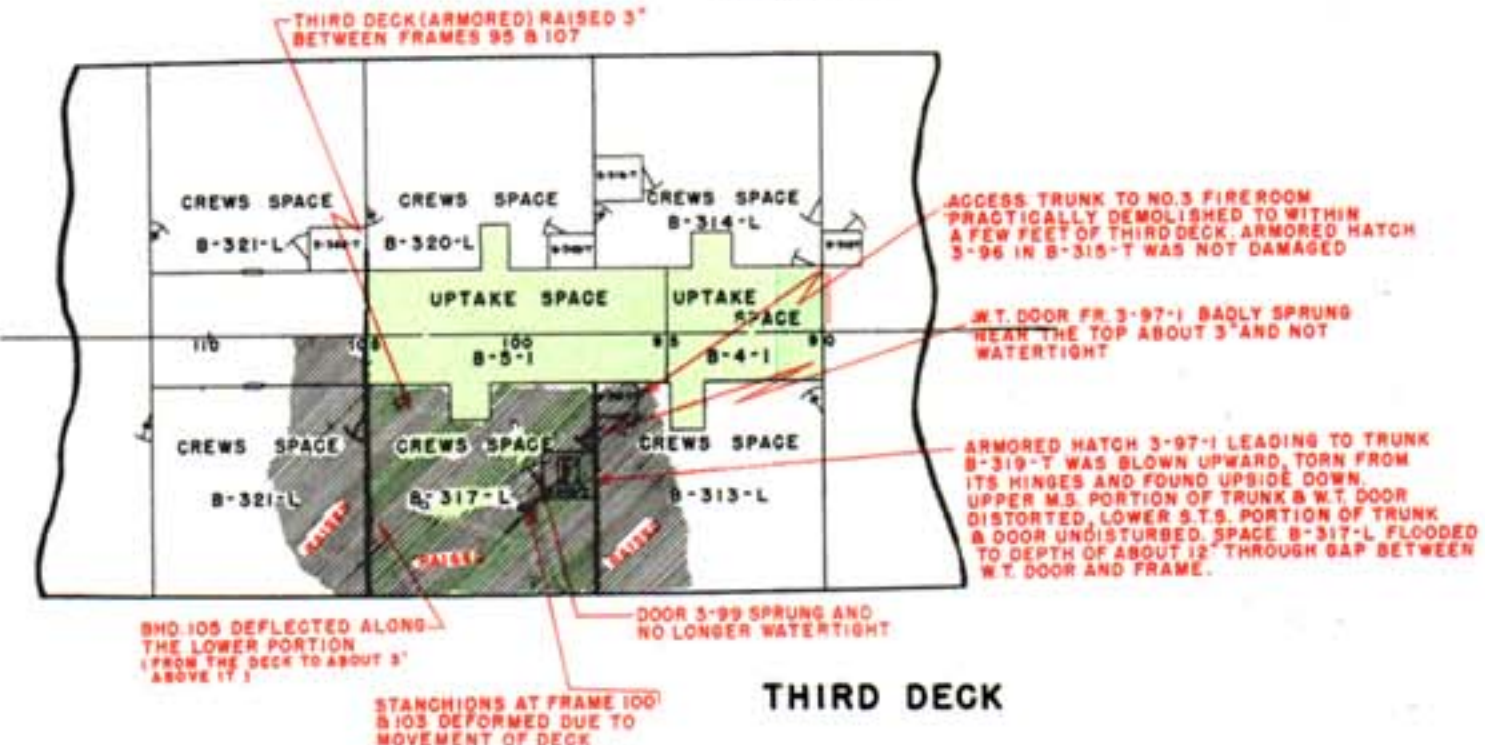
U.S.S. CANBERRA CA-70

TORPEDO DAMAGE

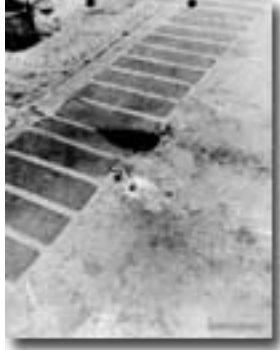
Photo 32: O'BRIEN DD415 Damage to bow from torpedo hit.

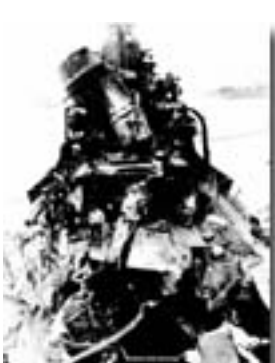
Photo 50: NEWCOMB (DD 586) Looking forward at damaged area.

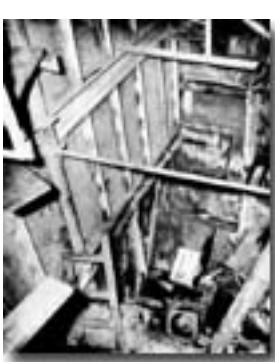
Photo 52: NEWCOMB (DD 586) After side, starboard, of temporary bulkhead 120-1/2.

- (a) A temporary transverse bulkhead was installed at frame 120 ([Plate 24](#), [Photo 52](#)).
 - (b) 15# plate was used to repair web frames 130 and 133, port, and web frames 133 and 136, starboard.

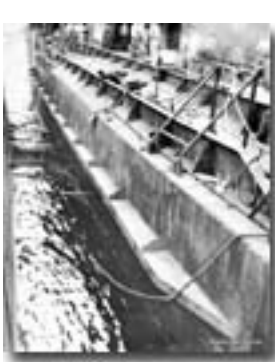
Photo 55: NEWCOMB (DD 586) Looking forward along port side at T stiffeners installed on shell and deck plating.

- (e) The damaged portion of the deck was replaced with 15# plate ([Photos 53](#) and [54](#))
- (e) The port and starboard sheer strakes were reinforced by 14"/6" x 15#,15# T's ([Photo Photo 55](#)).

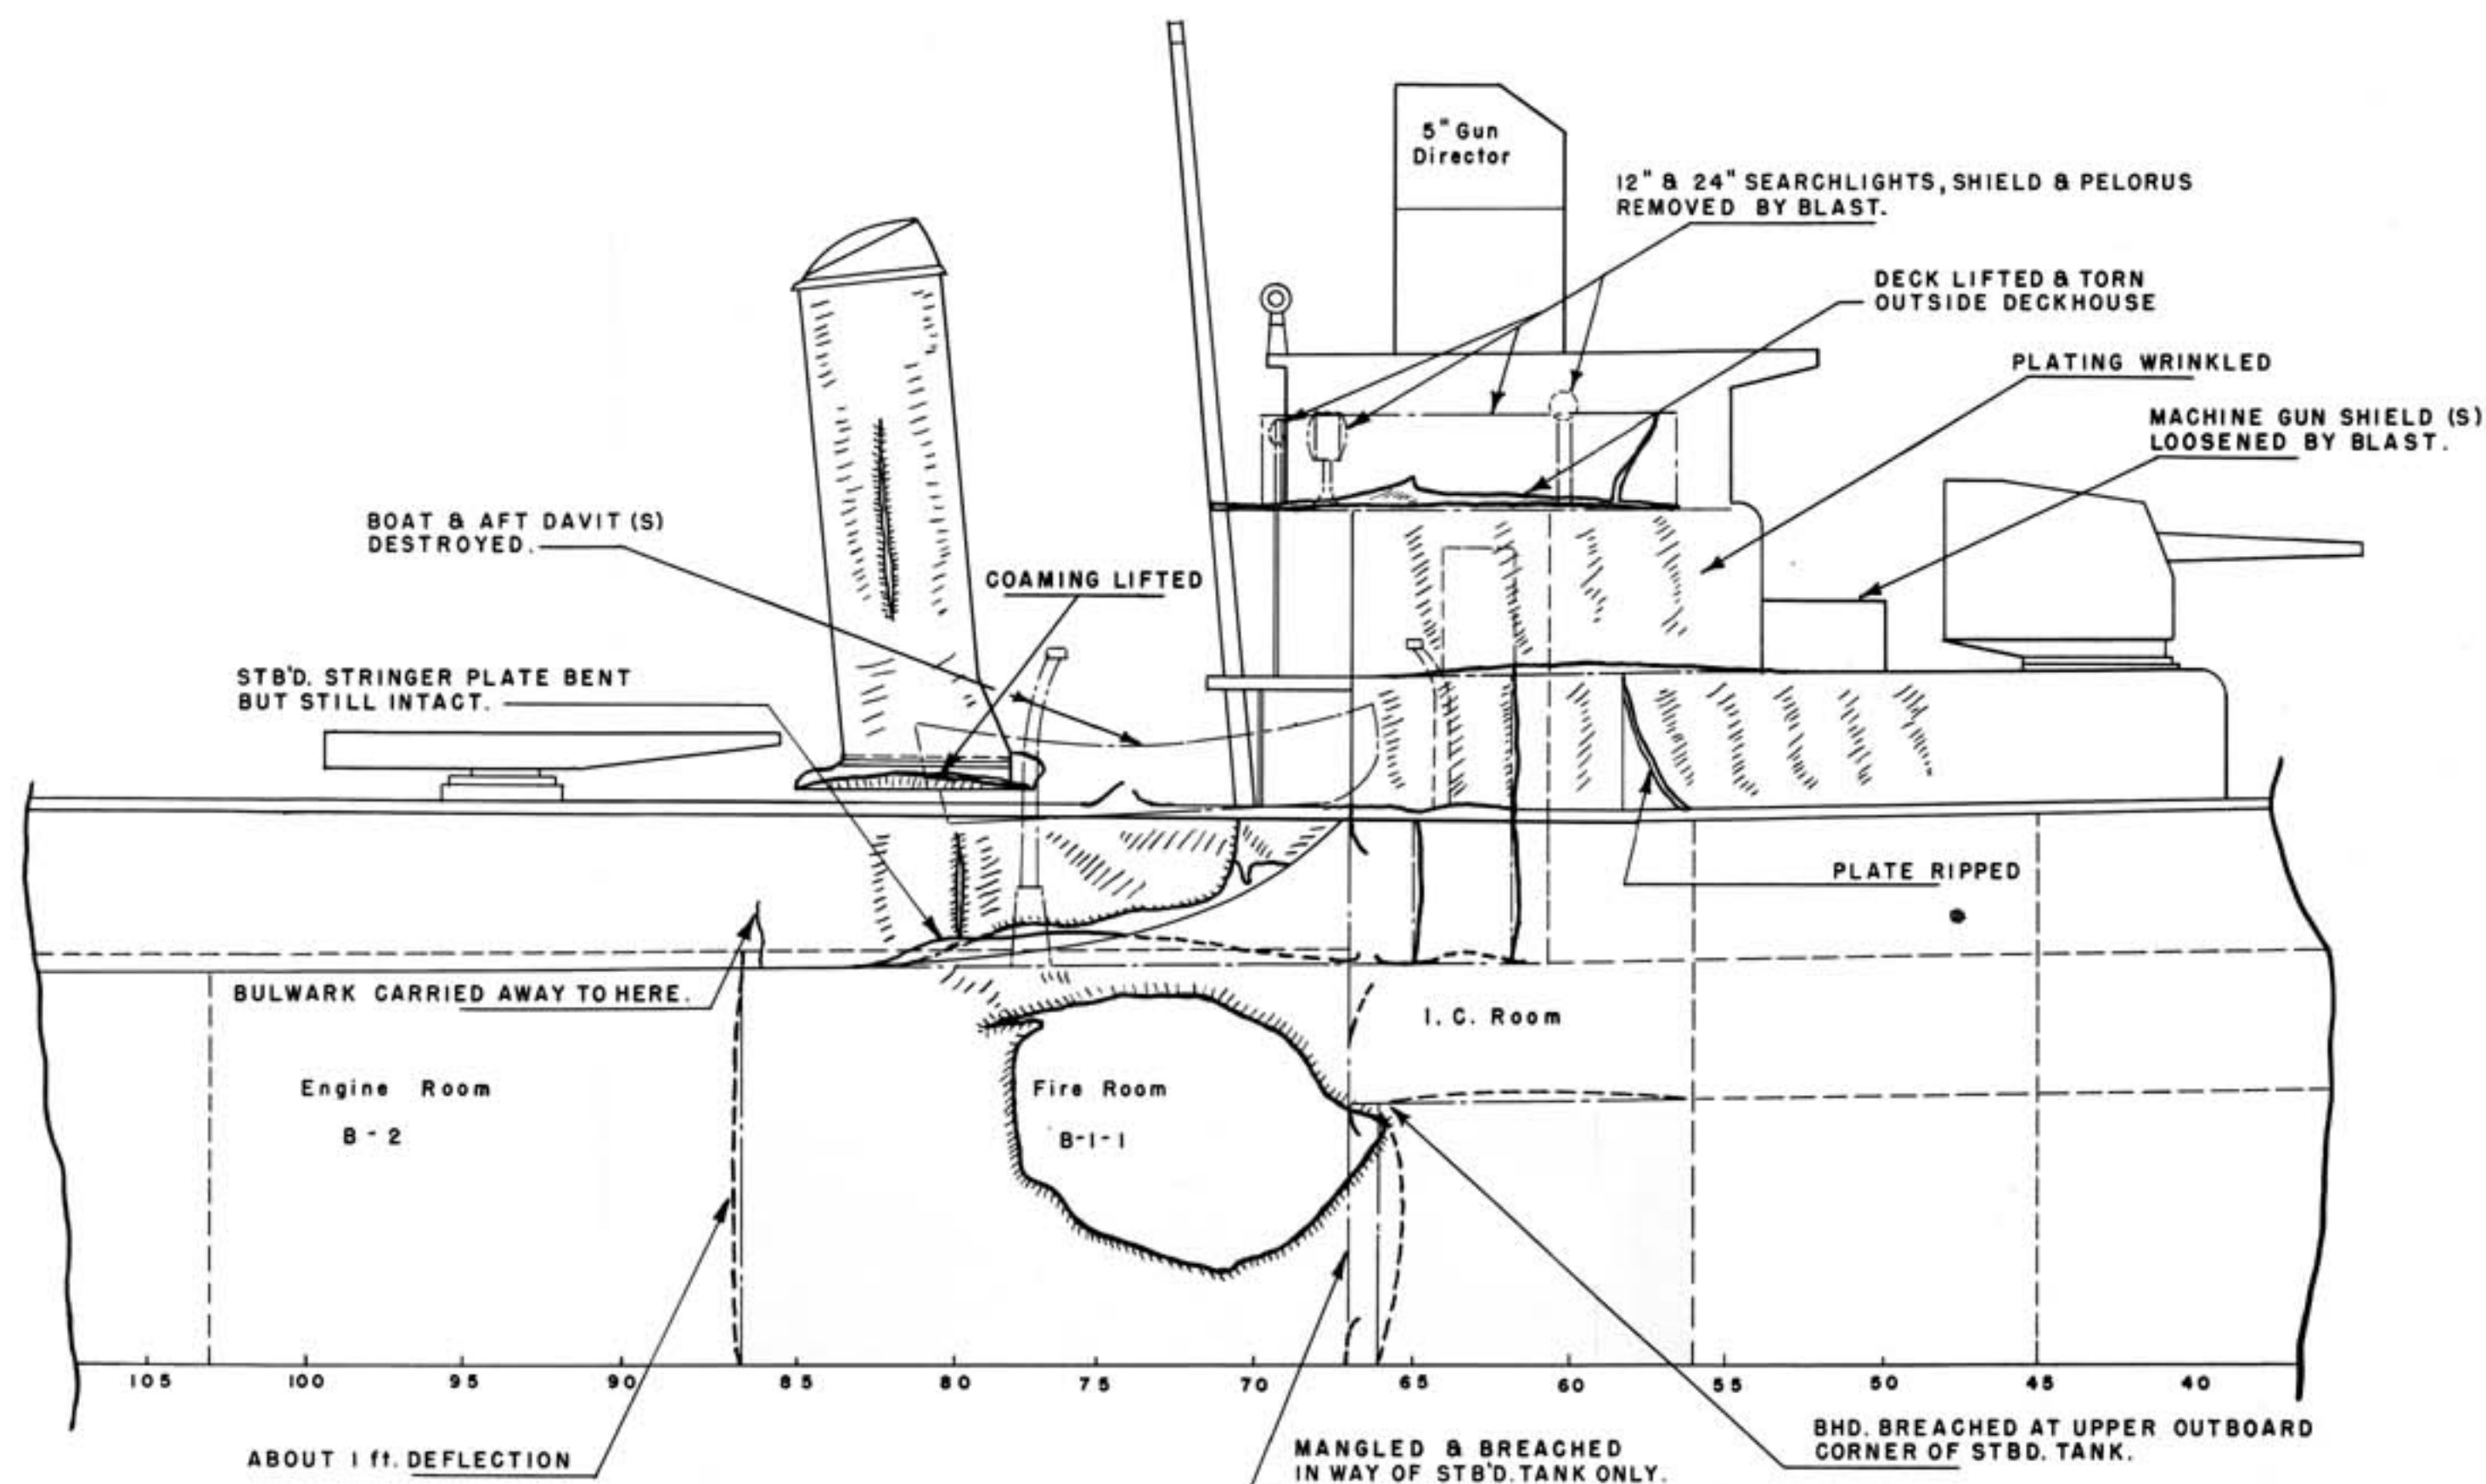
Plate 27: USS KEARNY (DD 432)
Torpedo Damage

1. While KEARNY was escorting a convoy in the North Atlantic, a torpedo detonated at frame 72, starboard, about 8 feet above the base line. The explosion caused a hole in the shell about 20 feet long by 16 feet high (Plate 27, Photo 56). The 17-pound sheer strake was dished inward, but did not fracture. The 25-pound starboard deck stringer plate bulged upward, but did not break. The strake of 8-pound plate inboard of the deck stringer was blown out. Fresh water tank B-5W was destroyed. The forward portion of B-7W, adjacent to the shell damage, was badly torn, but the remainder was substantially intact and the after portion was only moderately distorted. Structure on the port side of the ship was not damaged. After the attack, wind and sea conditions were favorable and KEARNY was able to proceed under her own power at a speed of 10 knots to Iceland, distance of 400 miles.

- FLOODING
- SPACES CONTAINING LIQUIDS BEFORE DAMAGE FLOODED TO WATERLINE.

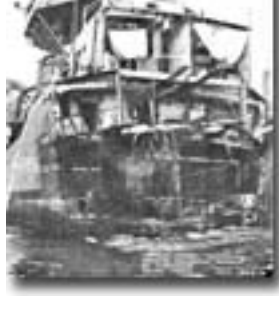
Photo 59: SELFRIDGE (DD 357) View of bow after removal of wreckage and start of temporary repairs.

2. At Purvis Bay, where no drydocking facilities were available, repairs were undertaken by ARISTAEUS (ARB-1). Damage to fuel oil tanks had spread oil over most of the wreckage, and ammunition was present in the remains of the various magazines, handling rooms and hoists. Before undertaking burning or removal of any major portion of the wreckage, it was necessary to reduce the fire hazard. After this had been completed, all salvageable equipment and wreckage were removed. From the keel to second platform all structure forward of frame 51 was removed; between the main deck and second platform, structure was removed forward of frame 55; and above the main deck, all structure forward of frame 52-1/2 was removed ([Photo 59](#)).

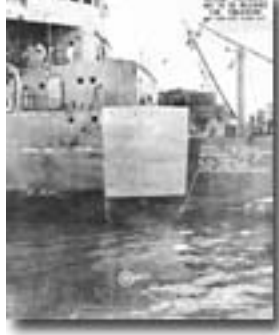
Photo 62: SELFRIDGE (DD 357) View of plating on temporary bow installed at Purvis Bay.

- (e) A temporary bow was installed above the first platform. The stem, fabricated from 15# plate, extended from frame 49 at the forecastle to frame 49-1/2 at the first platform. 10" centerline longitudinals were extended forward to meet the stem. At the forecastle and main deck levels these longitudinals were fabricated from 10# plate. A 10" I beam was used on the first platform. A 10" transverse web frame was constructed at frame 52 1/2 under the main and forecastle decks. Forward of this frame, the main and forecastle decks were completed with 7-1/2# plate. No deck was installed at the first platform level. The 10# flat shell plating of the temporary bow extended from the stem back to the shell at frame 55 ([Photo 62](#)).

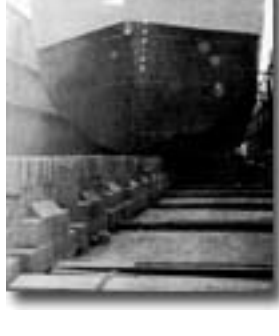
Photo 64: SELFRIDGE (DD 357) View in ARD-2 after plating had been installed on temporary bow.

4. On 23 November, SELFRIDGE got underway for Noumea, New Caledonia, arriving 1 December. There she was drydocked in ARD-2. The structure remaining below the waterline was trimmed to permit the use of straight structural shapes and flat plates in completing the temporary bow structure below the waterline. Bulkhead 55 was stiffened by installing a horizontal 10" I at the second platform level. The stem was made from a 10" I installed from the keel at frame 52 to the 1st platform. Similar girders were installed at the 2nd platform level from the center and ends of the I beams used to stiffen bulkhead 55 ([Photo 63](#)). Flat plating was then installed (Photos [64](#) and [65](#)).

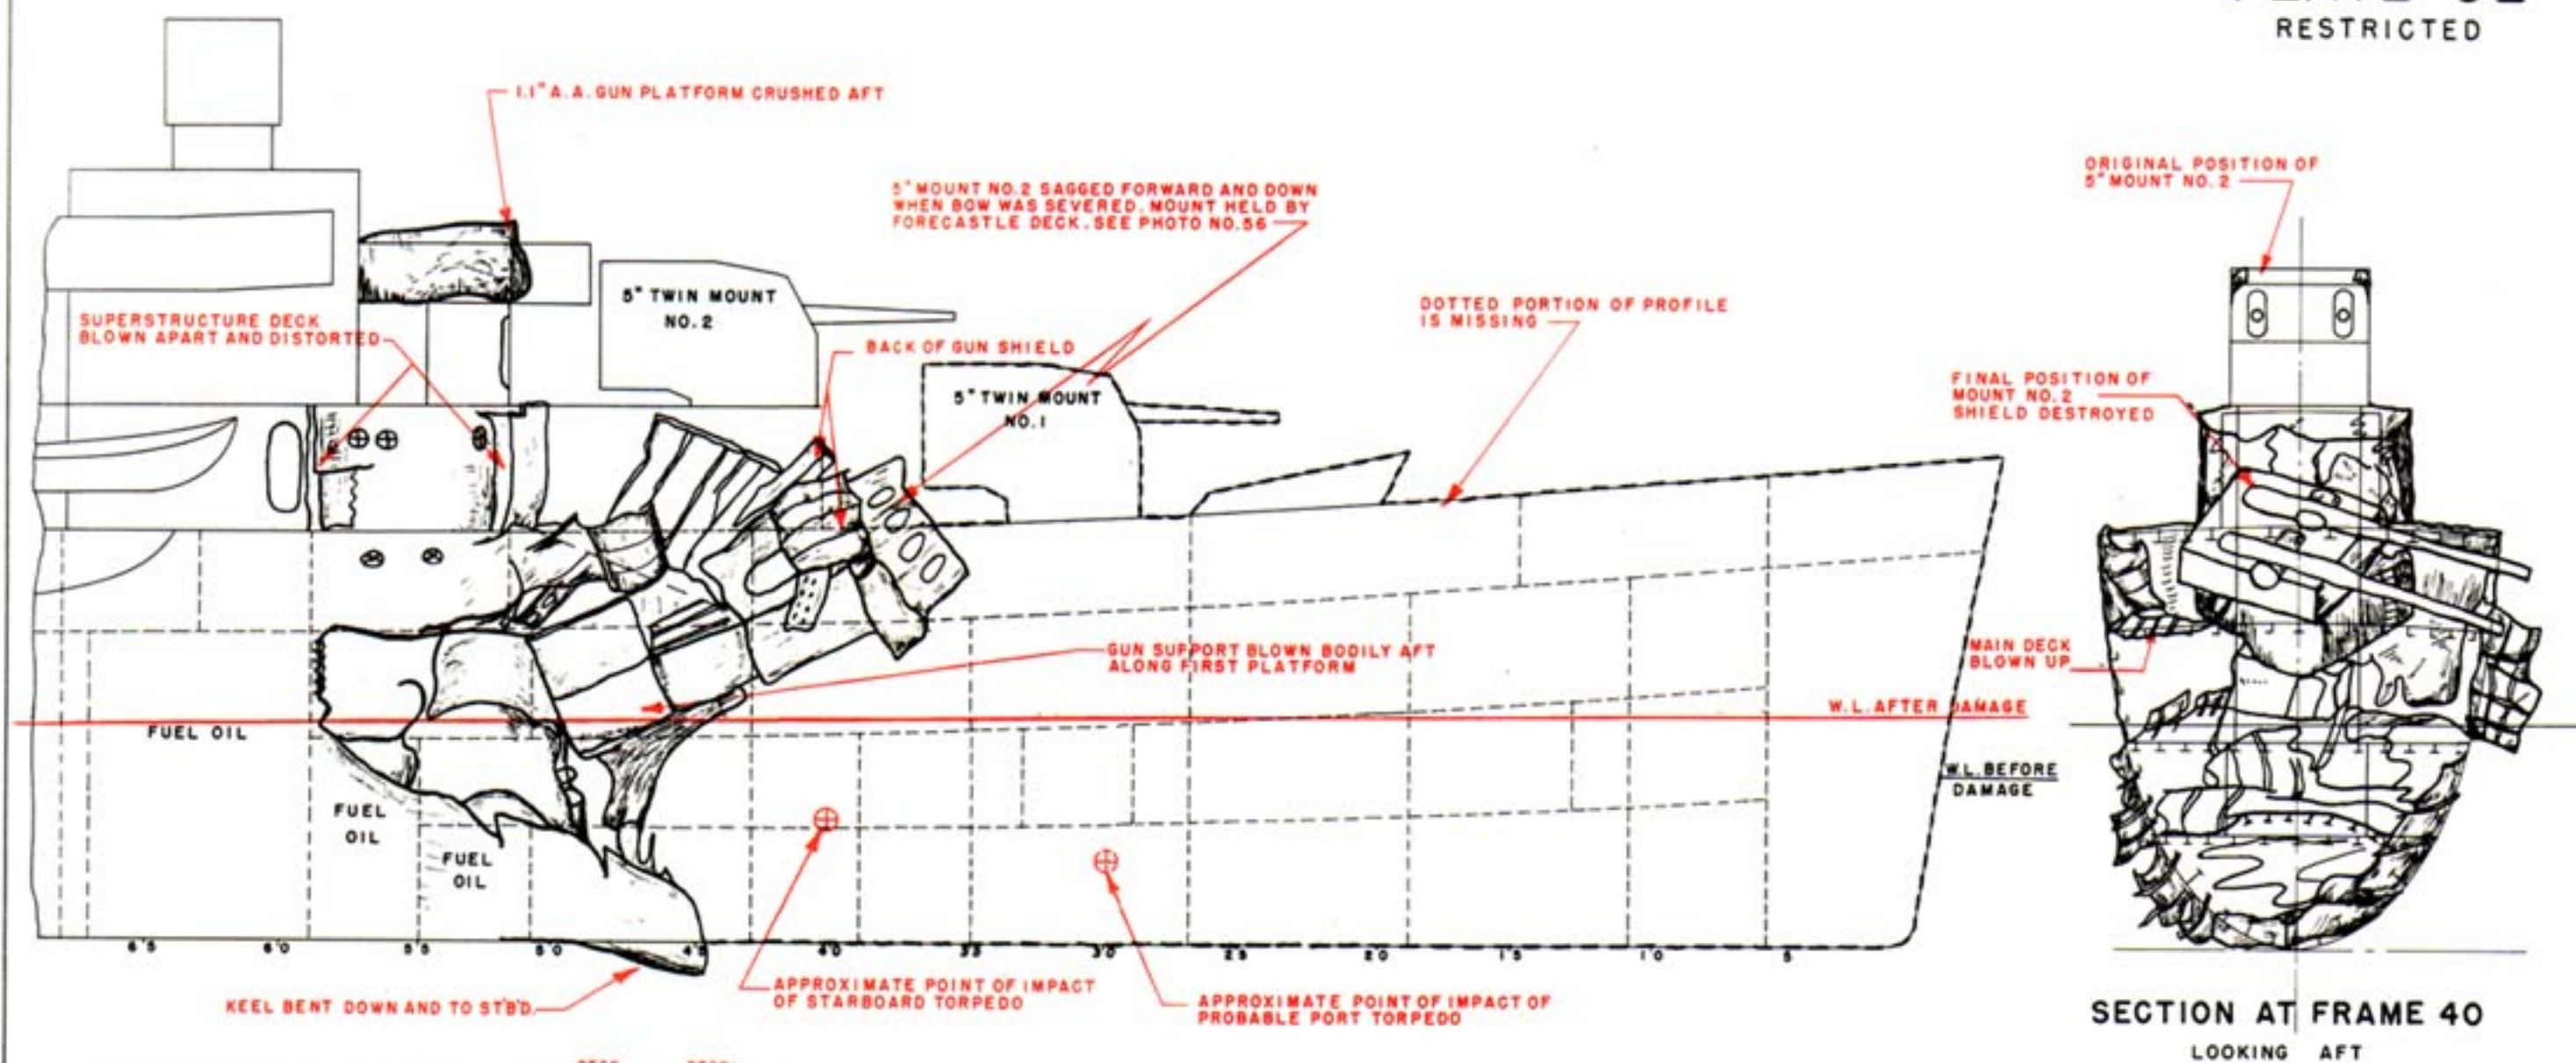
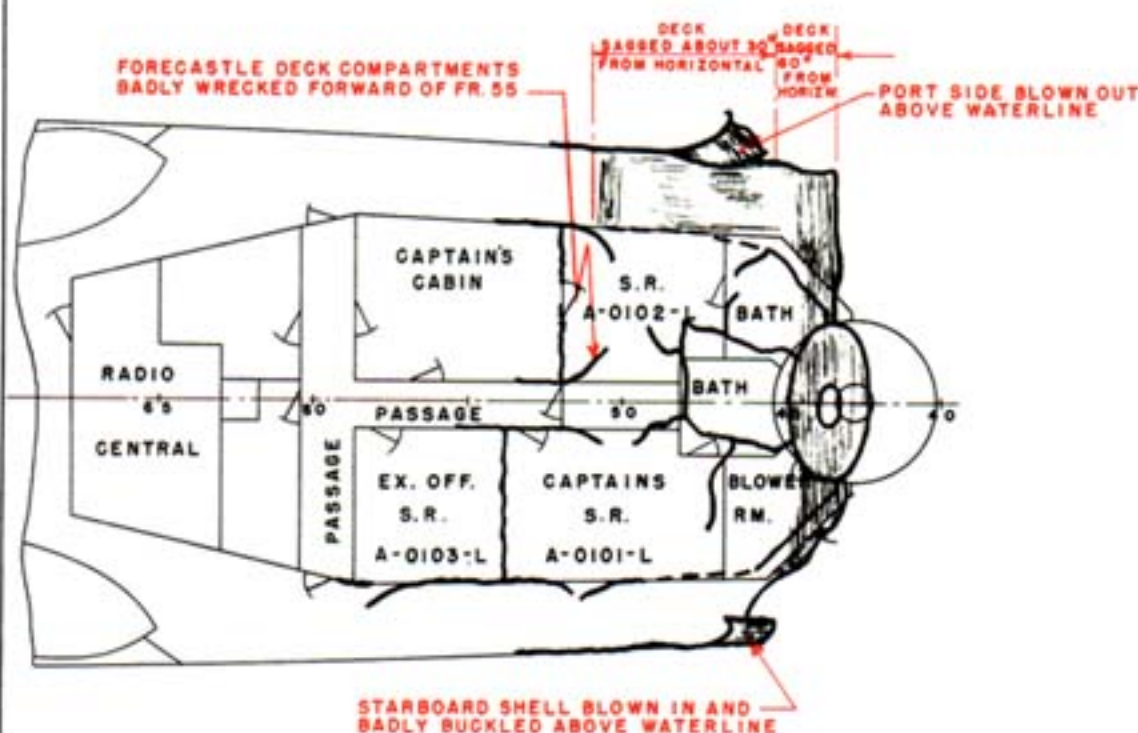
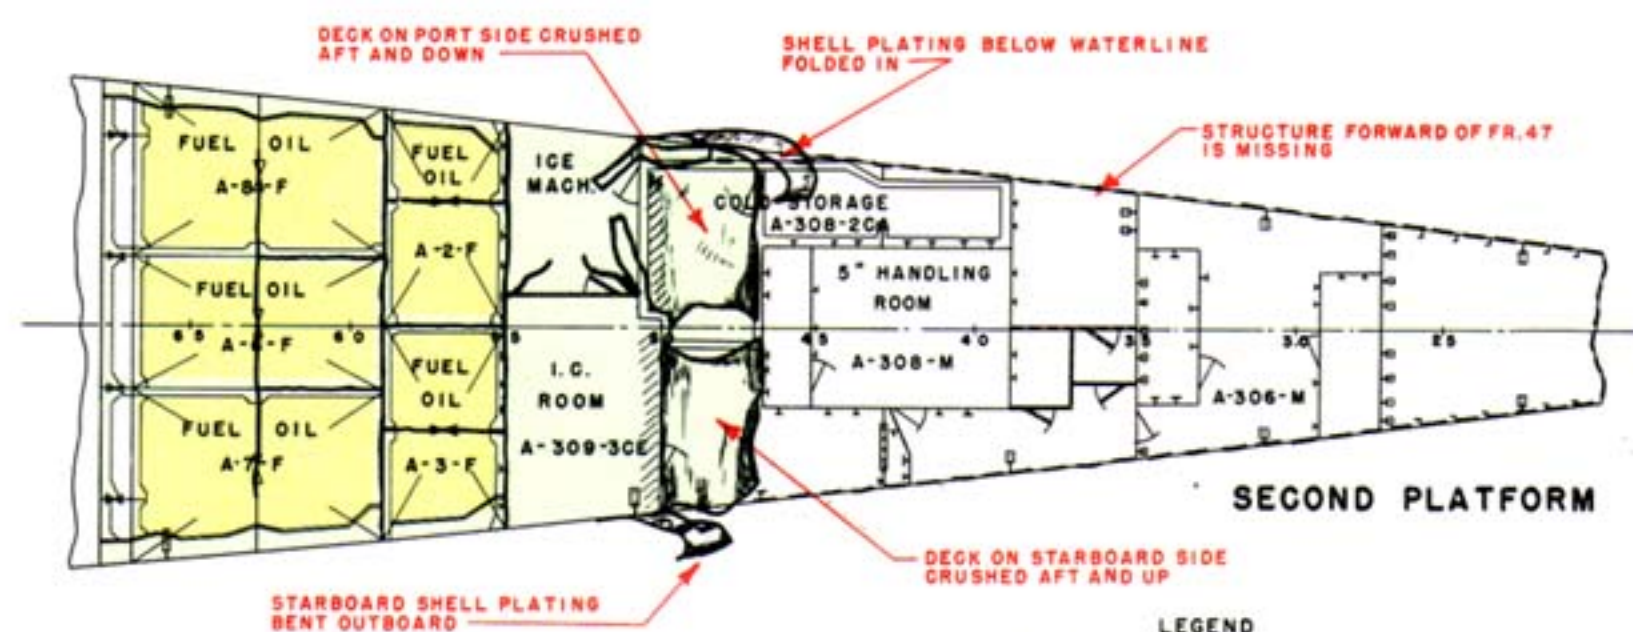
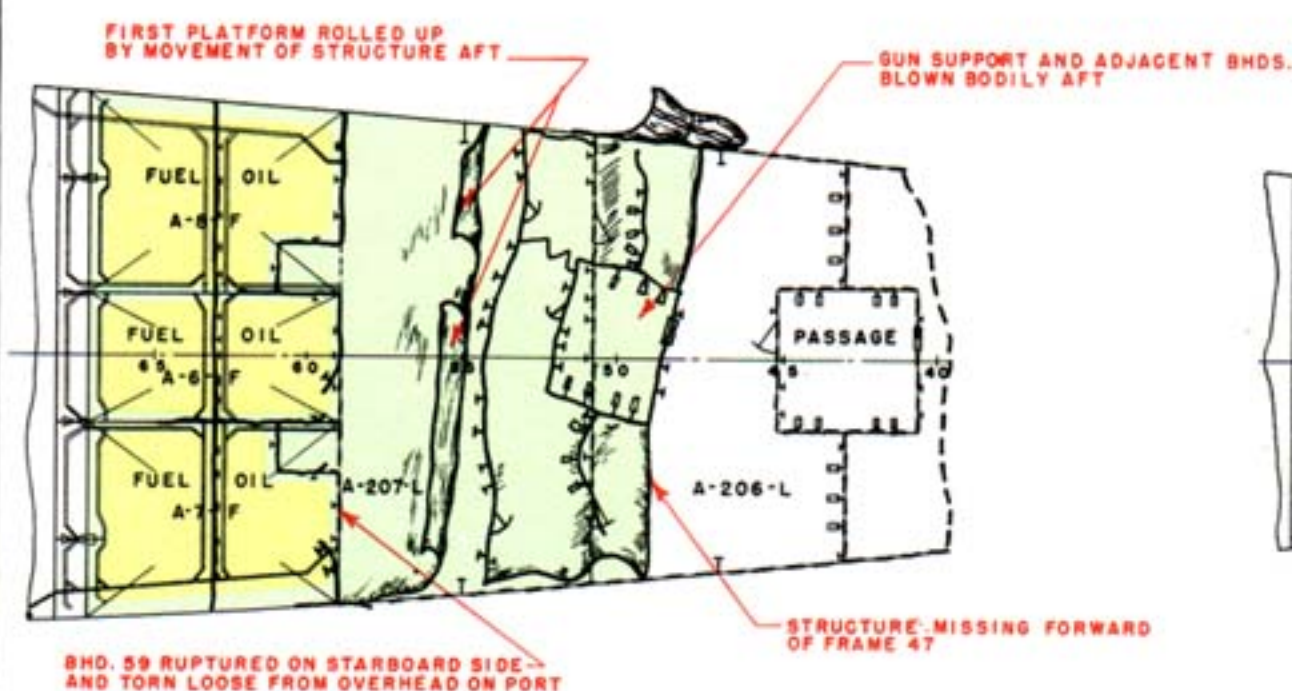
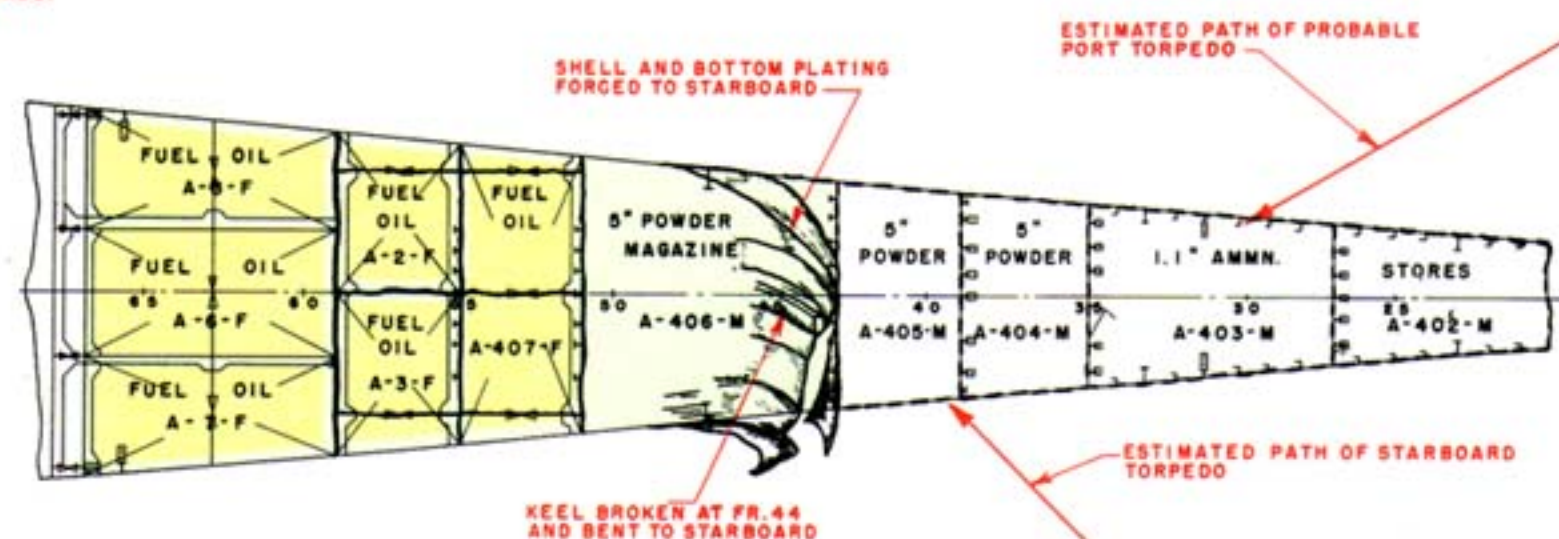
Plate 32: U.S.S. SELFRIDGE DD-357 Torpedo Damage

SECTION AT FRAME 40
LOOKING AFT

NOTE:
DAMAGE TO STARBOARD SHELL AND SHAFT CAUSED BY SEVERED BOW NOT SHOWN

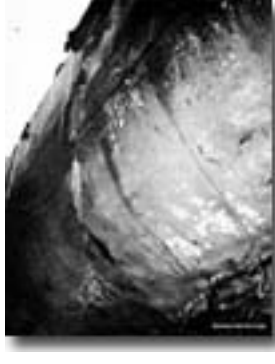
Photo 67: USS FOOTE (DD 511)
Wrinkles in shell plating frame 163, port. Damaged plating in way of port shaft can be seen at lower right corner. Note external longitudinal stiffener on sheer strake installed at Purvis Bay.

- (c) Restoration of longitudinal strength. 4" x 3"-20#/20# welded T stiffeners with tapered ends and web brackets were installed in way of damaged structure on the main deck and sheer strake, frame 154-176 ([Plate 34](#), [Photo 67](#)). Four 3" x 20# flatbar stiffeners were welded on the main deck, frame 26-32.

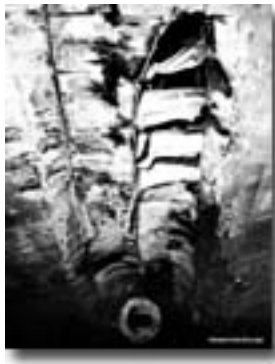
Photo 68: USS FOOTE (DD 511)
Damage to shell caused by starboard shaft.

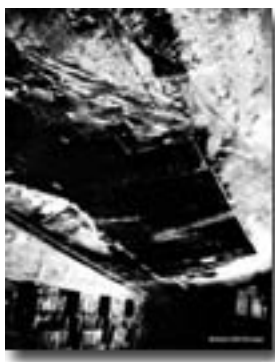
Photo 70: USS FOOTE (DD 511)
Flush patch over starboard stern tube./TD>

- (a) Additional longitudinal strength members were installed on the main deck ([Plate 34](#)).
- (b) A stern cofferdam was added aft of bulkhead 182 (Plates [34](#) and [35](#), [Photo 70](#)).
- (c) Two fixed fins were installed to improve towing characteristics ([Plate 35](#), Photos [70](#) and [71](#)). These fins were effective in preventing excessive yawing during tow to San Francisco.
- (d) Flush patches were welded over the damaged shell in the stern tube areas ([Plate 36](#), [Photo 72](#)).
- (e) Bulkheads 157, 170, and 182 were made watertight.

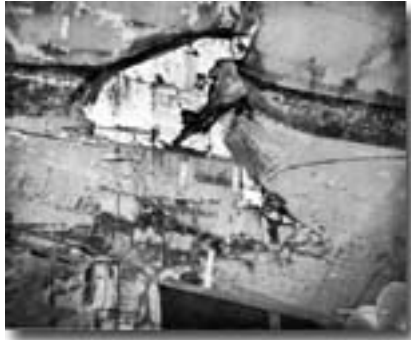
1. A deep running aircraft torpedo detonated at about frame 194, just forward of the rudder, while INTREPID was making a port turn. Structural damage and flooding were moderate, but the rudder and steering gear were damaged beyond use or repair and the fairing piece over the counterbalance portion of the rudder was blown off (Photos 73, 74 and 75). The effect of the damage on ship control was equivalent to maintaining 6 1/2° left rudder. After considerable experimentation, including measures to reduce the drag aft and to provide sail area forward, the ship was able to proceed from Truk to Pearl Harbor using main engines for steering. While in drydock at Pearl Harbor, the damaged rudder was removed with the expectation that this would facilitate controlling the ship by use of the engines during the trip to San Francisco.

Photo 73: Damage to starboard side and rudder.

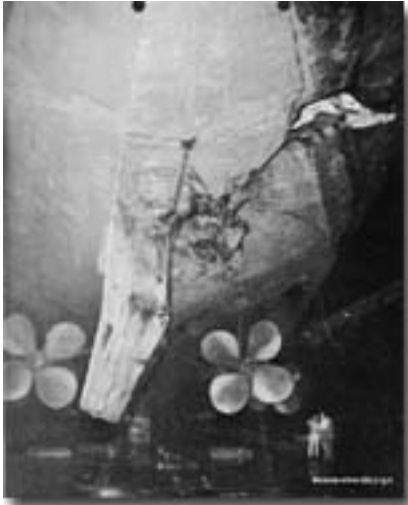
Photo 74: Looking forward towards damage to shell and rudder.

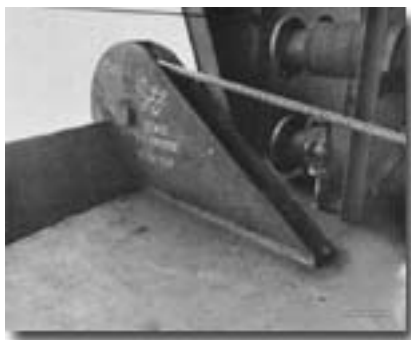
Photo 78: Looking forward, showing jury rudder and method of rigging control cables.

3. An auxiliary centerline fin, equal in area to the original rudder, was installed. A 100 square foot section at the after end of the fin was hinged to serve as a jury rudder; this hinged portion having about 20% of the area of the original rudder (Photos 76, 77 and 78). The jury rudder could be rotated through a maximum angle of 20° right or left. It was controlled by wire cables which passed through a protecting pipe outboard of the shell and over sheaves at the deck edge on the fantail (Photos 77, 78 and 79). The ends of the rudder cables were secured to gun-tackle purchases, the running ends of which were taken to the after capstan (Photos 80 and 81).

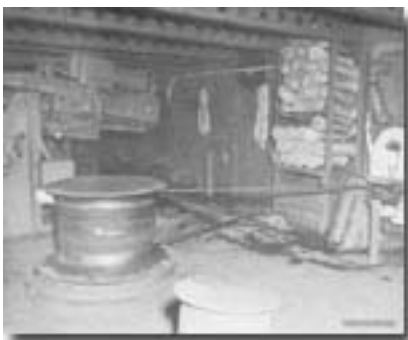
Photo 79: Sheave for jury rudder control cable.

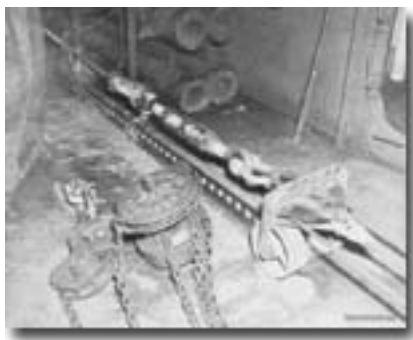
Photo 80: Fantail showing gun tackle purchases and rigging of wire to capstan.

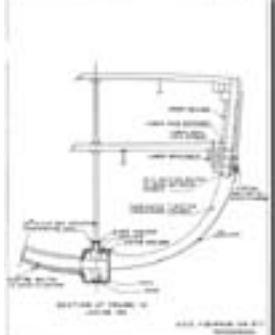
Photo 93: VIBURNUM (AN 57)
Structural support for main deck.

5. The damaged portion of the lower deck was replaced by a steel deck. Deep I beams were used to replace the longitudinal 9" x 9" timber girders and served as intermediate supports for transverse channel sections which terminated in specially designed structure that landed on the lower deck shelf and was bolted to the lower deck lockstrake (Photos 91 and 92), The replacement of the main deck was similar to that,of the lower deck, with deep longitudinal I girders replacing the 9" x 9" longitudinal timbers. Transverse channels were landed on the main deck shelf and were given intermediate support by the longitudinals (Photo 93). Pipe stanchions were installed between the hold, lower and main decks to provide additional support.

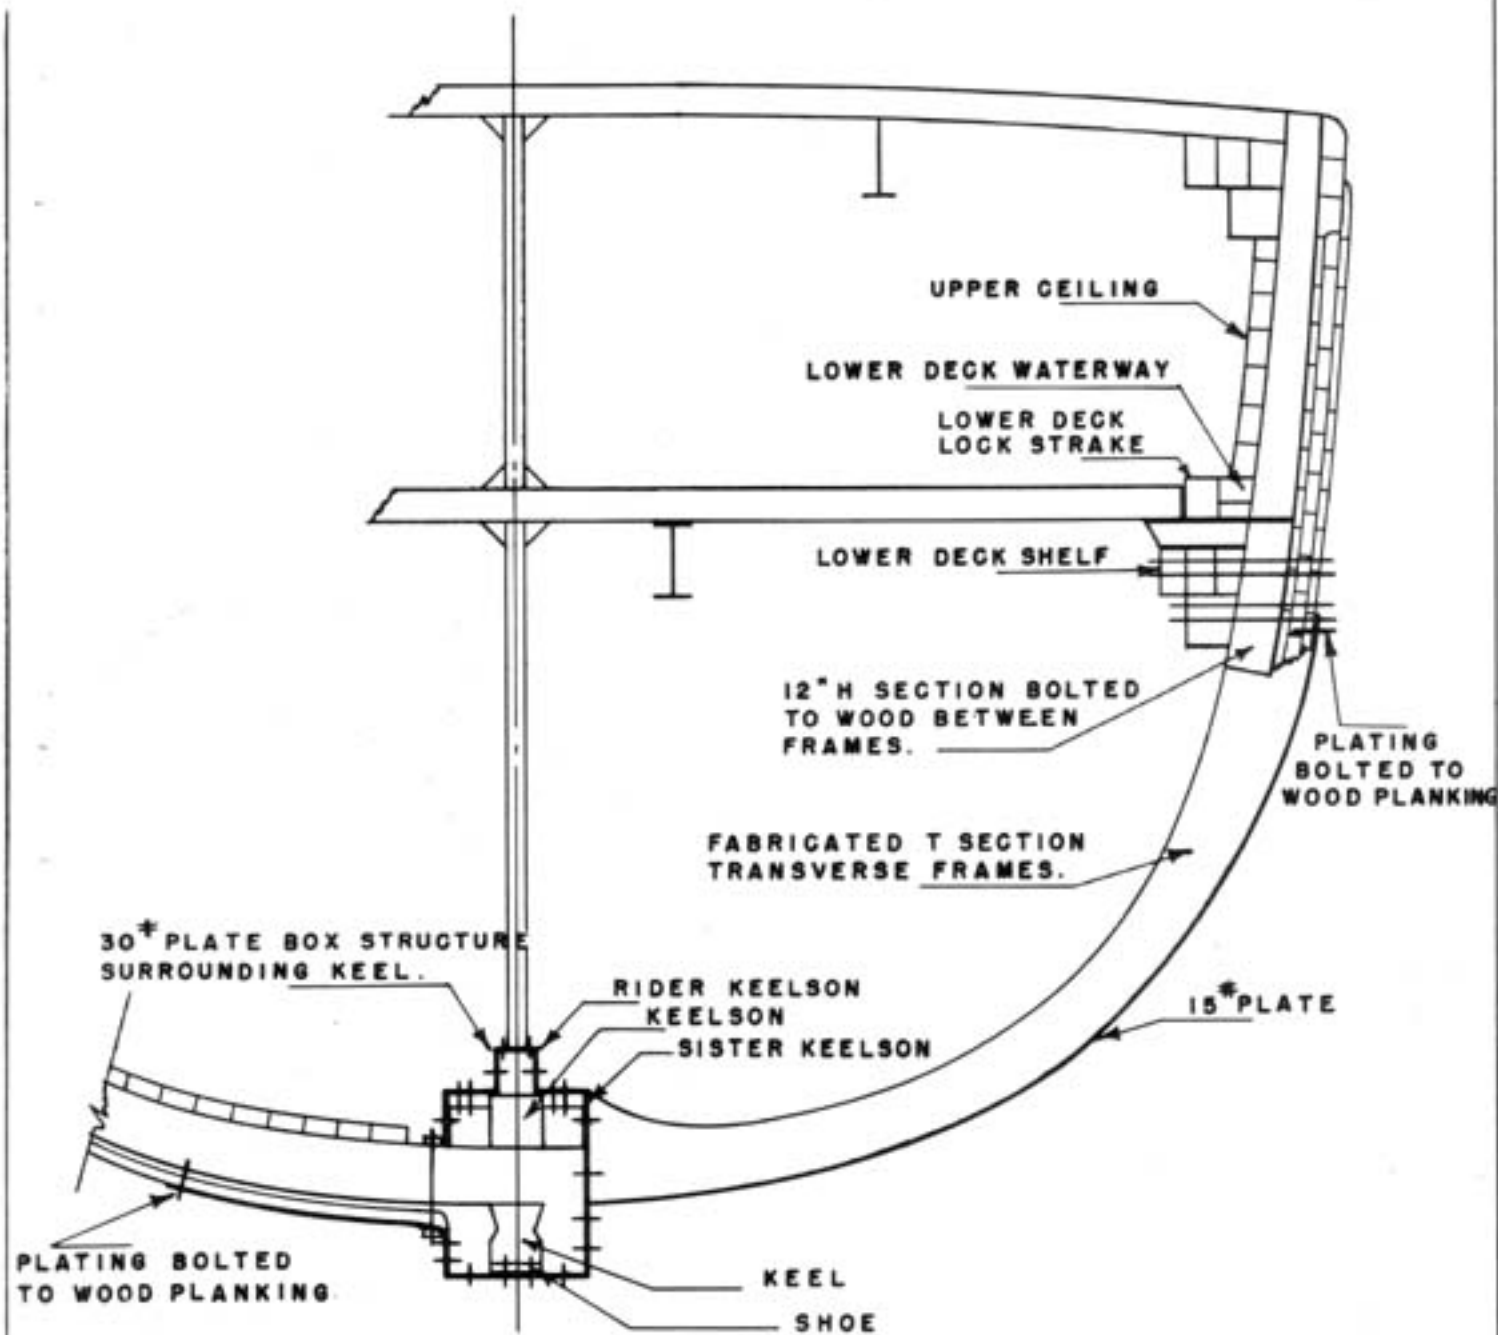
PLATE 38

SECTION AT FRAME 12
LOOKING FWD.

2. The crew undertook salvage measures that succeeded in reducing the drafts to 17' 6" forward and 12' aft. In order to accomplish this, the horns were cut off and moved to the fantail, the anchor chains were moved aft, debris was removed from the damaged spaces forward, and A-1W and the space between bulkheads 27 and 30 were made tight so that the spaces could be pumped dry. This made it possible to drydock VIBURNUM in ARDL 32 (Plate 38).
